# TAURANGA STORM EVENT OF 18 MAY, 2005: LANDSLIP ISSUES

## INTRODUCTION

## **APPENDIX 2 Report of Dr Laurie Richards.**

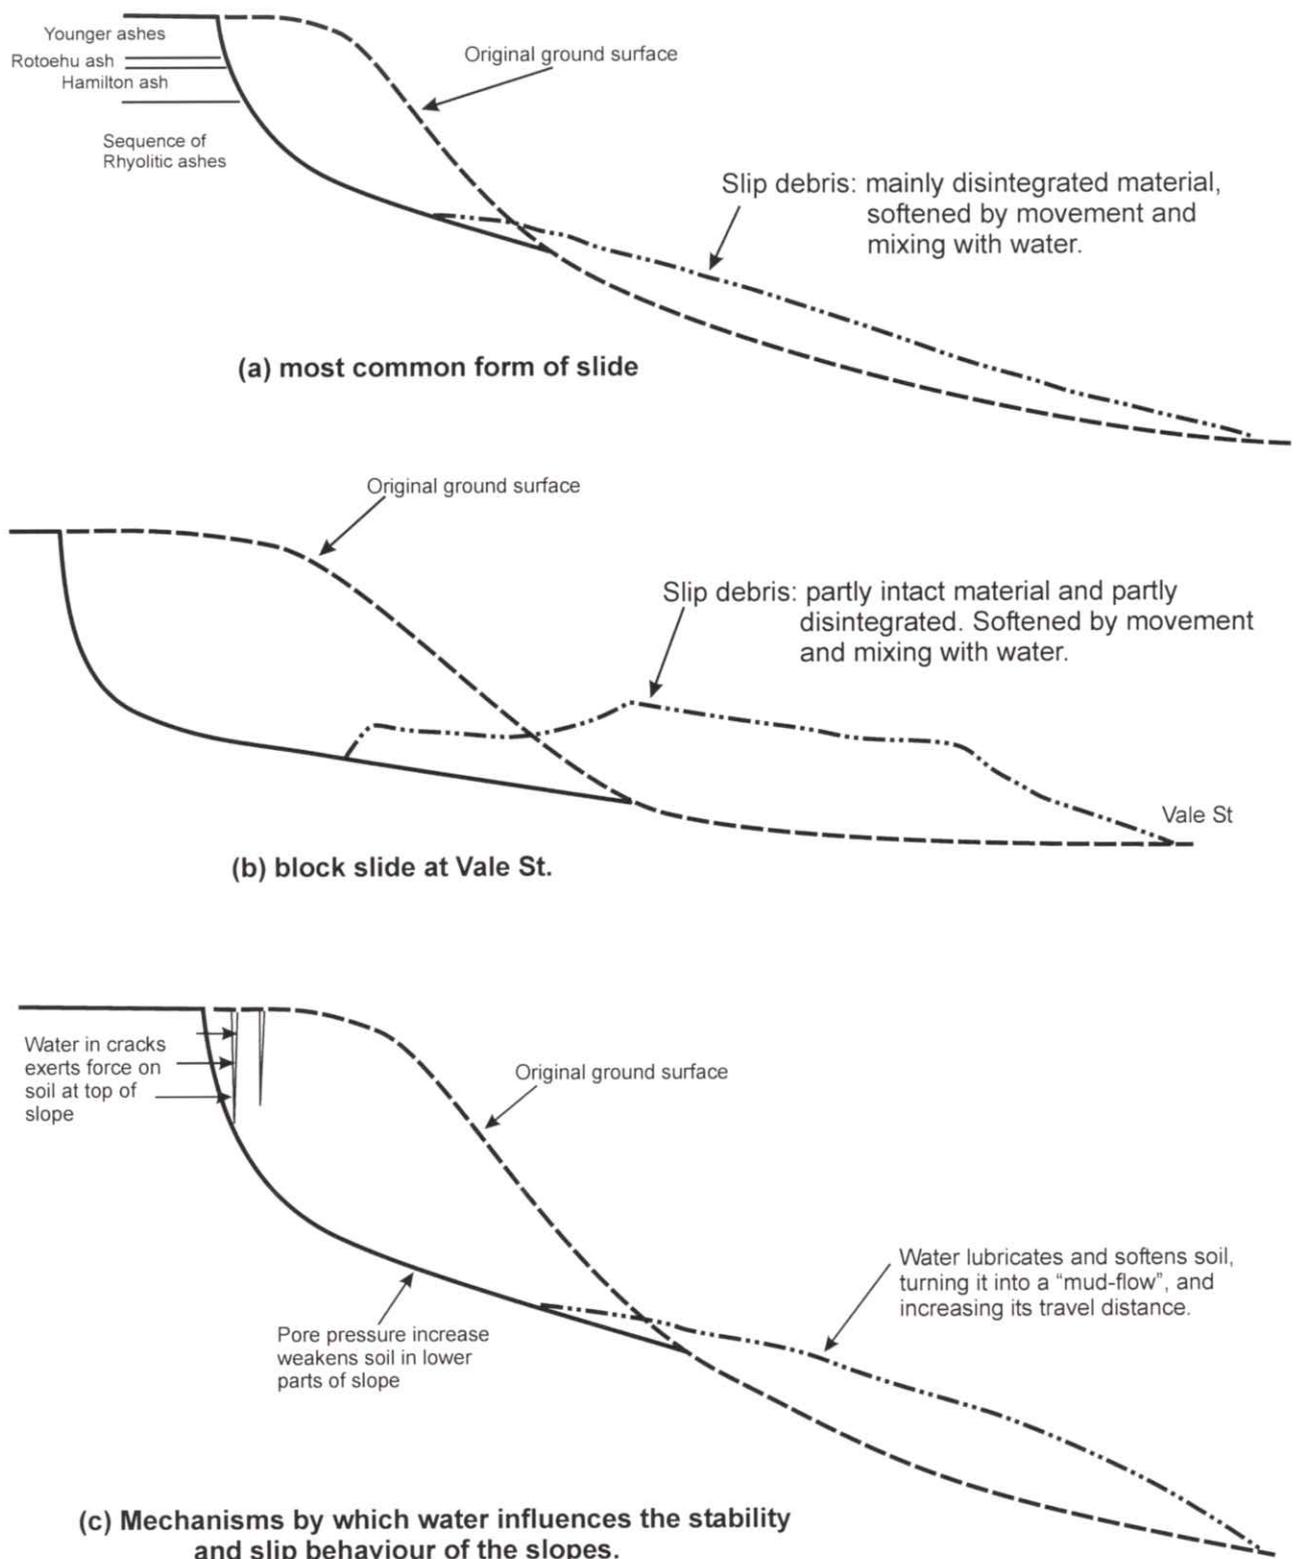
Figure 1 Diagramatic representation of slip cross sections

There was, however, at least one slip that was rather different from most of the slips. This was the large slip in Vale St. which pushed the house below it a considerable distance towards the road. This slip extended over almost the full height of the slope and had the form of what is known as a “block” slide. In this case a large block of the slope moved semi-horizontally towards the front of the section. As with the other slips, it partly disintegrated as it moved, and became softened by any water that was available to it. This form of this slide is shown in Figure 1(b).

Figure 1(c) attempts to illustrate diagrammatically the way in which water induces slips in slopes. The mechanism is not one whereby previously dry sloped become wet. All soils, especially those in Tauranga consisting of fine-grained clayey materials, contain large quantities of water all year round. The influence of periods of intense rainfall is to “pressurise” this water, and consequently to weaken the soil. The longer the time over which the site is subjected to abundant supplies of surface water, the greater will be the increase in pressure and consequent weakening effect.

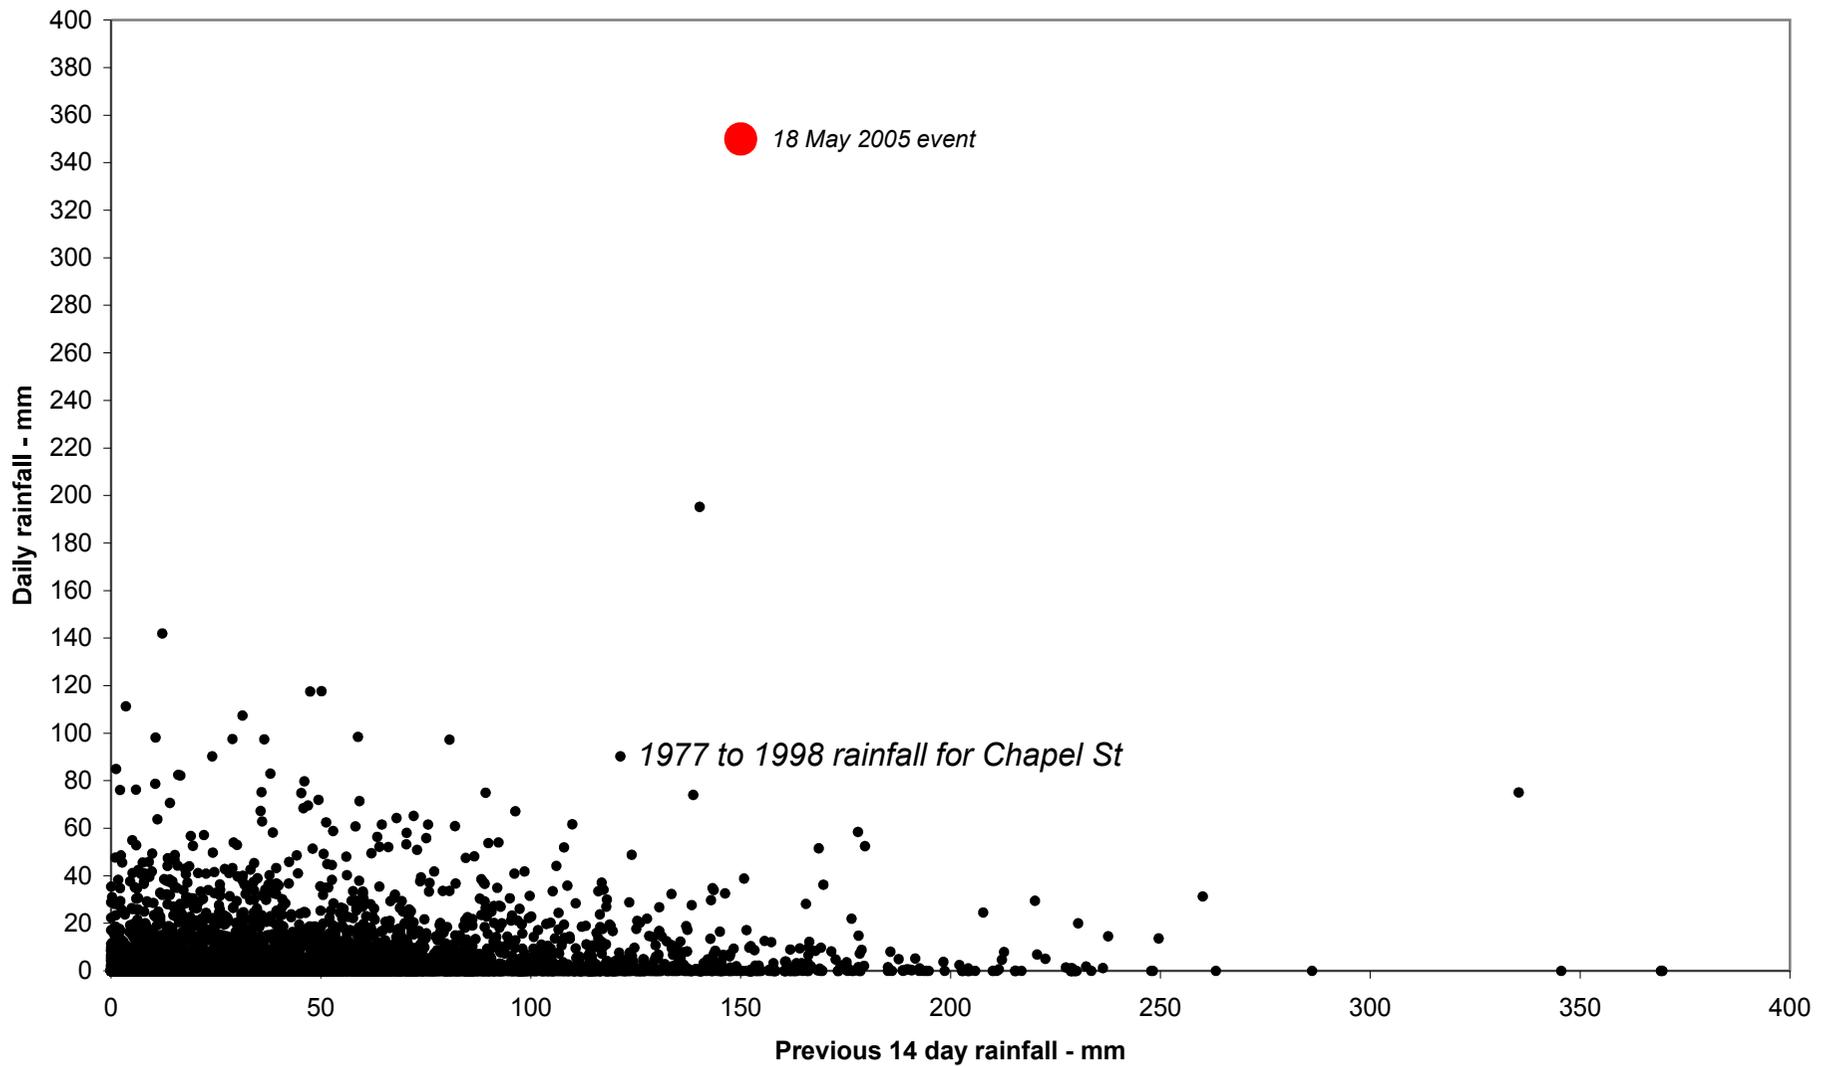
Figure 1: 18 May 2005 rainfall compared with 1977 to 1998 at Chapel St

2. The triggering event for the landslides was unprecedented rainfall leading to failure of the stormwater drainage system and uncontrolled overland flow. NIWA's Autumn 2005 climate summary indicates unprecedented rainfalls at Tauranga Airport on and prior to 18 May:

8. The 18 May 2005 rainfall event was the highest 24 hour rainfall recorded in Tauranga. Because of the failure of the stormwater drainage system, slope failures would have been significant even if the previous few months had been drier than normal.

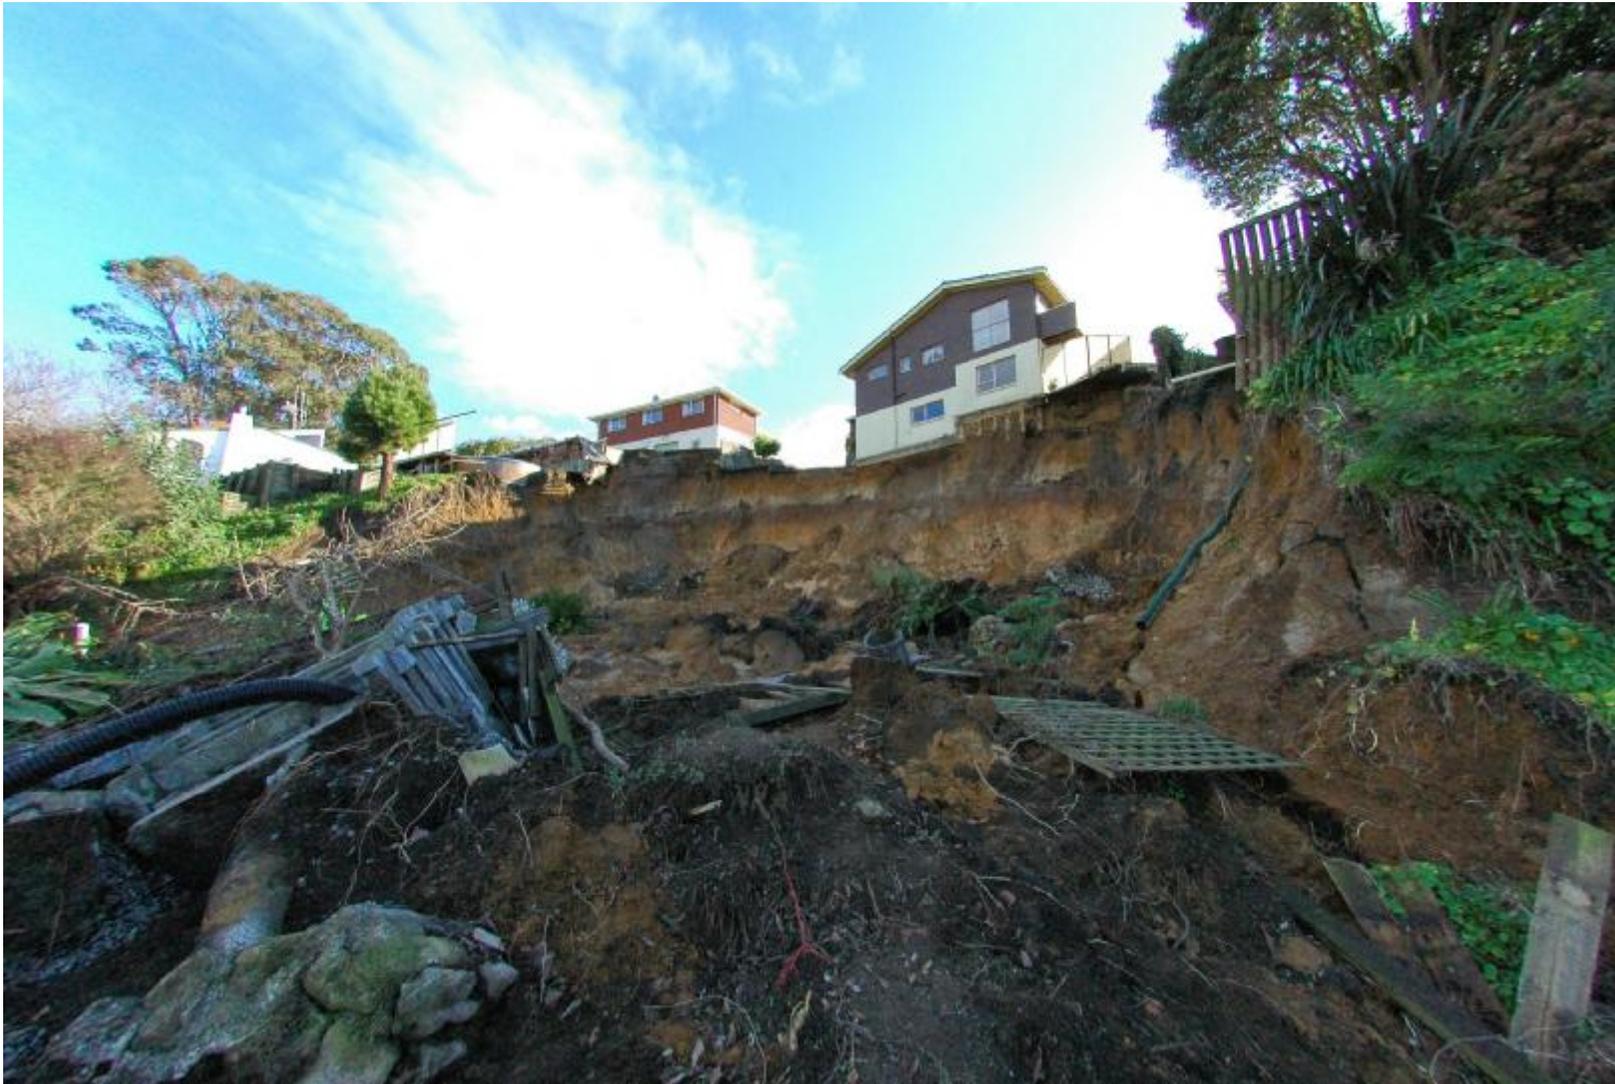
Figure 2: Example of landslide geometry at Vale Street  
**TAURANGA MAY 2005 LANDSLIDES**

- Landslide runout was generally within a 4H:1V line projected from the headscarp. Most of the damage to houses was caused by runout rather than subsidence effects.

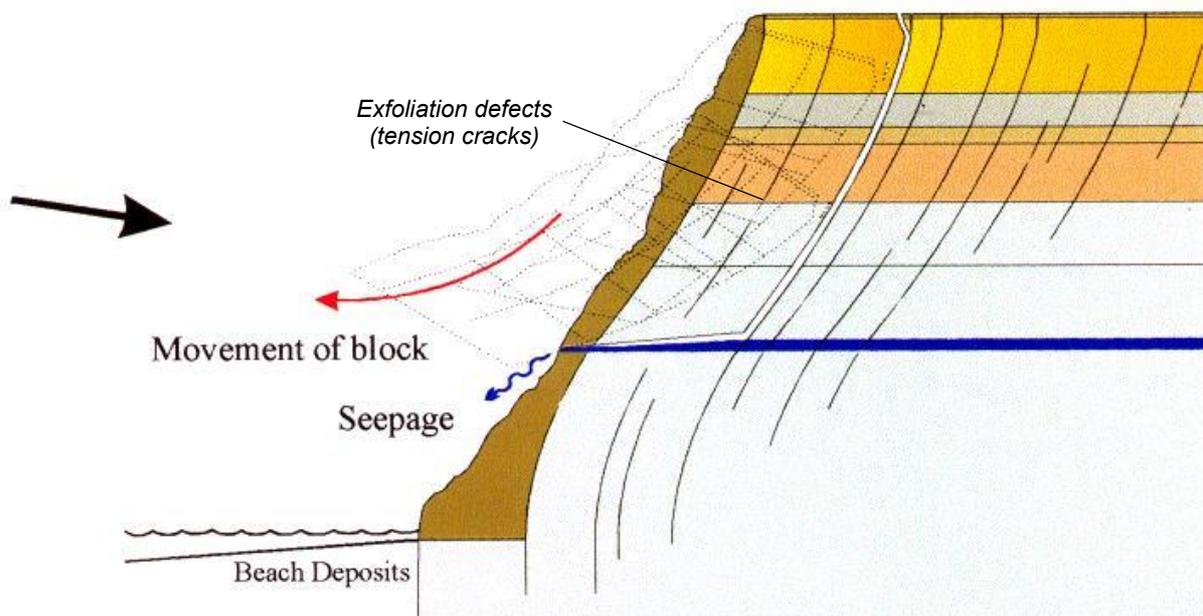
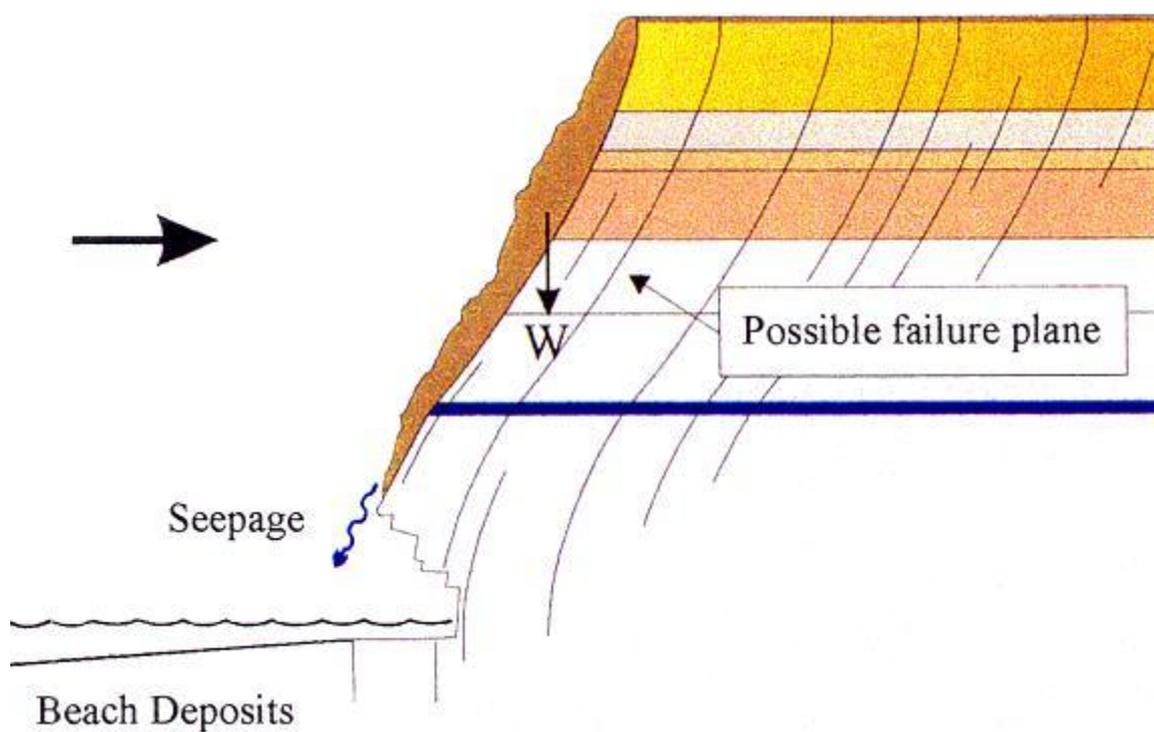
Figure 3: Slide morphology described by Oliver 1997

The presence of tension cracks is critically important to these slides. Such features have previously been identified by Oliver<sup>5</sup> (*Figure 3*) who referred to these as *exfoliation defects* rather than the more appropriate terminology of *tension crack* or *stress-relief defect*. These features have a significant effect on slope failures since their orientation precludes any significant frictional resistance along the features, and the water pressure in the open joints can exert high horizontal pressures on the slide mass.

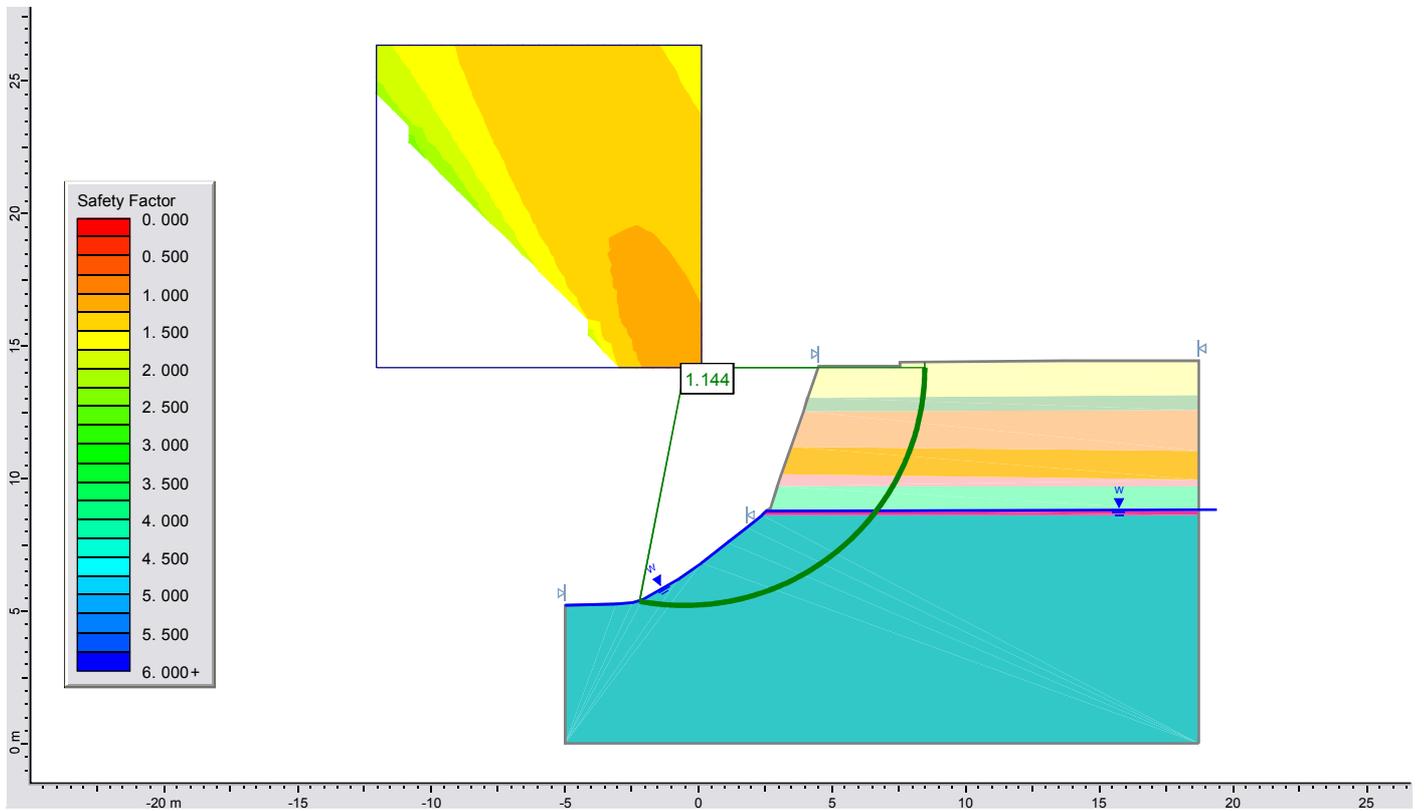
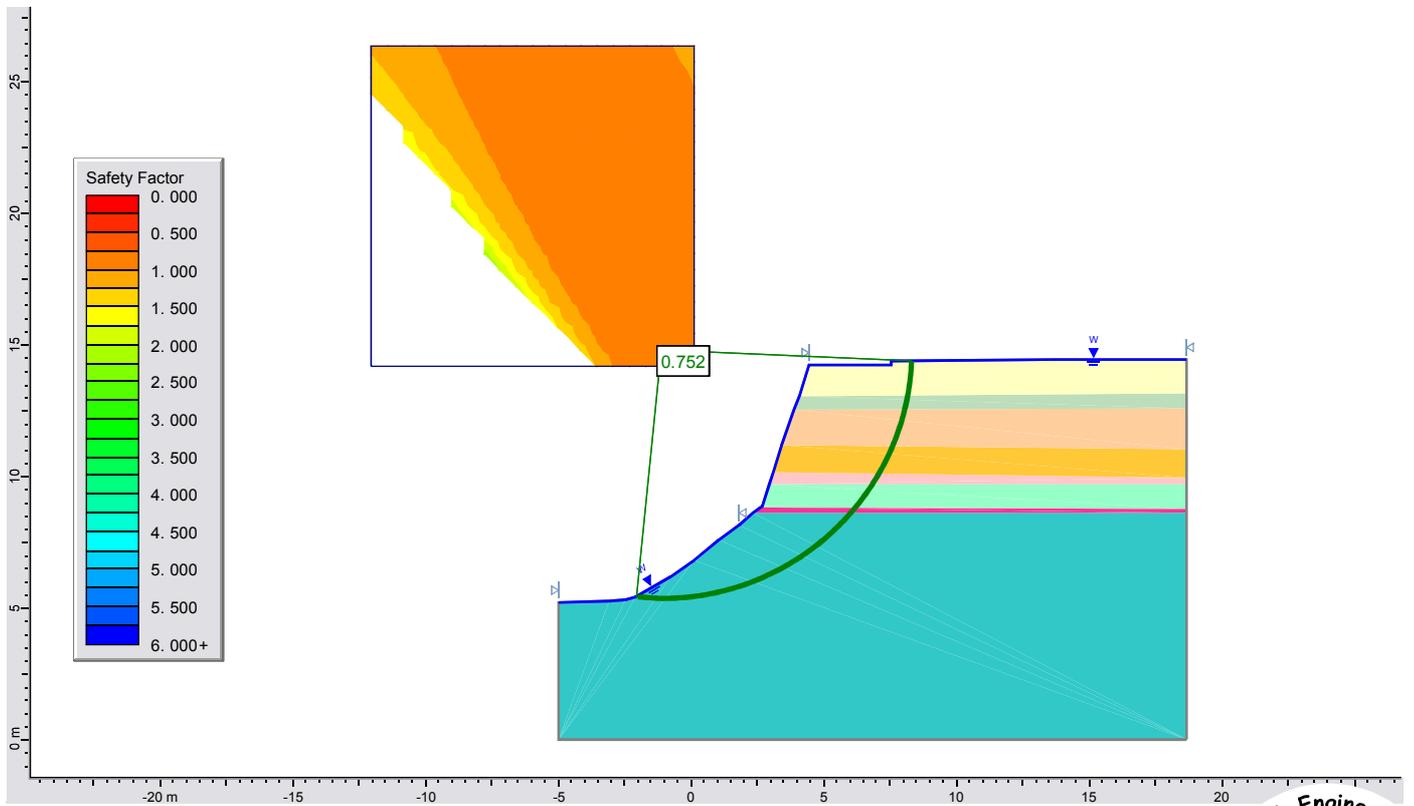
5. Without tension cracks or other structural controls present, the critical failure mode in these types of materials would be fairly deep-seated circular failures (see *Figures 4* and *5*) regardless of the level of the groundwater table. With water-filled tension cracks (*Figures 6* and *7*), the Factor of Safety (FOS) of the slope is significantly reduced and the critical failure surface moves closer to the slope crest for all groundwater conditions. Note that the above analyses are fairly simplistic since the toe of most failures is generally at the ash horizon.

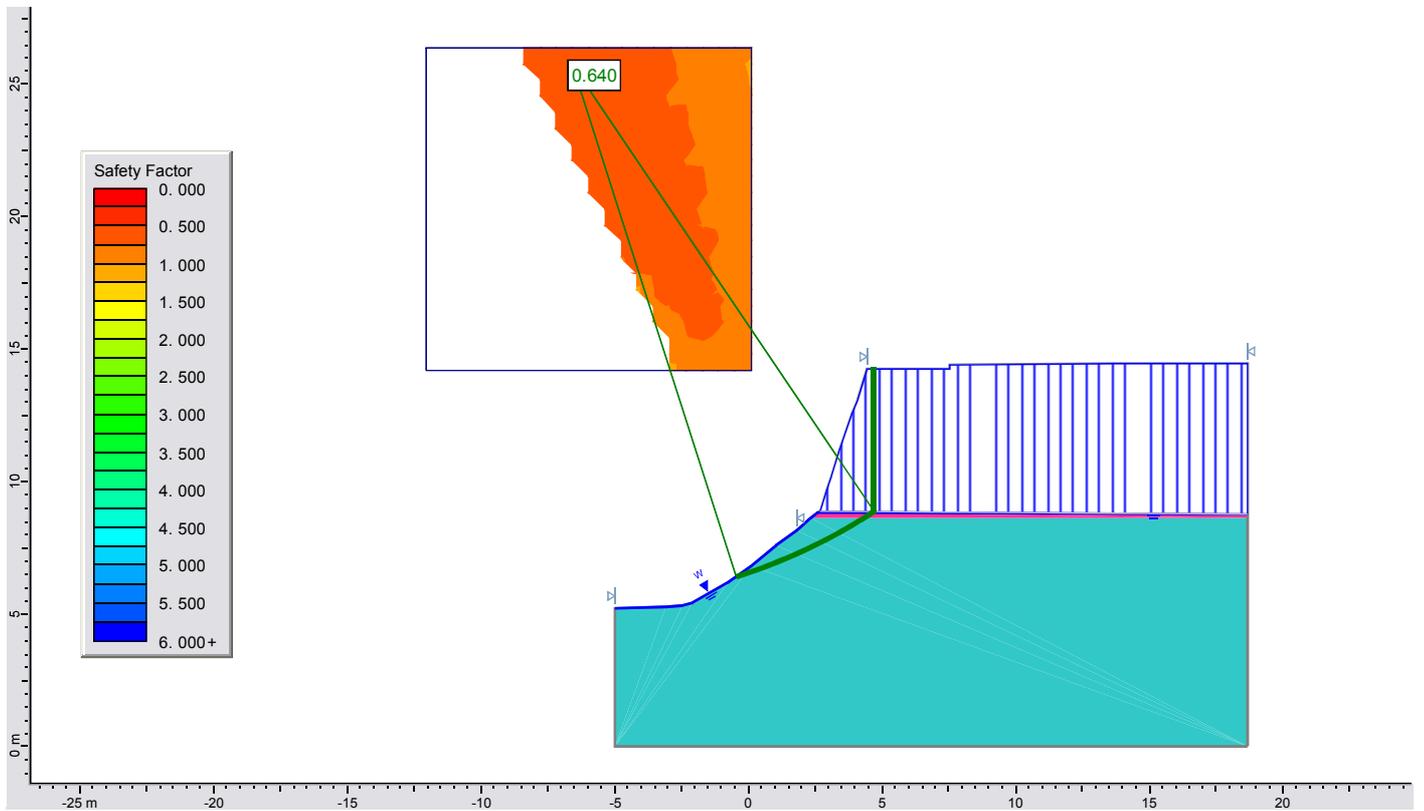
Figure 6: Slide with low groundwater level on ash layer plus tension cracks

- The back faces of the slides are often controlled by near vertical discontinuities or tension cracks
  - High water pressures in these tension cracks have the effect of causing slide "blowouts" which would have initiated regardless of the inherent soil or rock mass strength

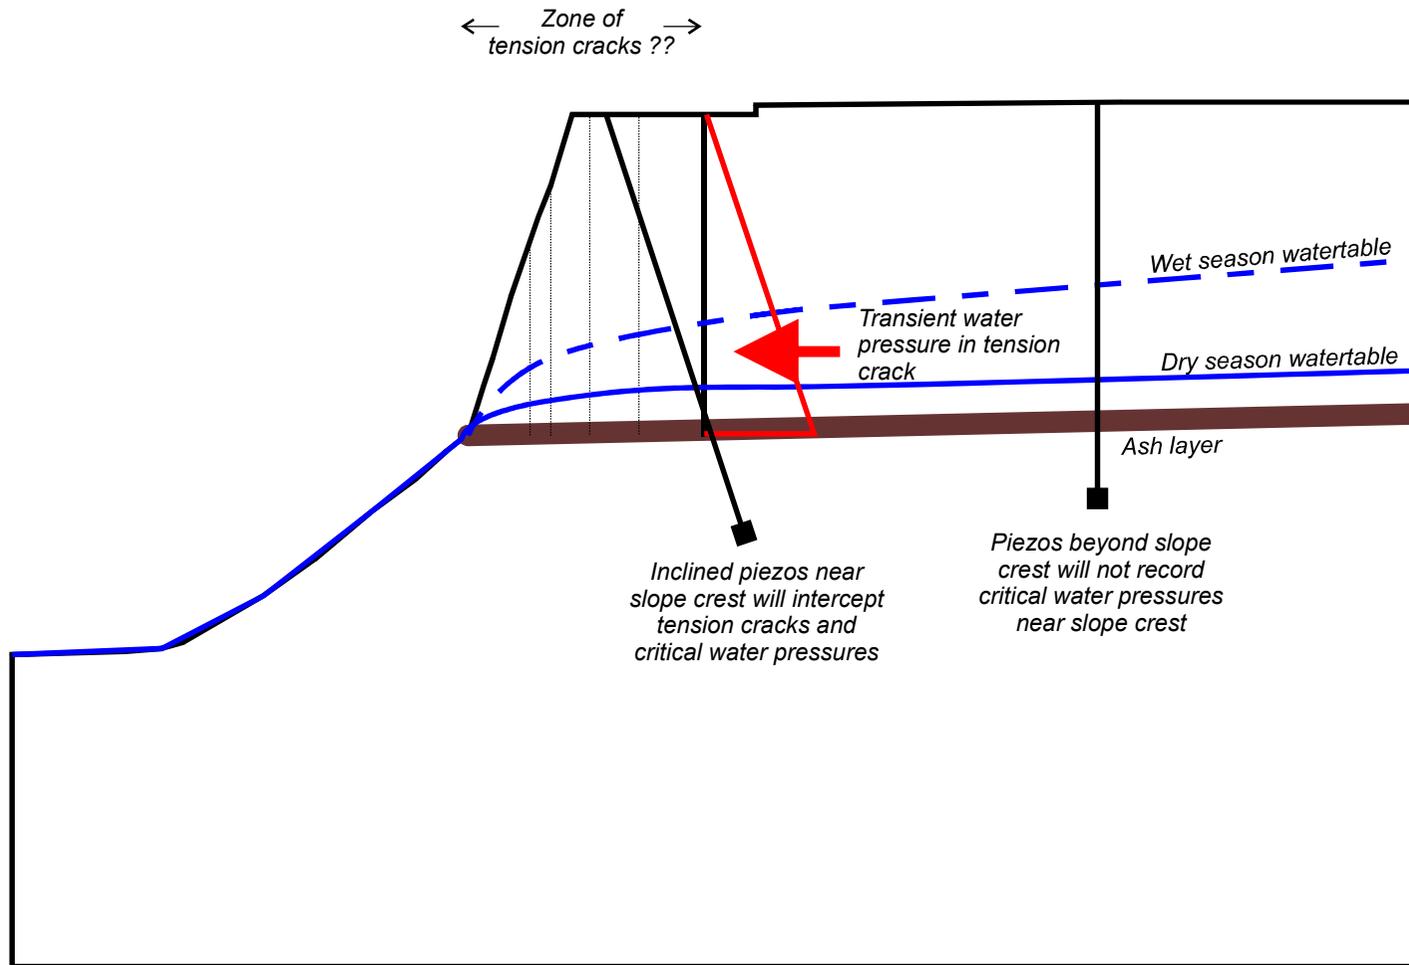
Figure 8: Piezo locations and slope water pressures  
**TAURANGA MAY 2005 LANDSLIDES**

10. Very little is known about the response of these tension cracks to rainfall events (i.e. crack water pressure versus rainfall relationships). These features are most critical nearest the slope crests. Piezometers placed at some distance from the slope crest (measuring pore pressures within the slope) may give little indication of critical water pressures near the crest. Piezometric monitoring needs to take account of the tension cracks – this is likely to result in piezometers being placed in inclined drillholes to ensure interception of the tension cracks (*Figure 8*). Given the aerial variation of rainfall, automatic rainfall gauges should be located close to all automatic piezometer locations.

- 
18. Piezometric monitoring should be established to identify critical water pressures near the slope crests. Automatic rainfall gauges will be required in the general area of the piezometers.
  19. Any further proposals for slope monitoring should be reviewed in relation to the slope failure mechanisms and the instrument capabilities.
  20. Conclusions arising from the review of these slides should be used to review TDC land development criteria and made available to all those concerned with development in this area.
