THE NATURE AND CAUSES OF  
COASTAL LANDSLIDING ON  
THE MAUNGATAPU PENINSULA,  
TAURANGA, NEW ZEALAND.

A thesis submitted in partial fulfilment of the  
requirements for the Degree of Master of Science  
in Earth Sciences

University of Waikato

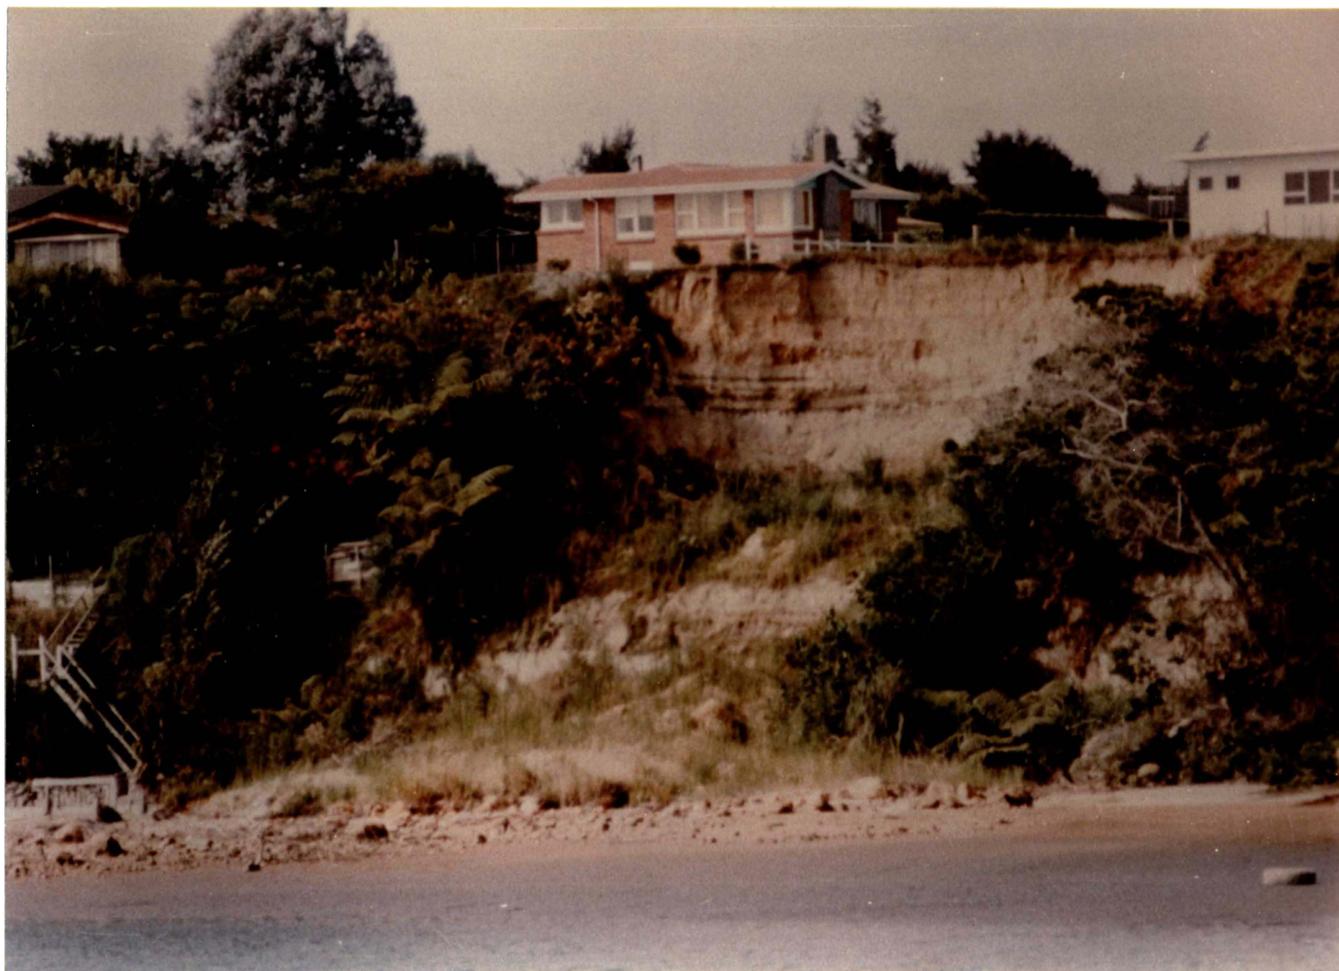
A frontal view of the landslide scar behind the Anglican church on Te Hono st., Maungatapu (Site 1).

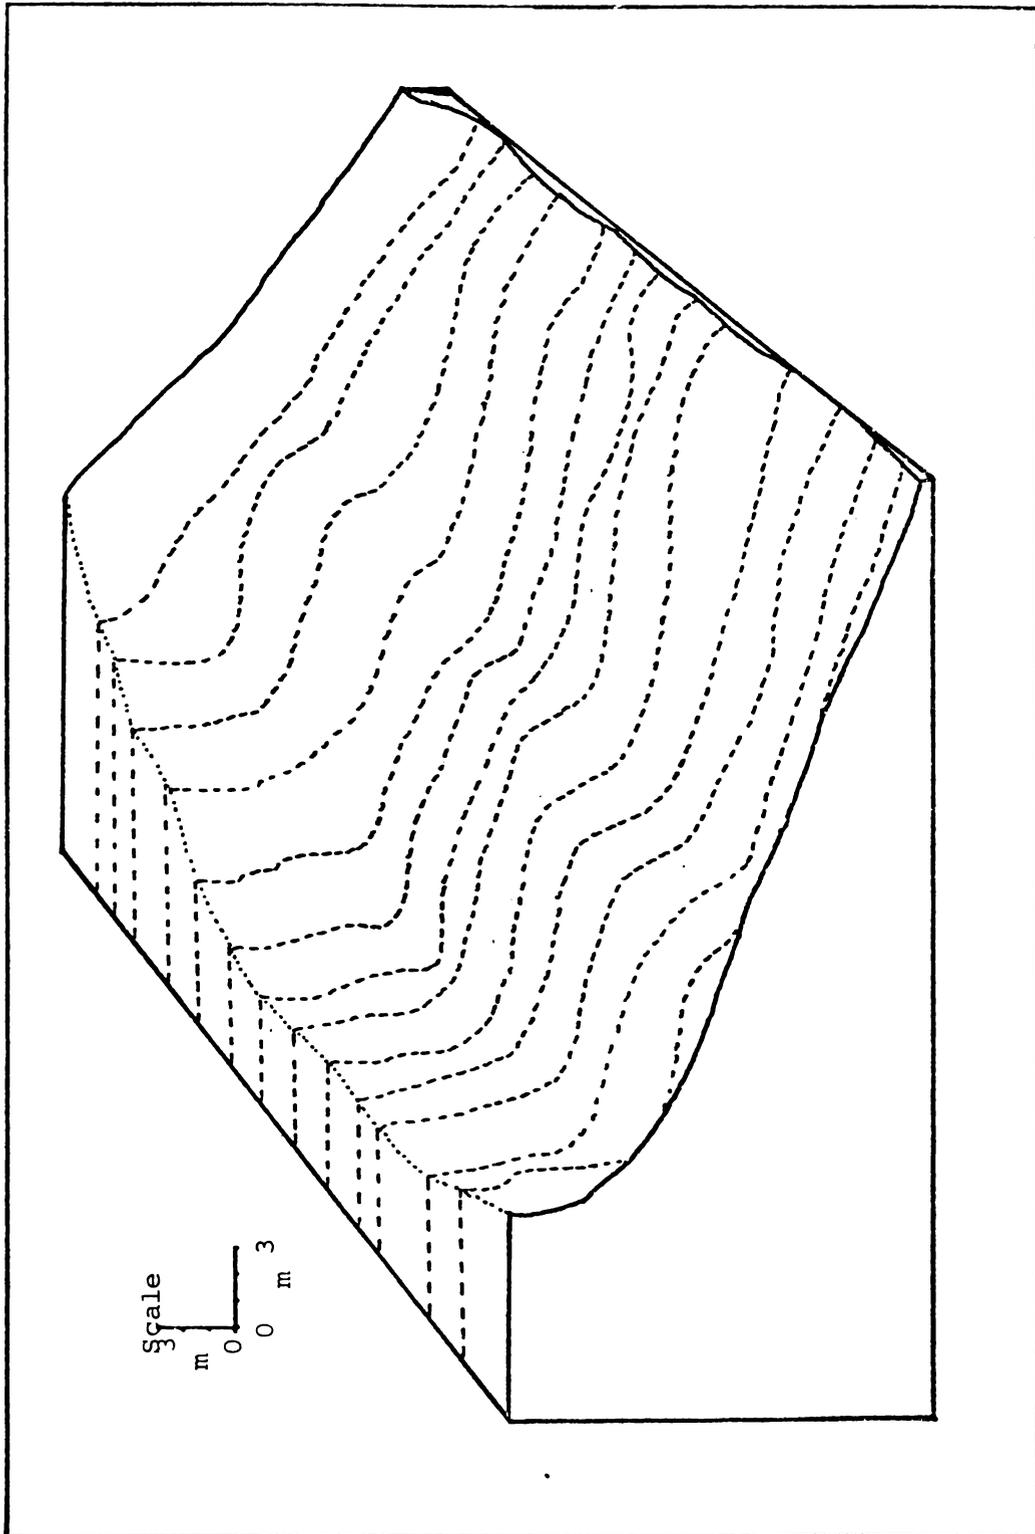
Figure 1.1. Block diagram of site 1.

These landslides occurred in the upper part of the cliff profiles, typically producing a cliff edge retreat of 0.3 to 2 metres across arcuate crowns, and had a distinctive shelf-like feature at 6 to 8 metres below the main scarp (fig. 1.1). Recent landslide scars of similar form may be observed about the harbour on the Matapihi, Te Puna, and Pahoia peninsulas, as well as on Motuhua island (fig. 1.2). A series of landslides similar in form but on a larger scale, with about three times the scarp height and cliff-edge retreat, were noted on Omokoroa peninsula following intense rain during August 1979 (Gibb, 1980). This group of distinctively shaped landslides observed along the coast of the Tauranga Harbour, and more particularly the Maungatapu peninsula, is the object of this study.

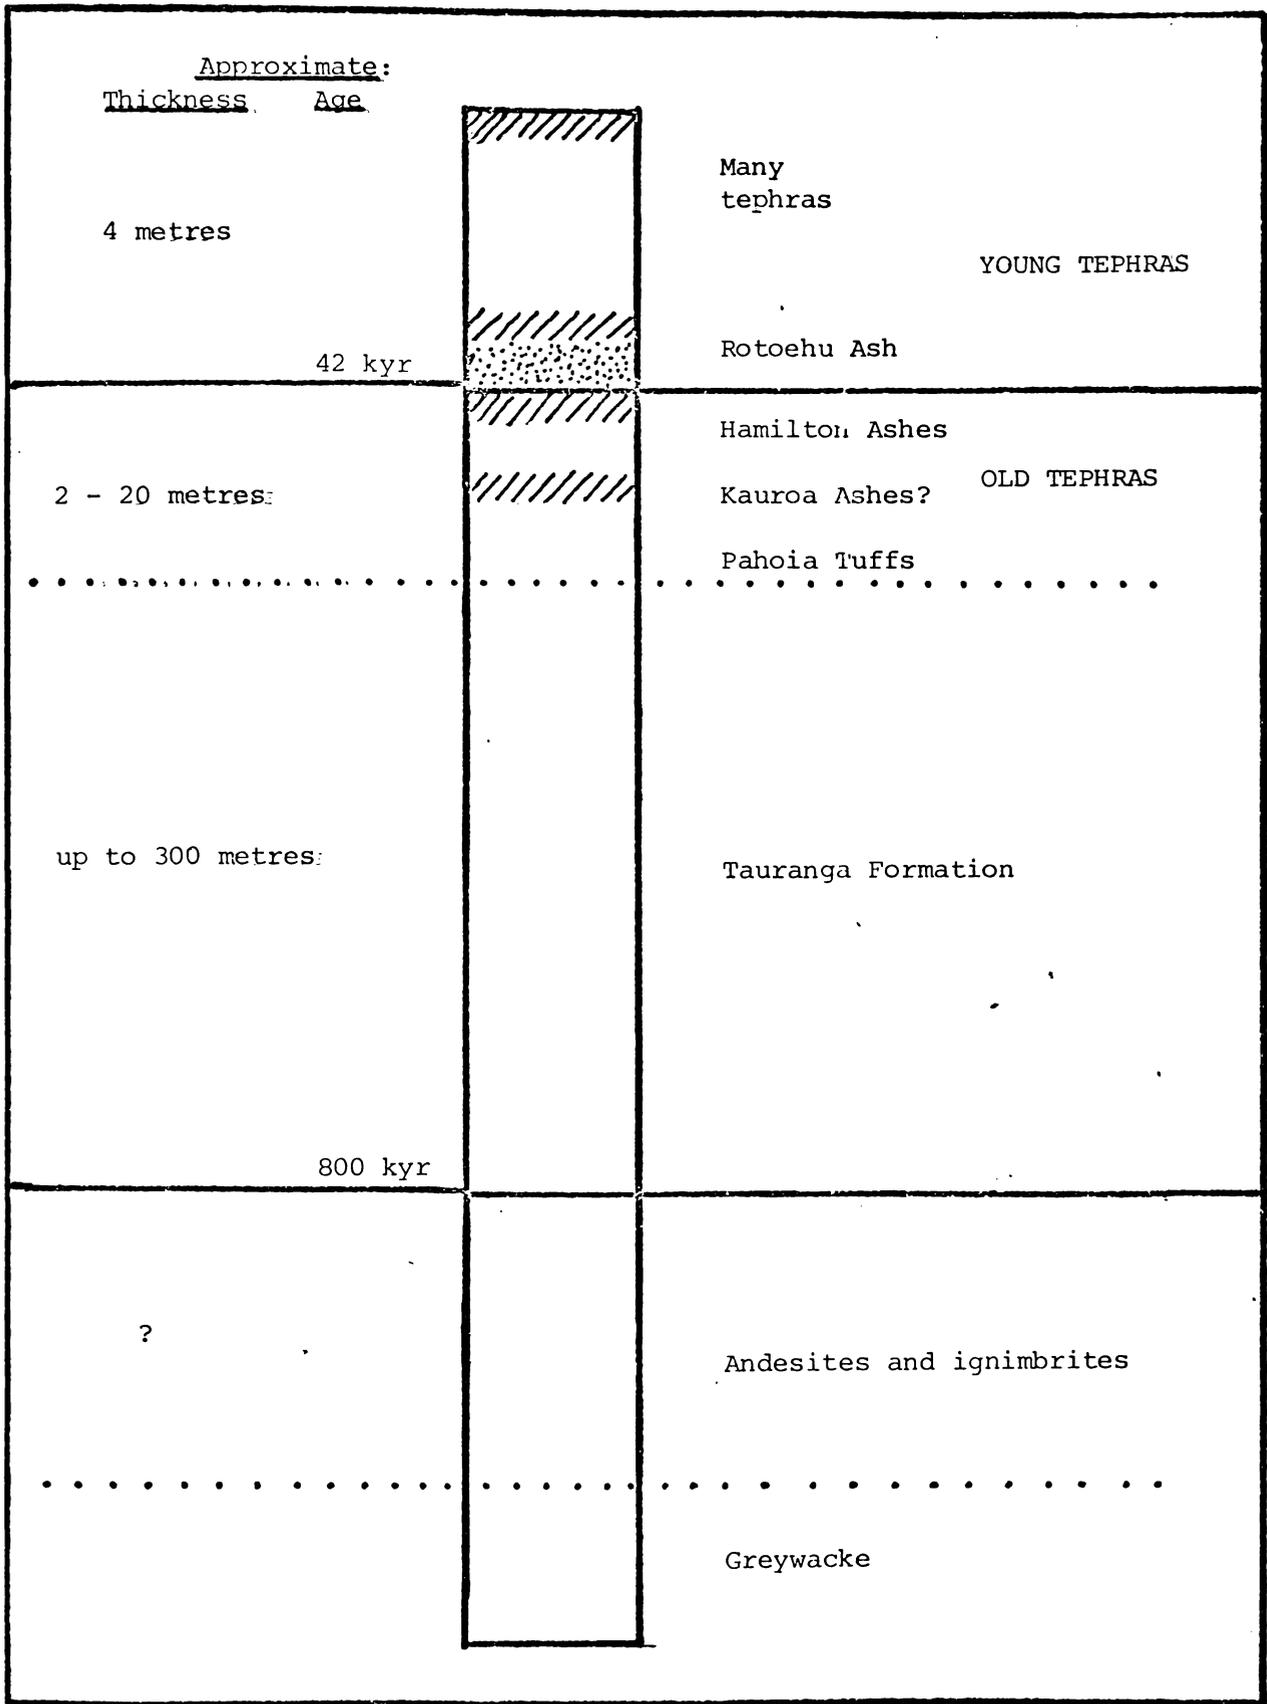
Figure 2.2. Stylised stratigraphic column of the Tauranga Basin.

The stratigraphic column of the Tauranga basin may be broken down into four main sections (fig. 2.2):

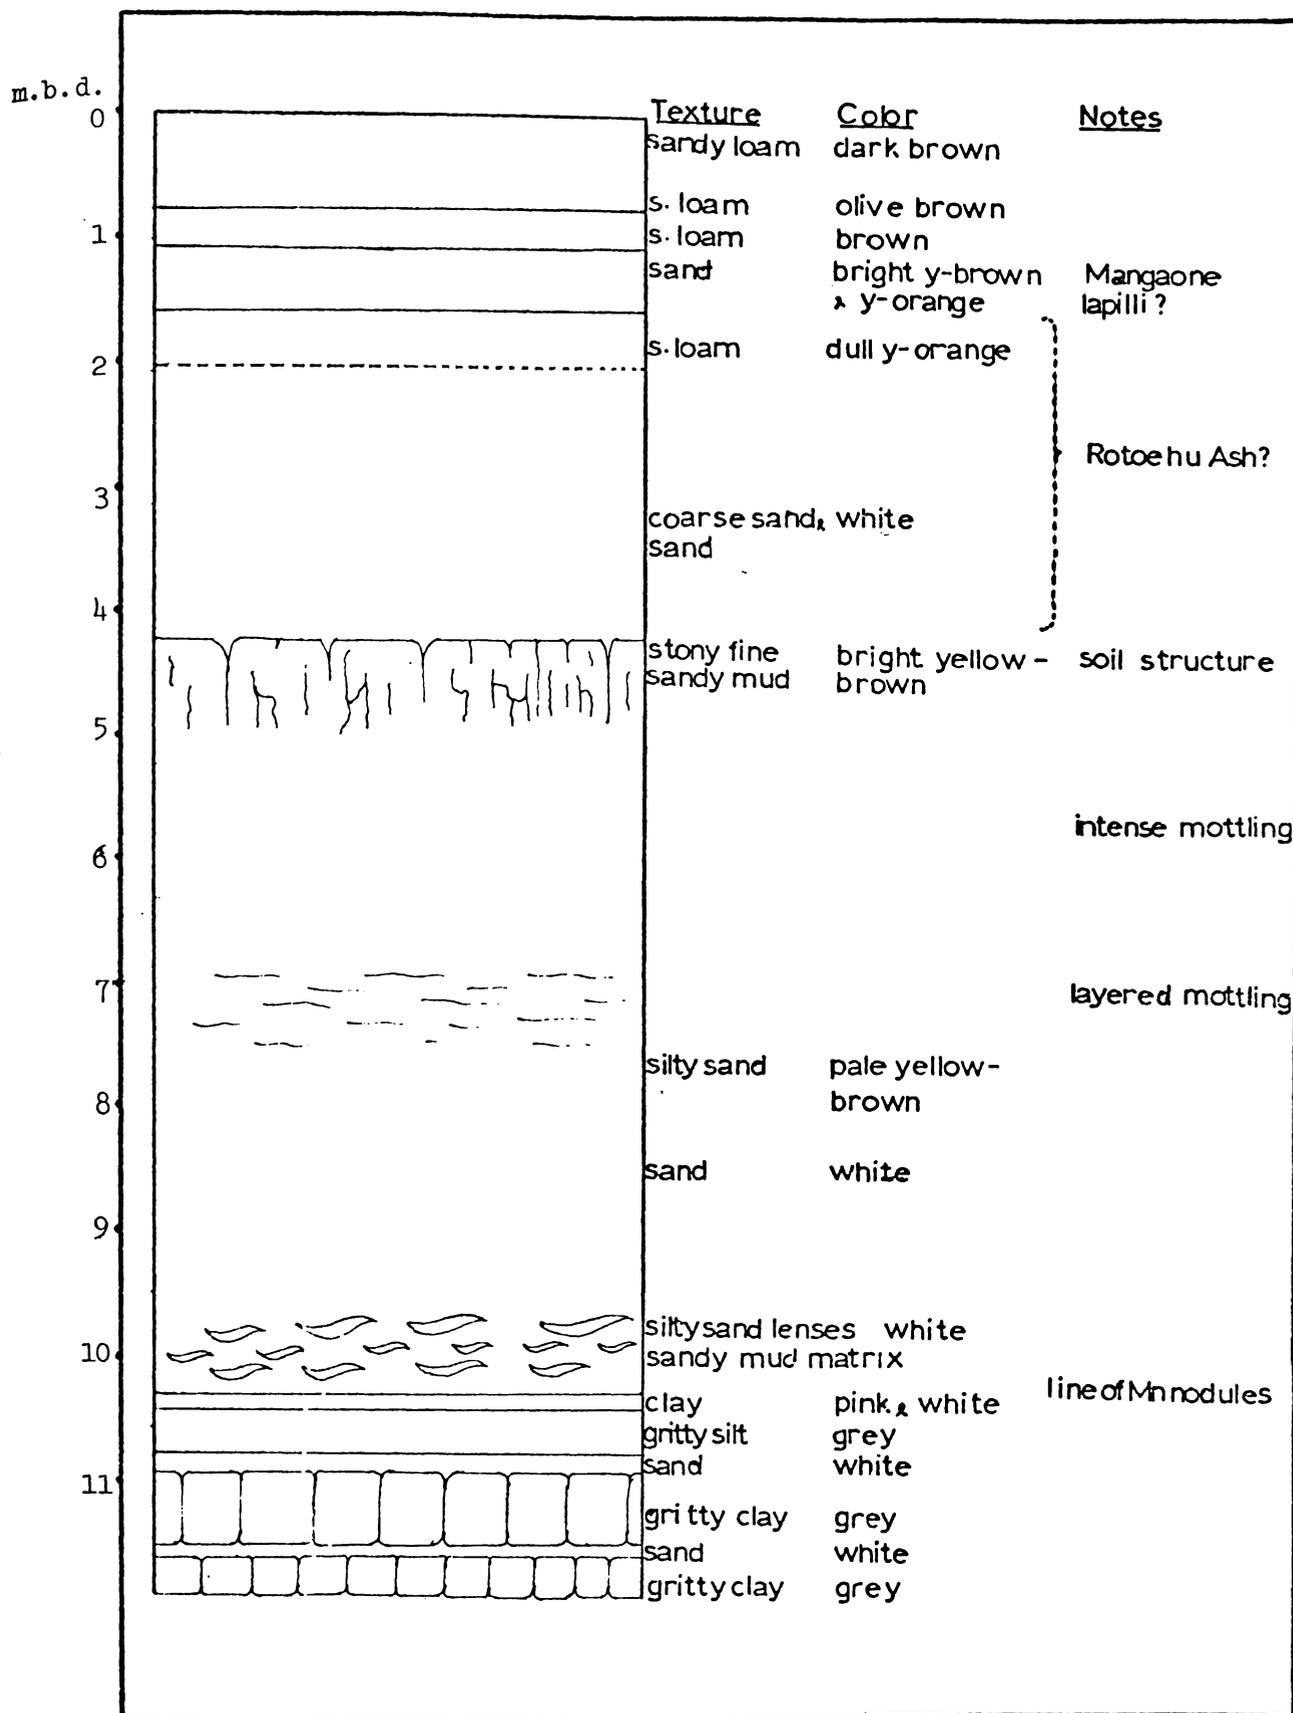
Figure 3.3. Idealised soil profile.

The idealised soil profile presented in fig. 3.3 was first drawn up at test site 1, then checked and found

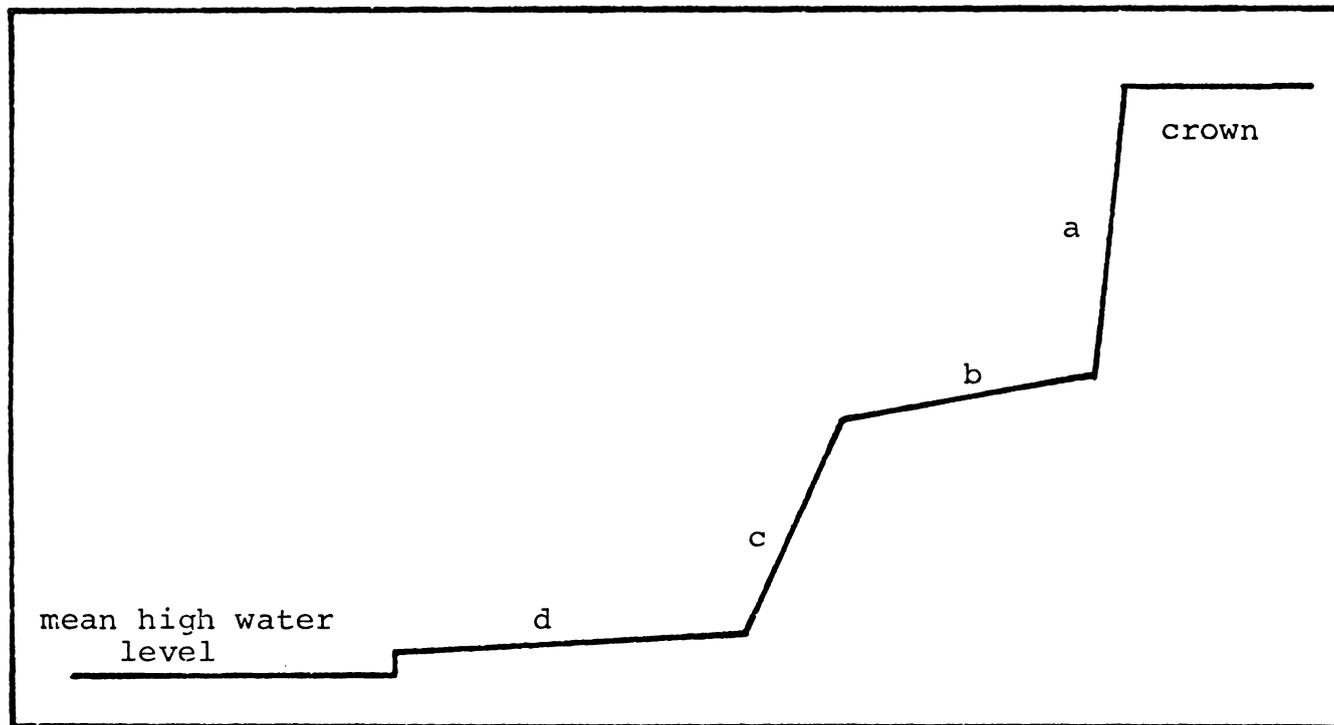
Figure 3.4. Idealised slope profile.

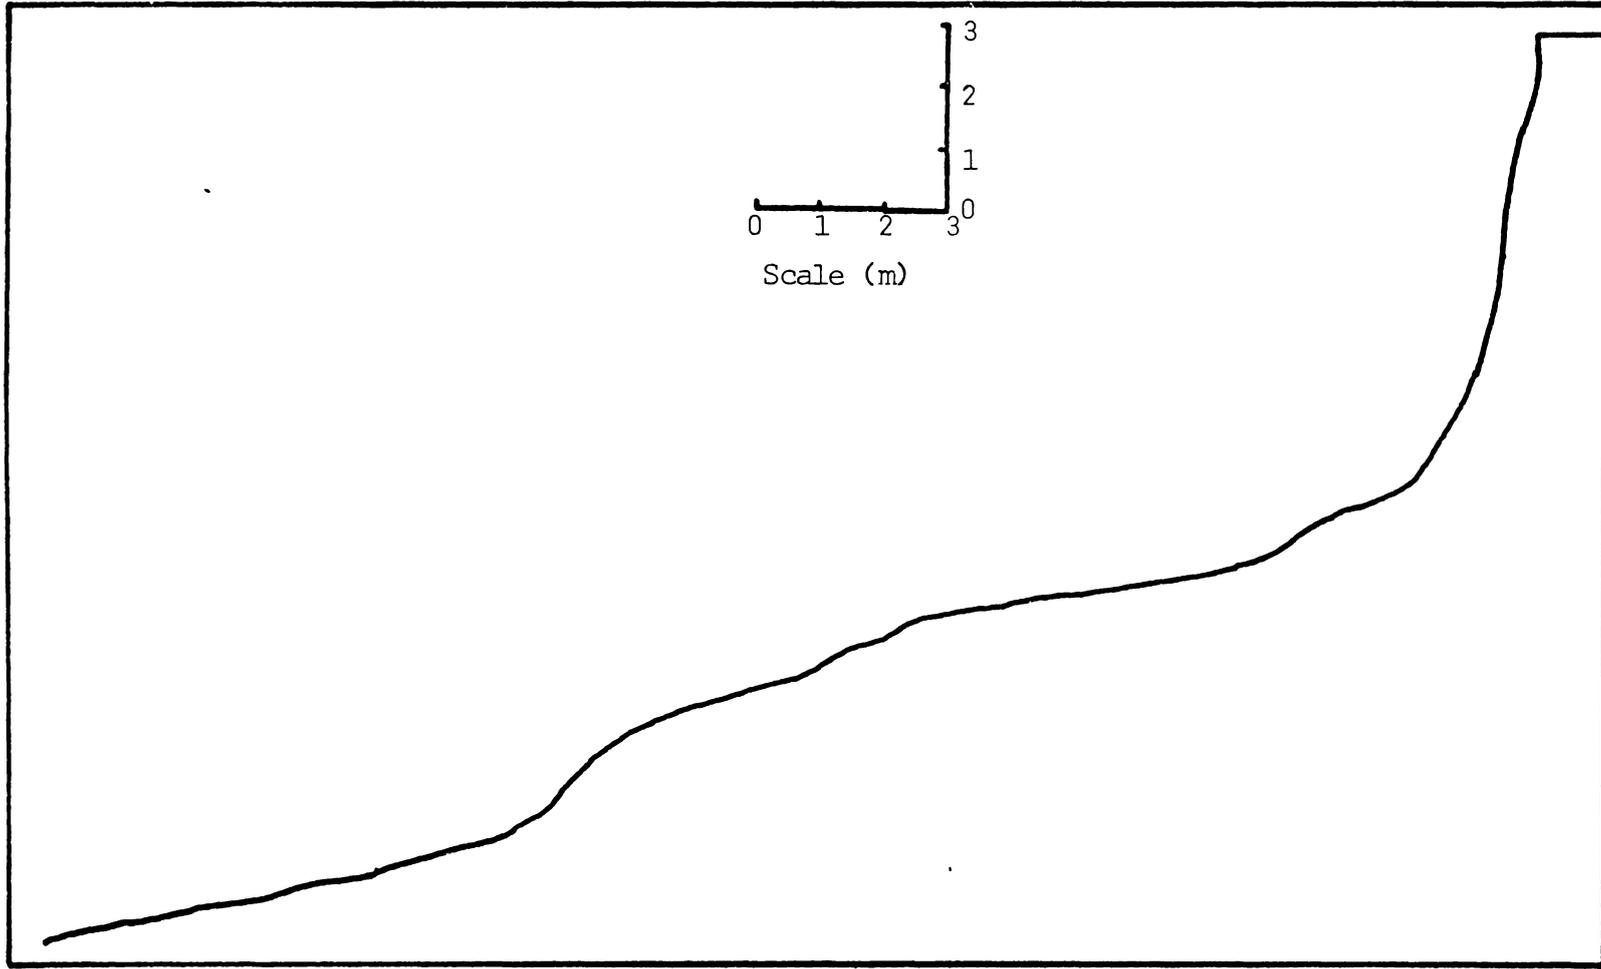
Figure 3.5(a). Surveyed profile of site 1.

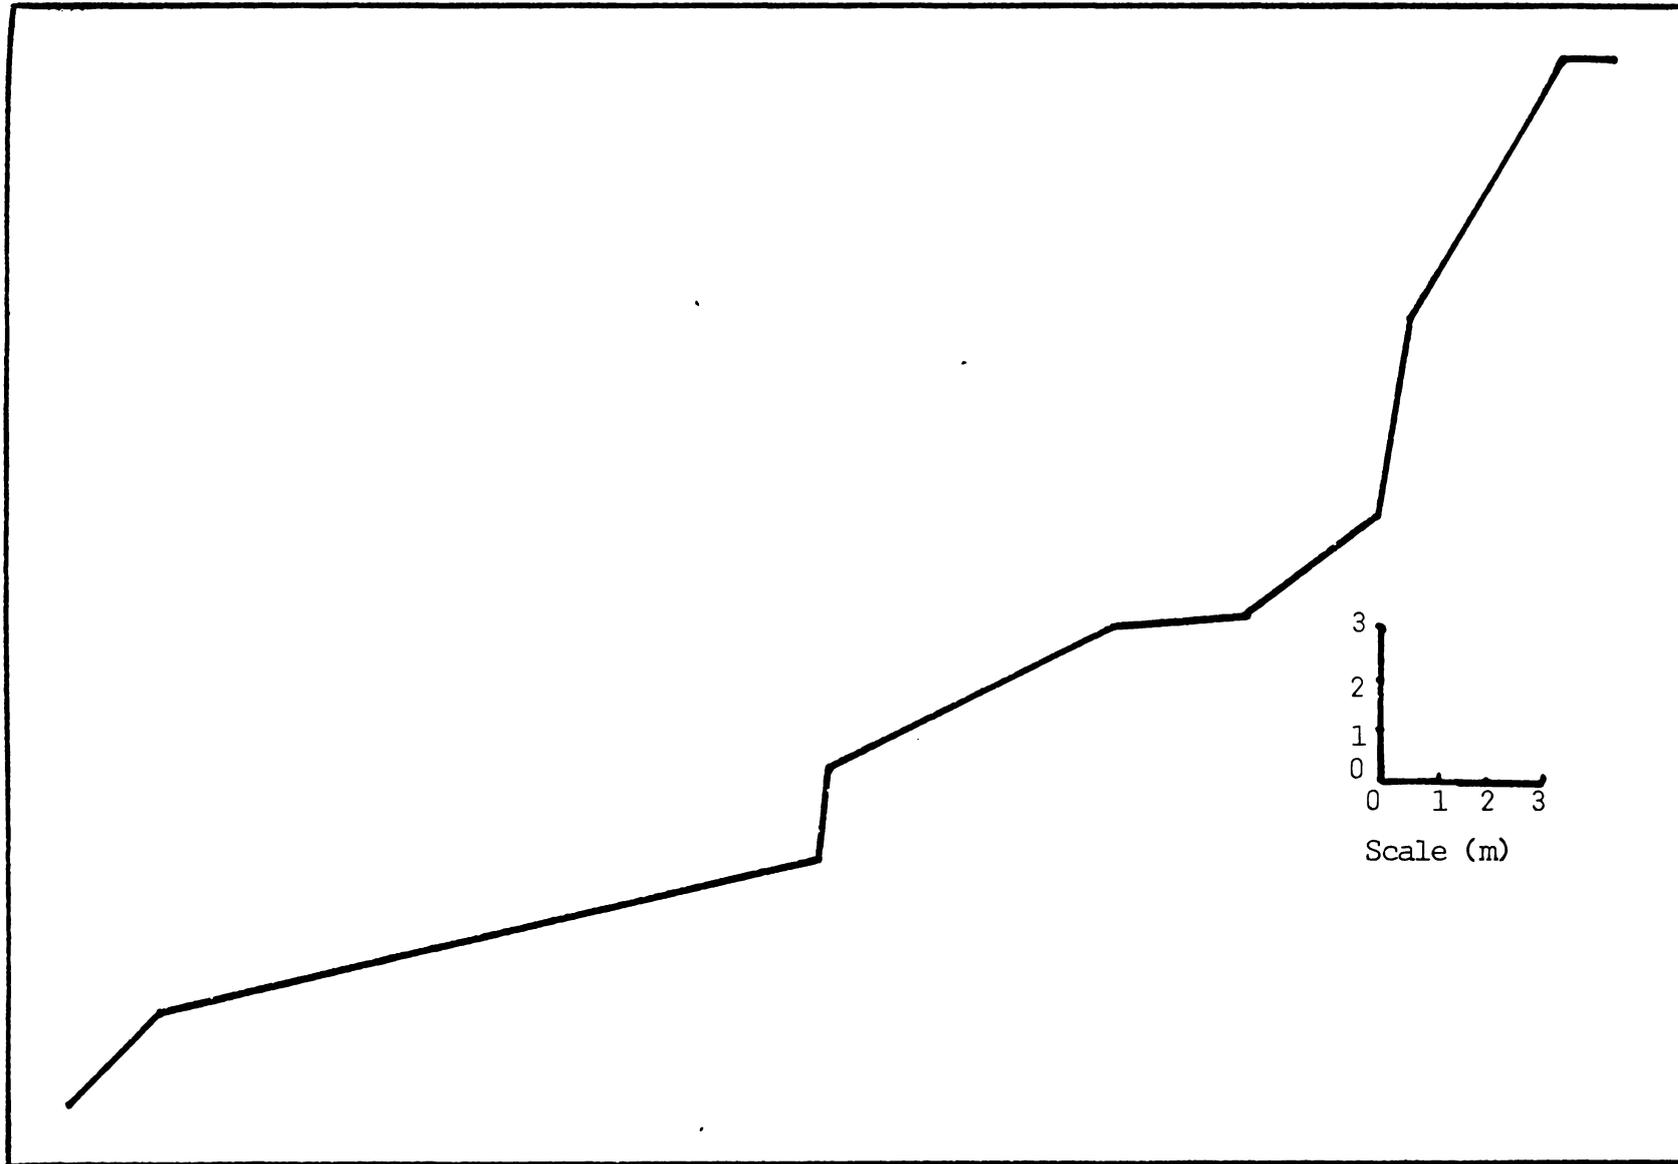
Figure 3.5(b). Surveyed profile of site 2.

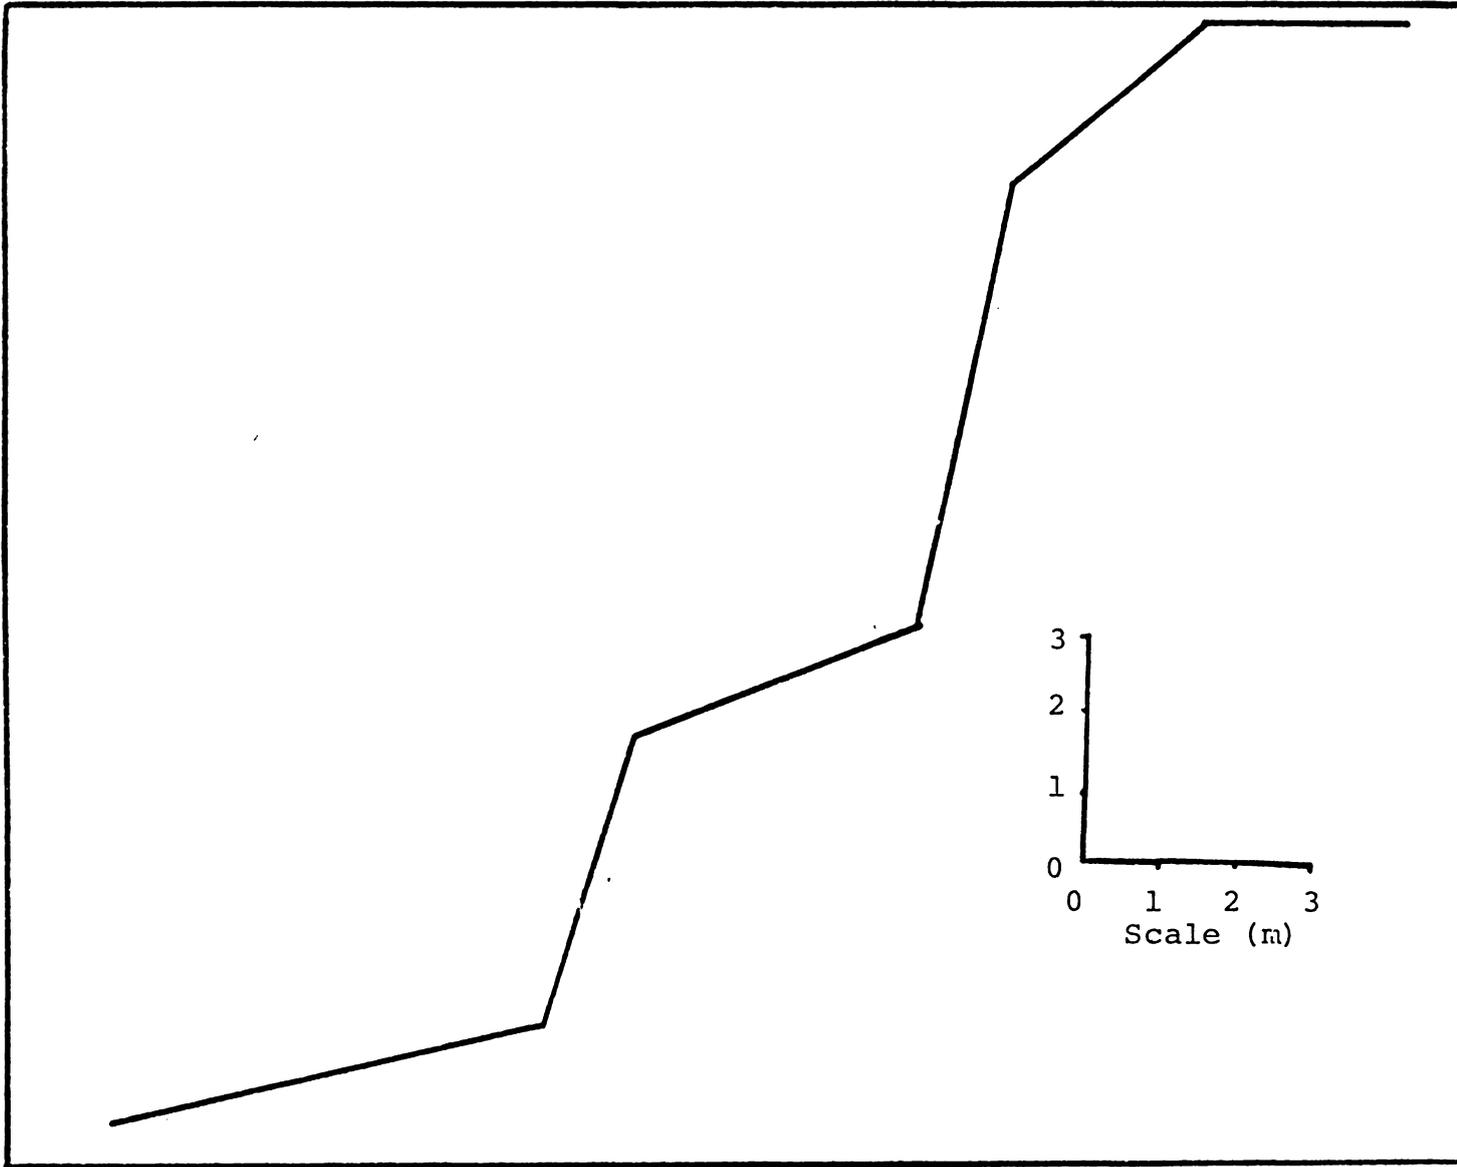
Figure 3.5(c). Surveyed profile of site 3.

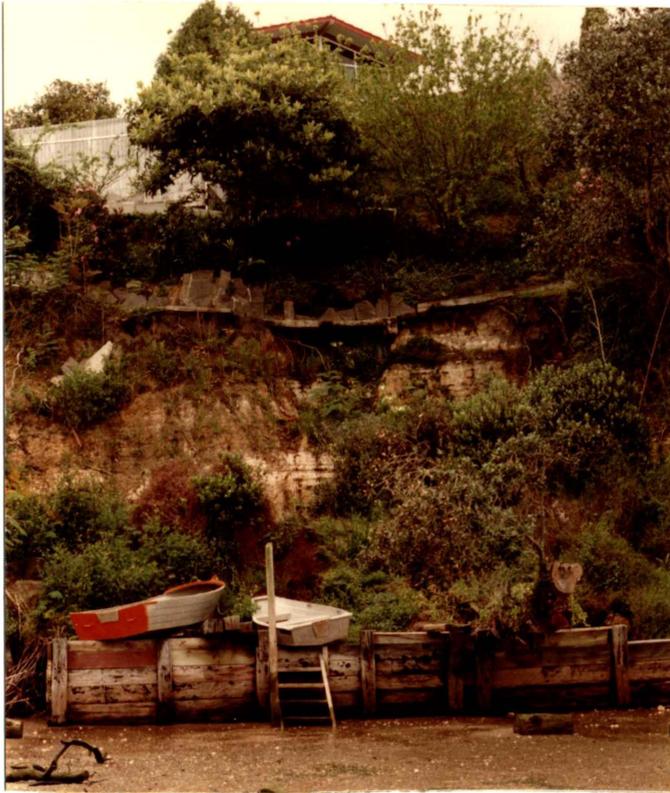
Fig 3.9(a). Site of failure behind anchored concrete path.

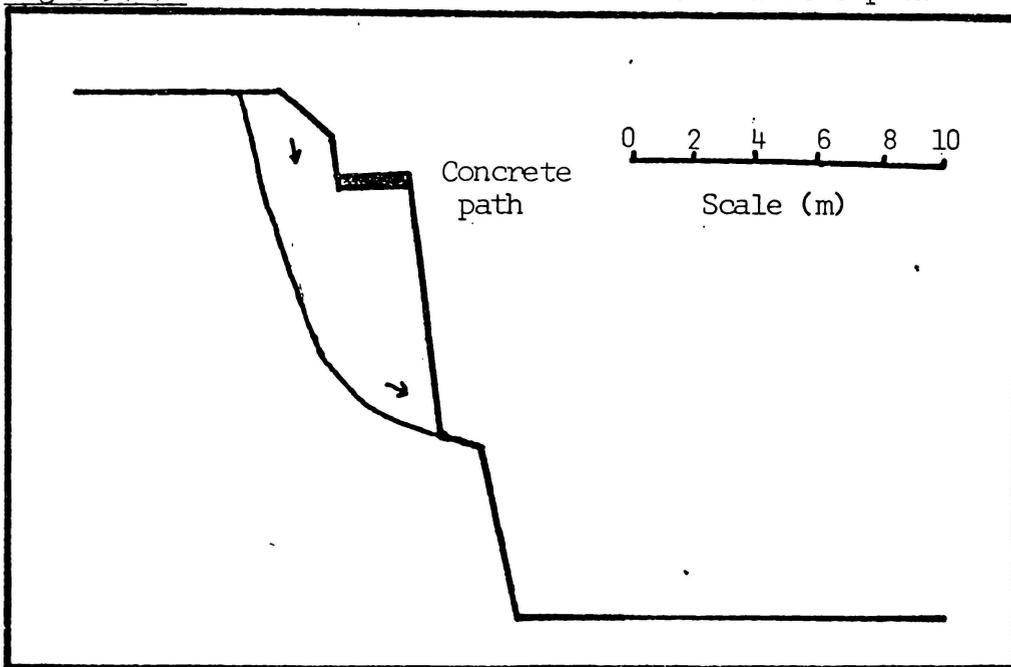
Figure 3.9(b). Movement of displaced mass beneath and behind concrete path.

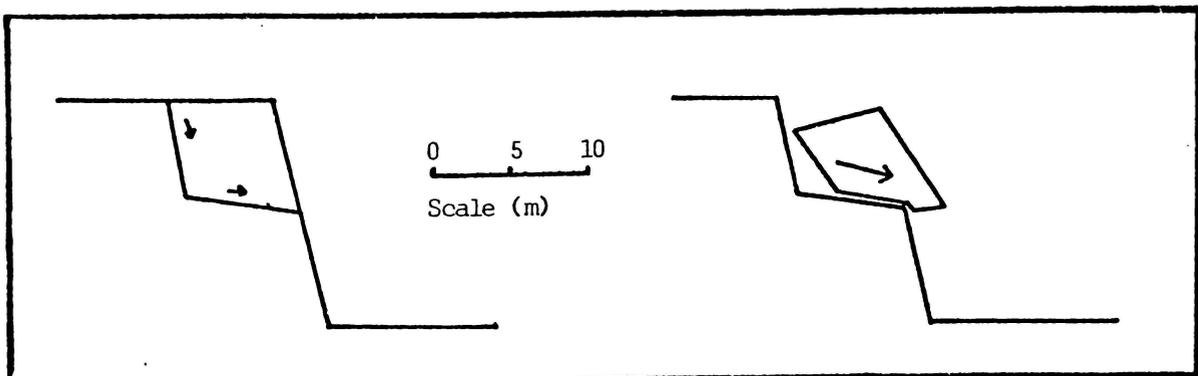
Figure 3:9(c). Initial rotational, and subsequent translational movement.

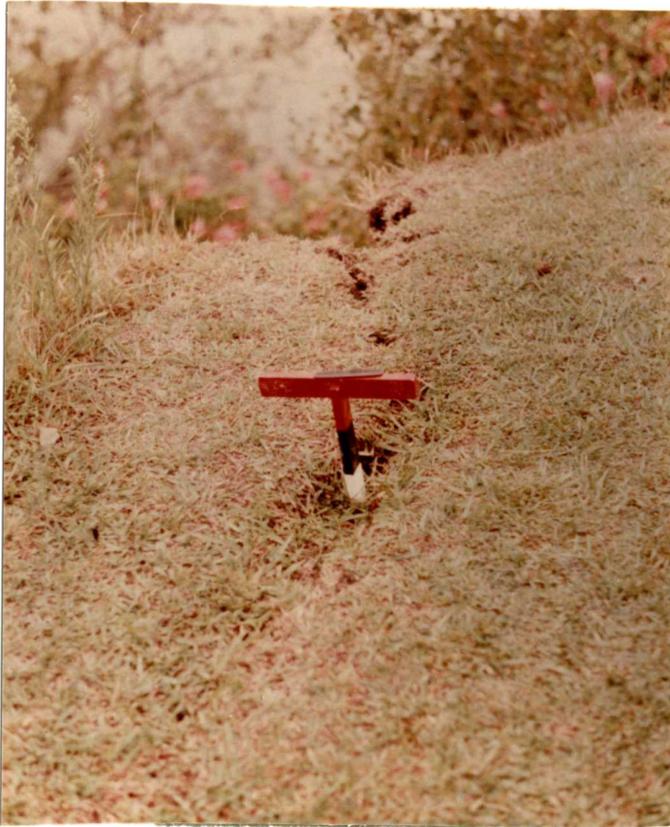
Fig. 3.10(a). 1.2 metre deep crack behind the block which toppled.

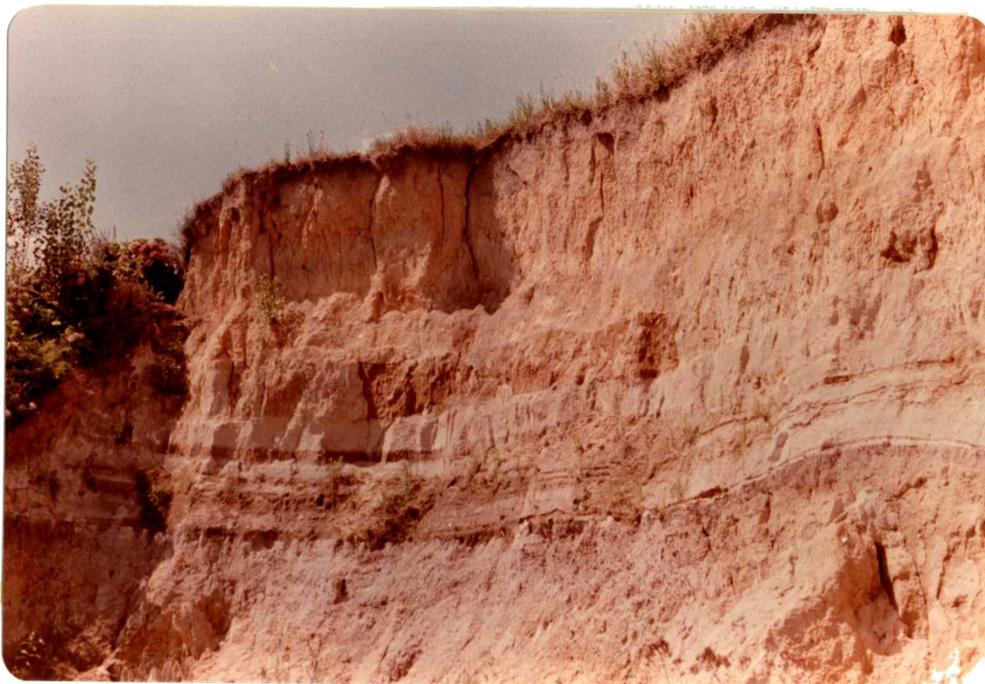
Fig. 3.10(b). The block,  
a few minutes prior to  
failure.

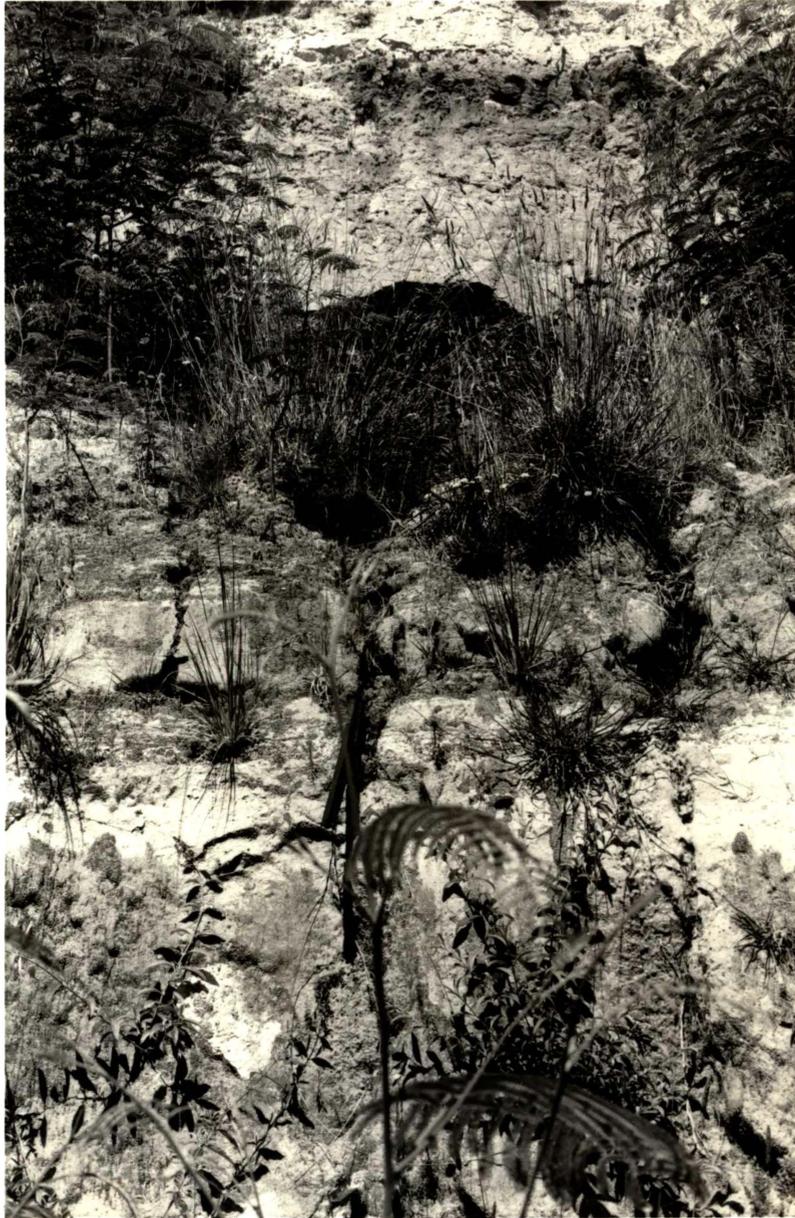
Fig. 3.11. Spalling failure at the centre of site 3.

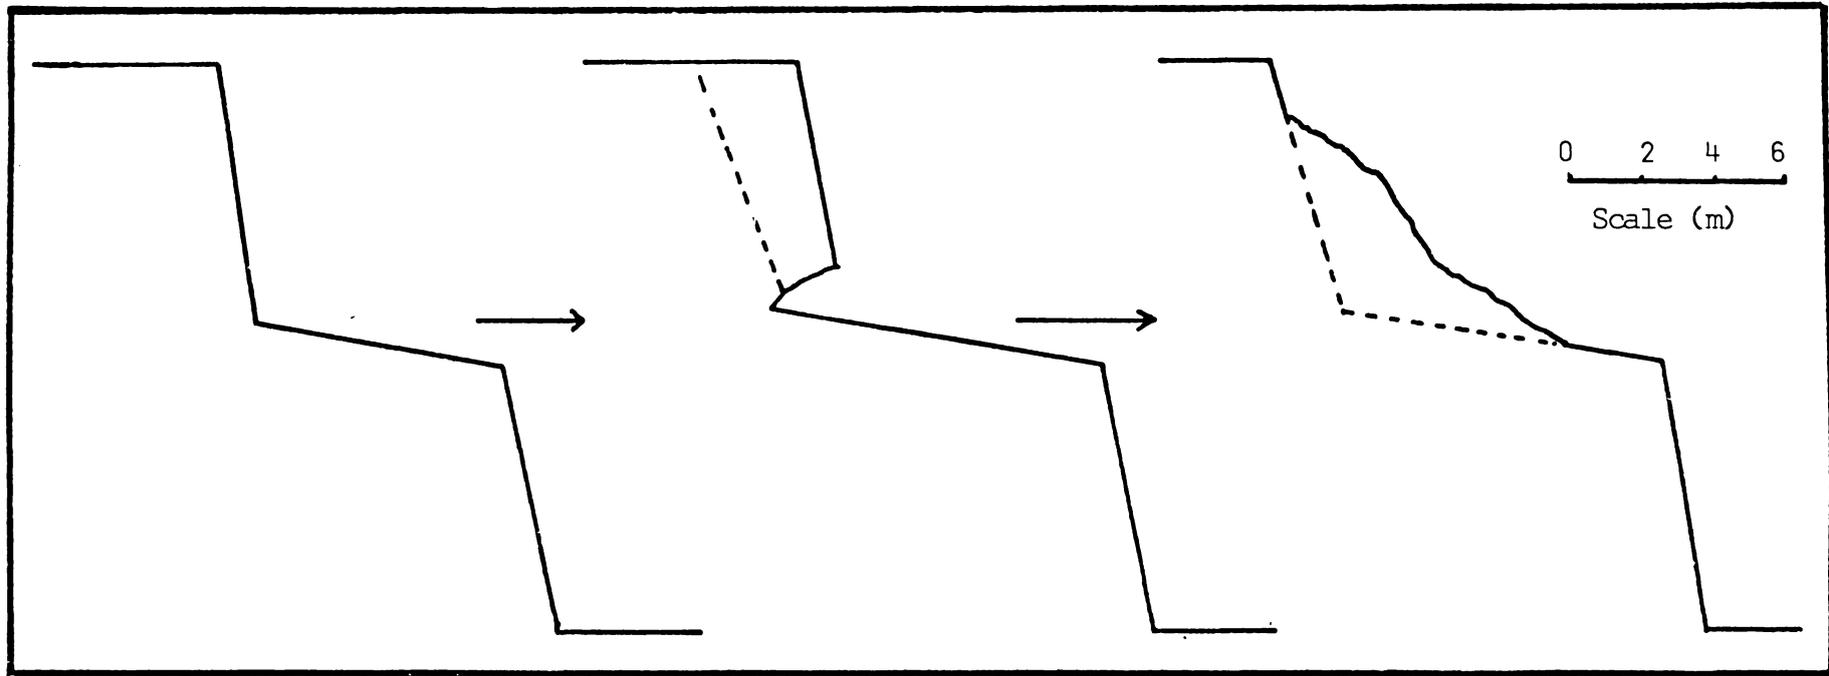
Figure 3.12. Effect of spalling-type failures on bluff morphology.

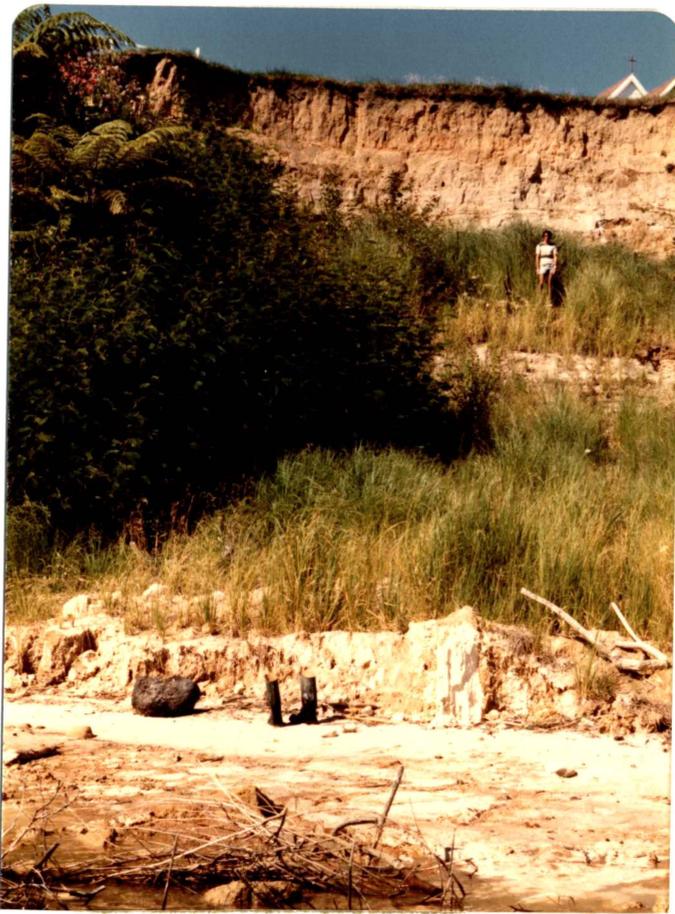
Fig. 3.13(a) Passive erosion: western side of debris lobe.

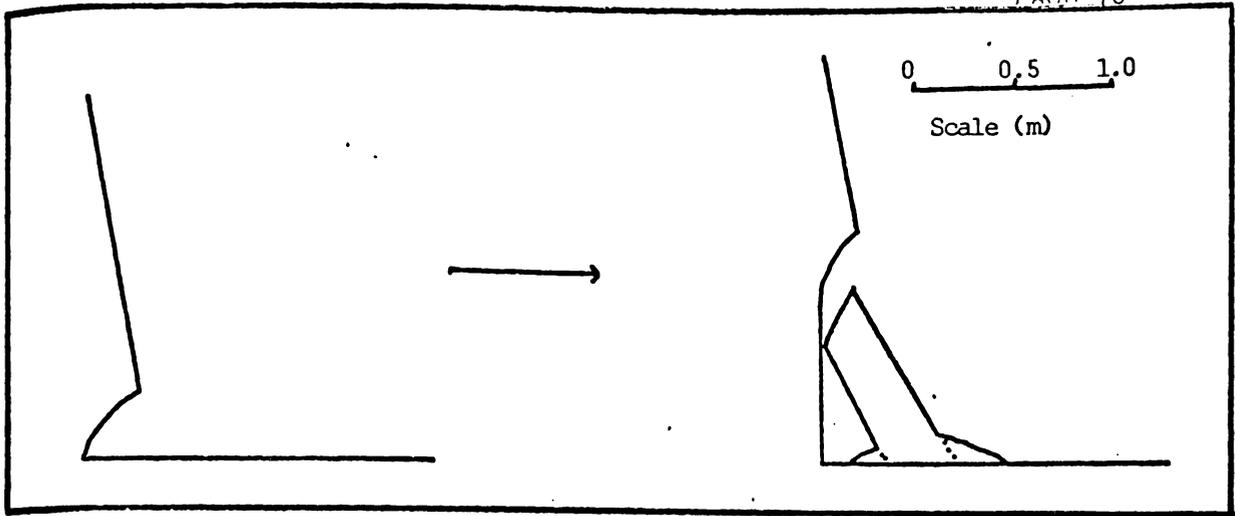
Figure 3.14. Collapse-fall failure at the bluff base.

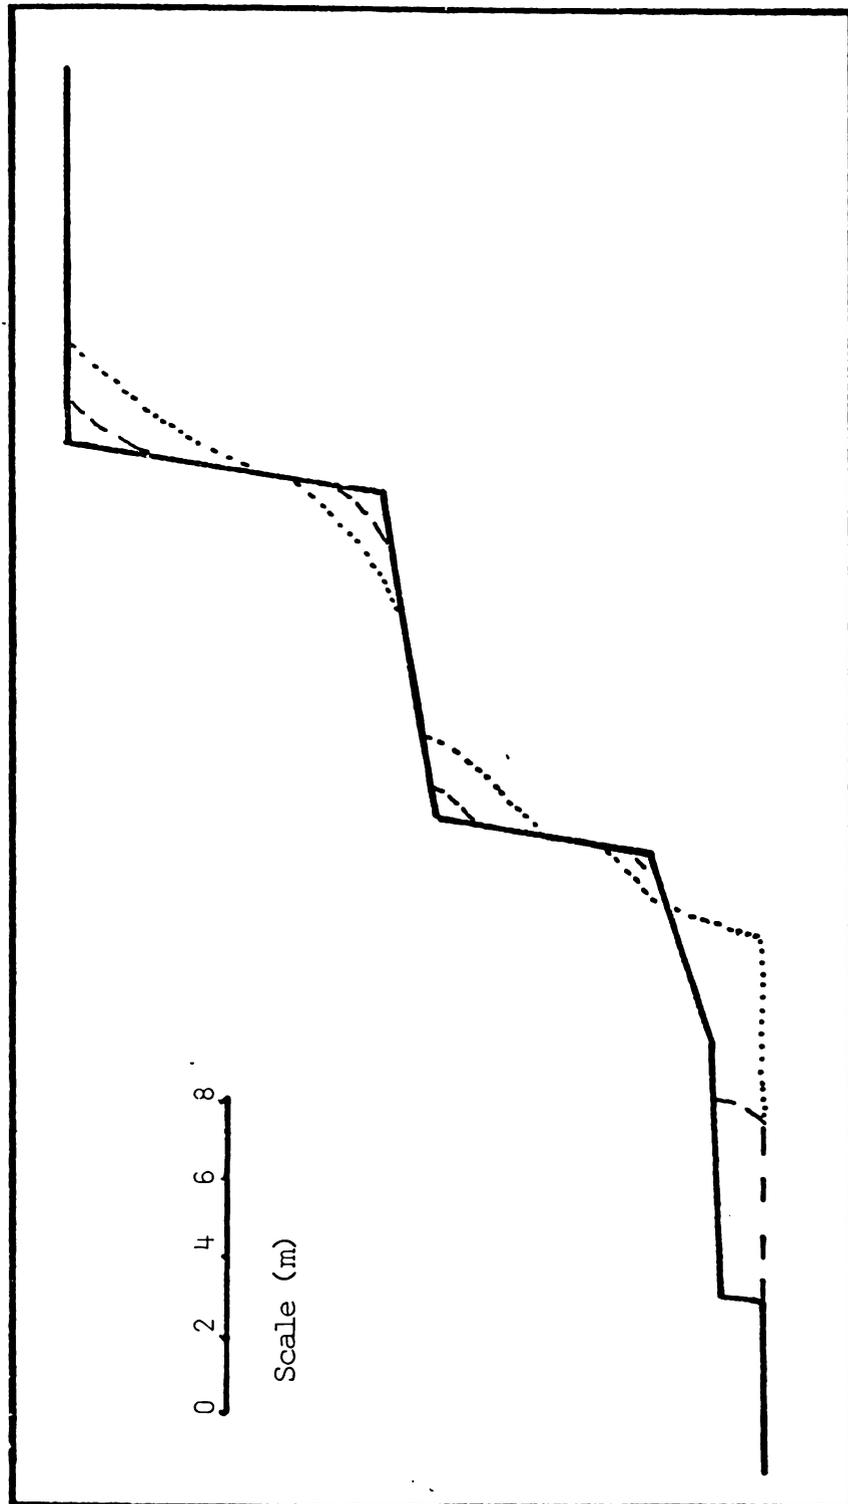
Figure 3.15. Cumulative effect of slope modifying processes.
