THE NATURE AND CAUSES OF  
COASTAL LANDSLIDING ON  
THE MAUNGATAPU PENINSULA,  
TAURANGA, NEW ZEALAND.

A thesis submitted in partial fulfilment of the  
requirements for the Degree of Master of Science  
in Earth Sciences

University of Waikato

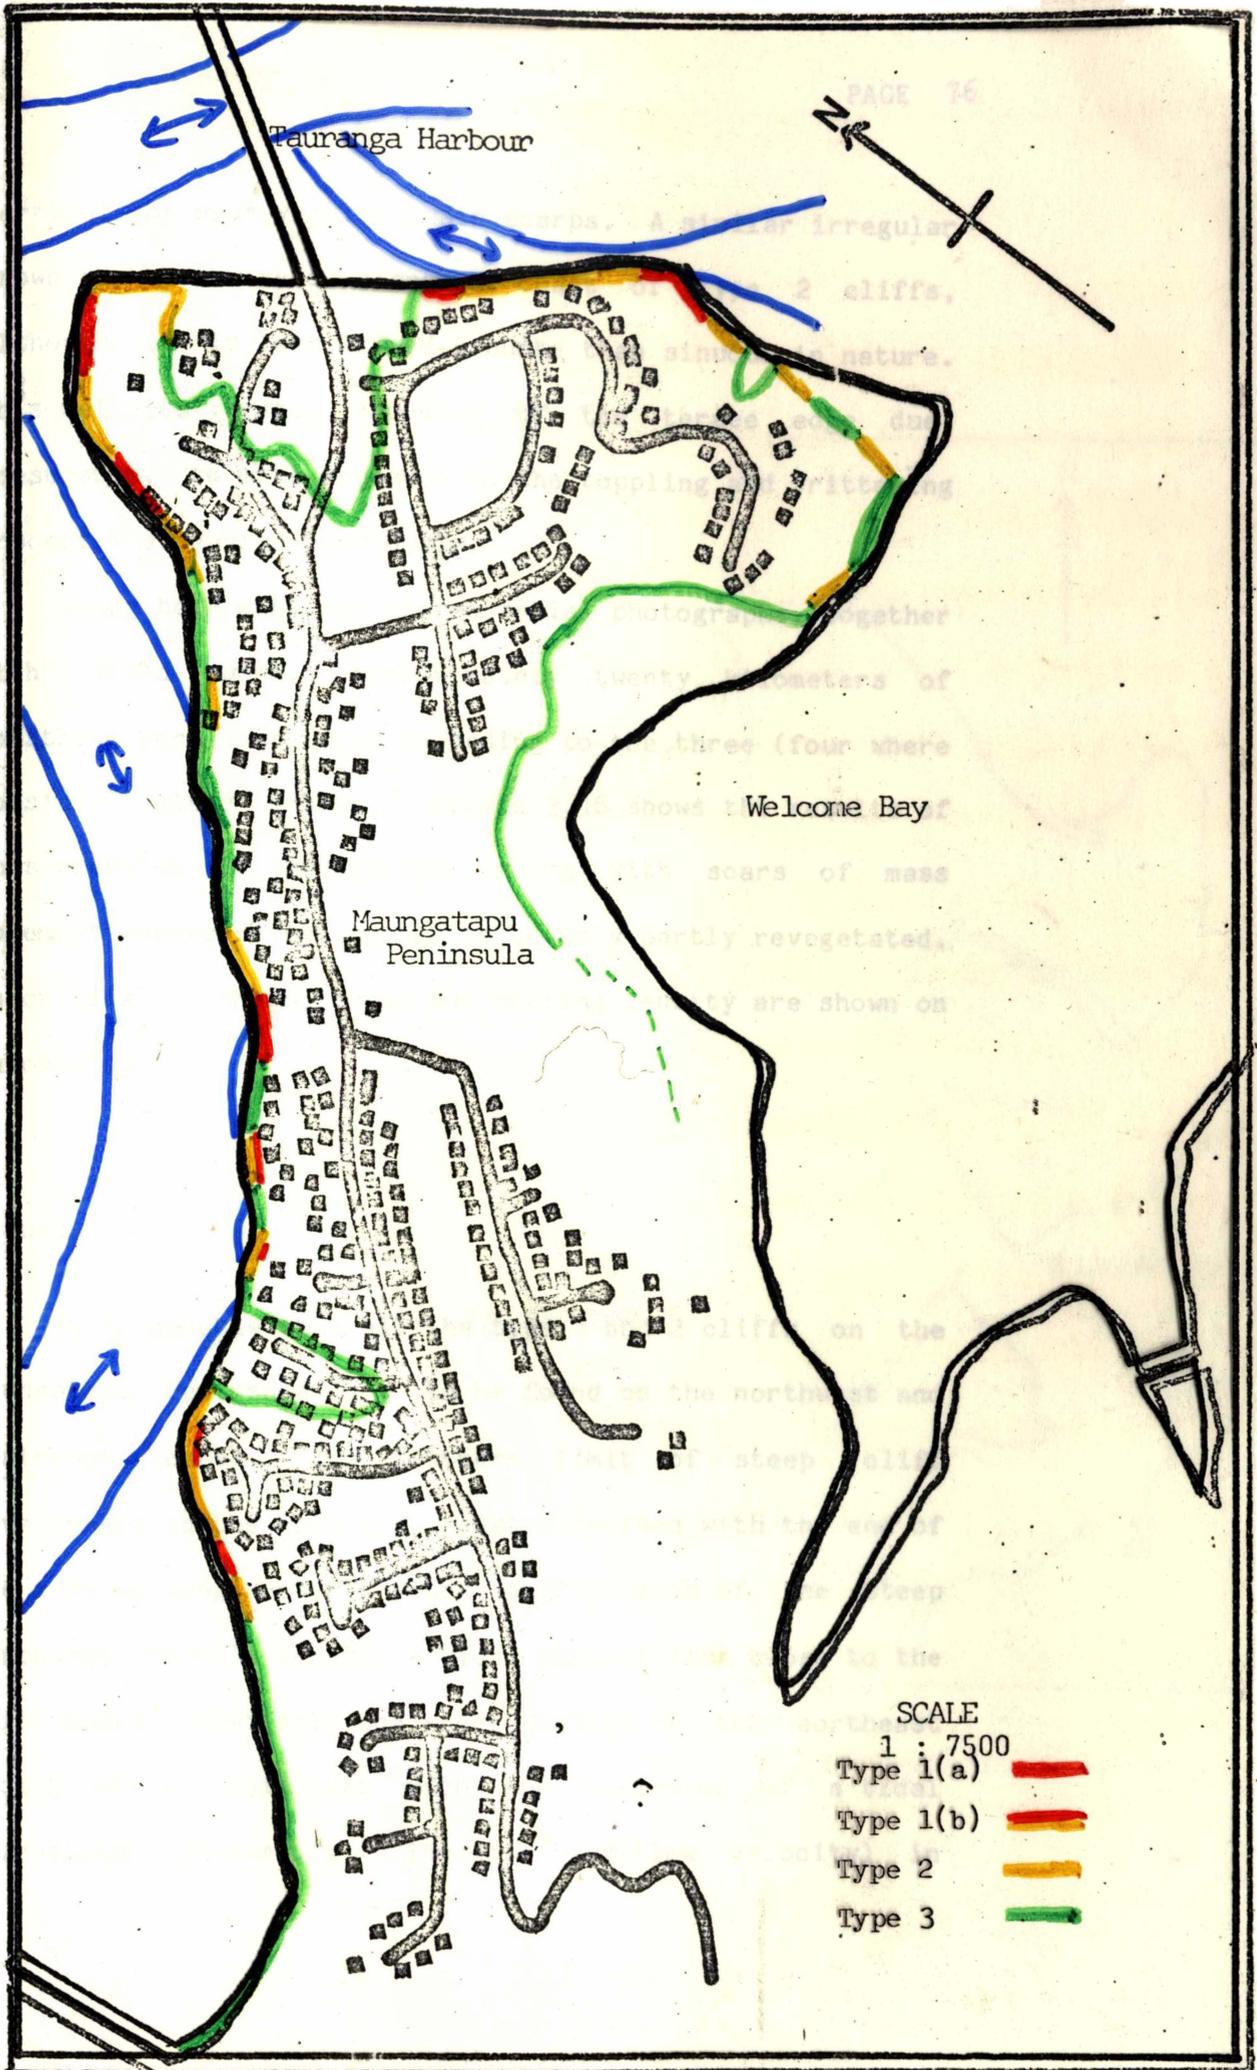
Fig.3.16. The distribution of typed cliffs, landslide scars, roading and housing densities on the Maungatapu Peninsula.

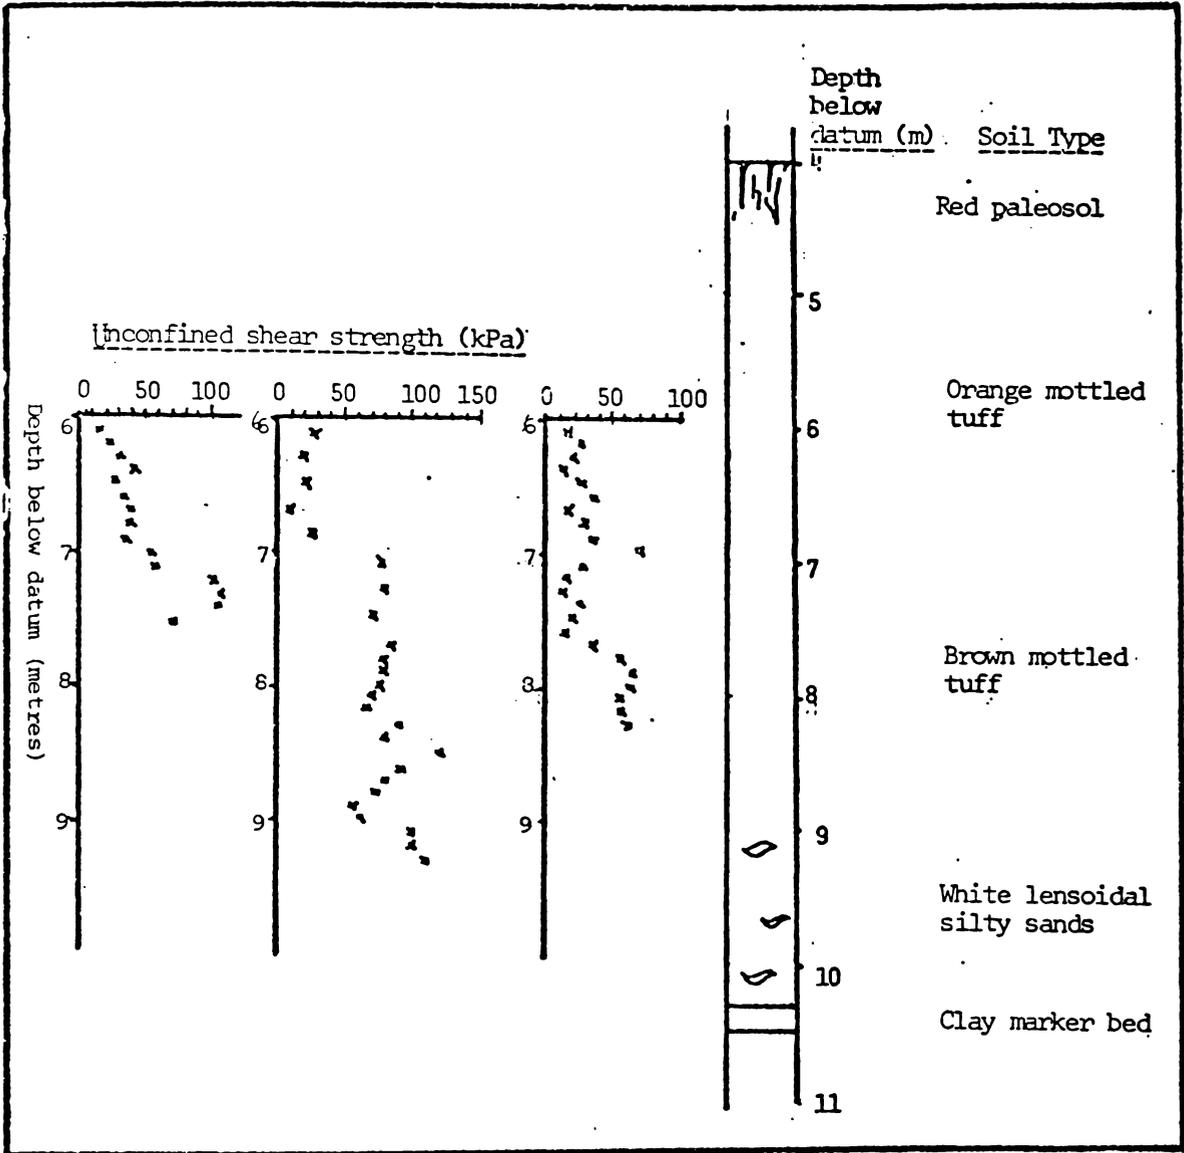
Figure 4.2. Partial vane shear strength profiles obtained at test site 1

In order to obtain an estimate of the relative densities of some of the sandy materials, similar peak and residual strength determinations were carried out, rather than determining large numbers of bulk density and particle density values. It was thought that, as sand strength is dependent to a large extent on the degree of packing, loose sands would provide initially low strength values and would pack down during the 20 rotations used for 'remoulding' to give an extremely low second value. Denser materials might be expected to give a higher initial reading, and a less marked loss in strength on remoulding. Packing indices were calculated in the same manner as Terzaghi's sensitivity numbers. It was originally intended that an attempt be made to evaluate both entire strength profiles, and variations within the profiles with seasonal moisture changes. Accordingly initial work was aimed at evaluating the variability of readings obtained for individual beds. Coefficients of variation at site 1 were found to be about 0.15 (vane) and 0.15 to 0.40 (penetrometer) for 15 trials of 20 readings taken within 1.5 metre horizontal spreads. Three partial profiles of soil strength taken within 2 to 3 metres of one another at site 1 show intra-bed differences of the same order as the inter-bed differences (fig. 4.2). Similar differences were observed in comparing full profiles from sites 1 and 2 (fig. 4.2). Similarly fig. 4.3 shows

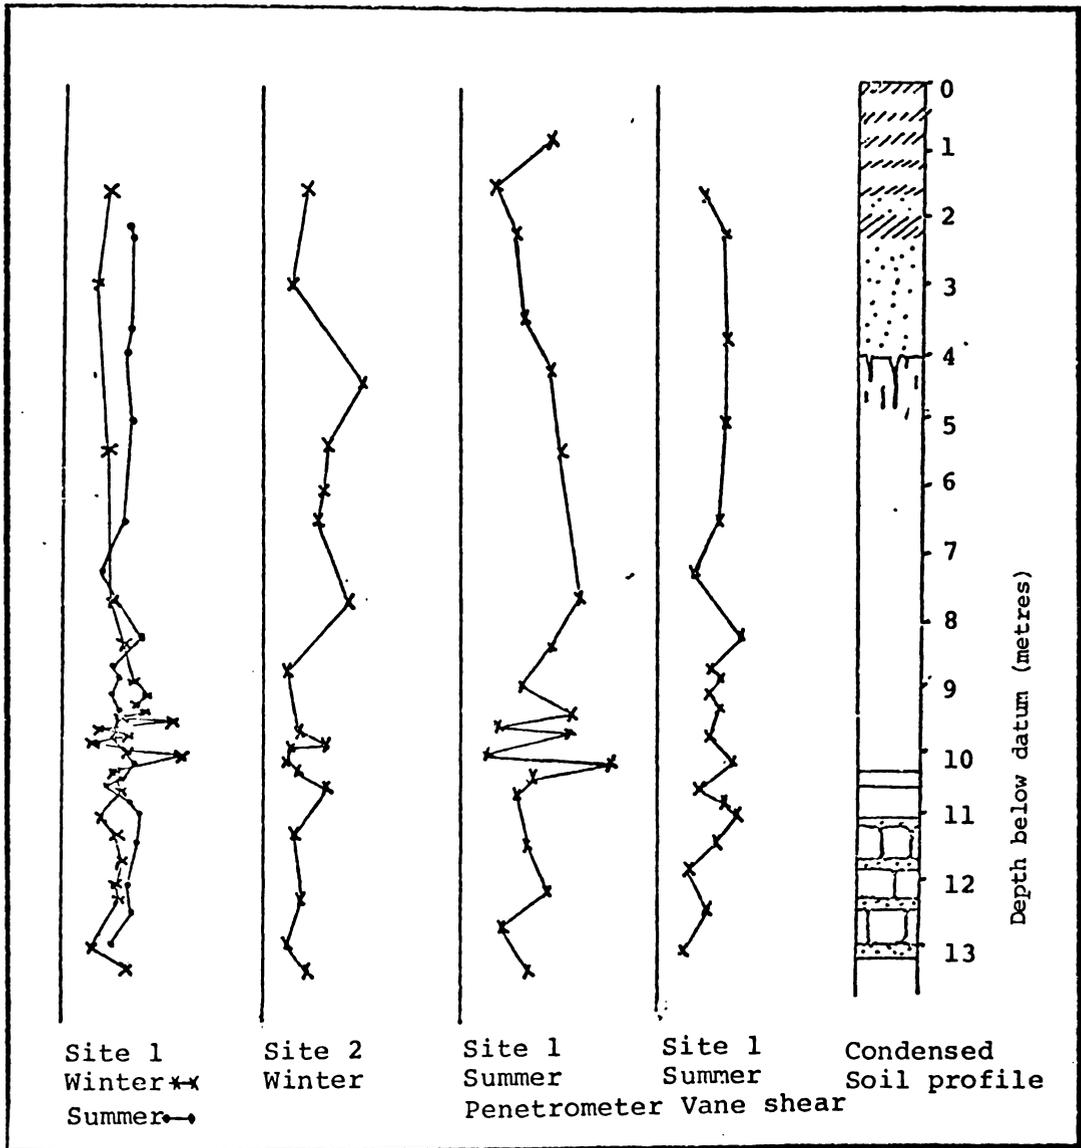
Figure 4.3. Field relative shear strength data.

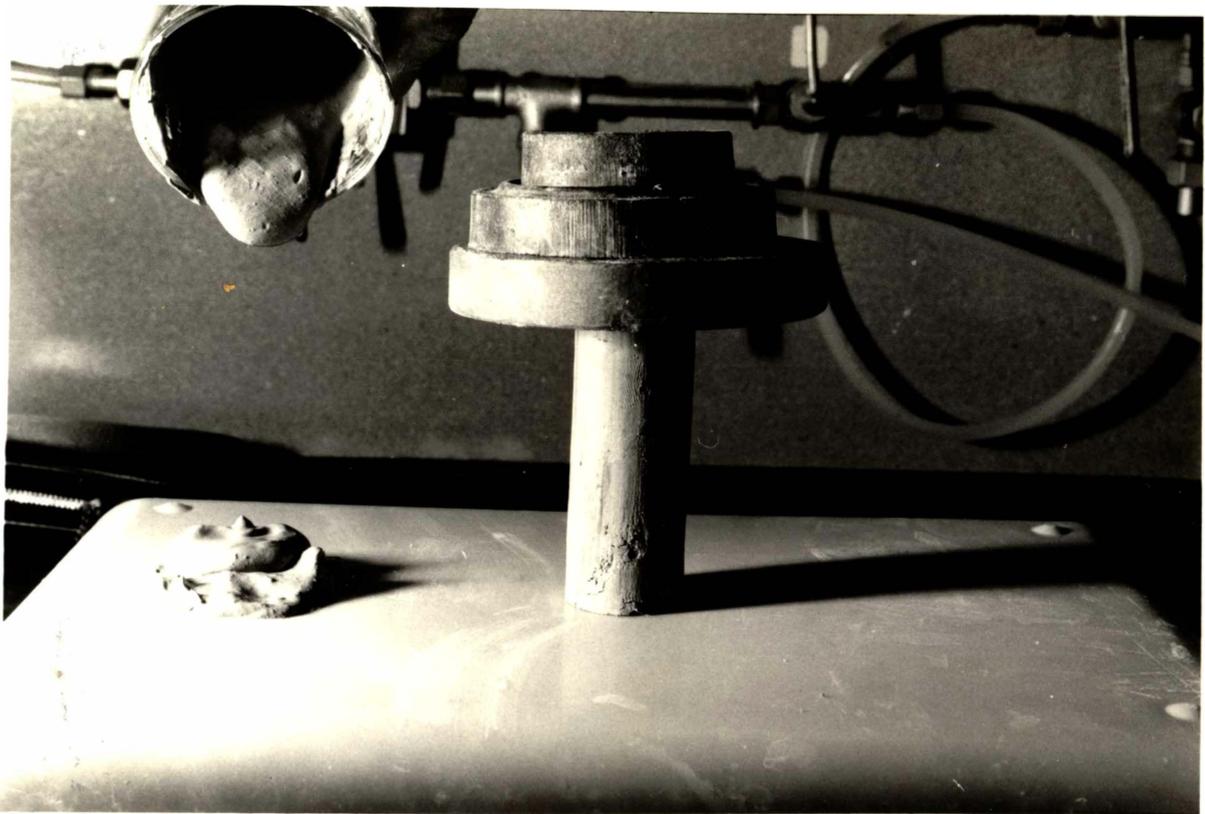
Fig. 4.4. Remoulded and undisturbed samples of the clay marker bed.

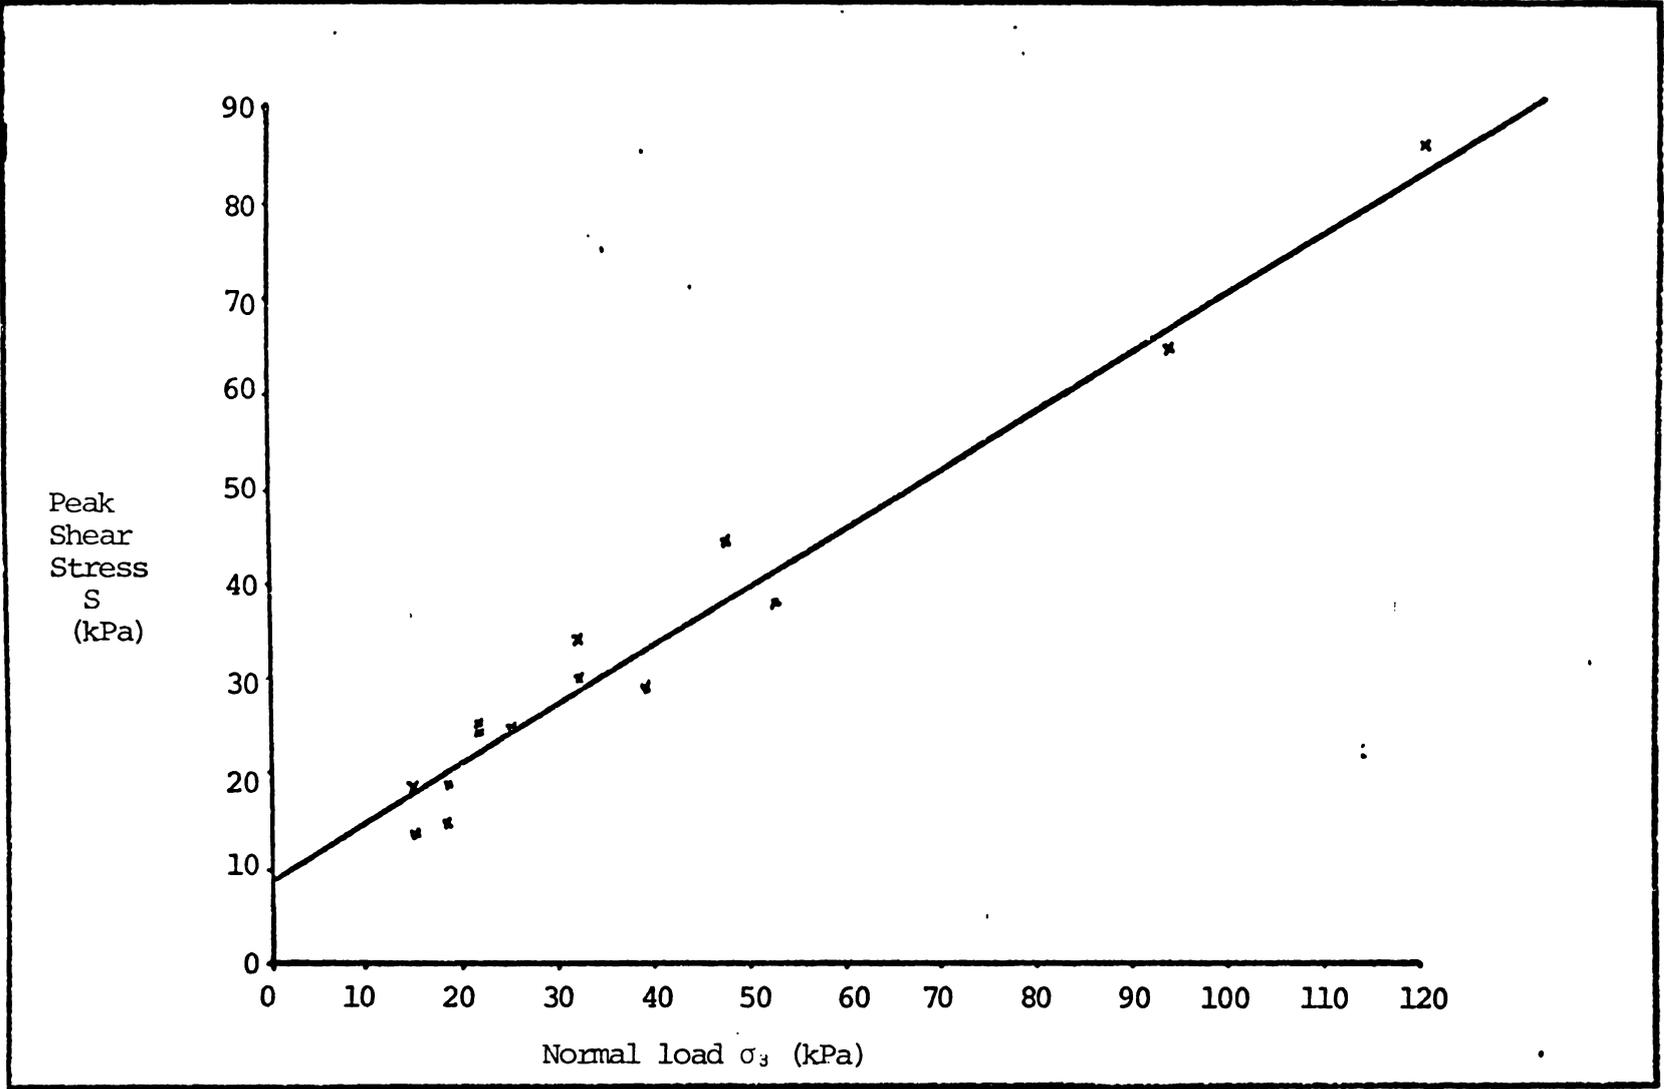
Figure 4.6. Direct shear box strength results.

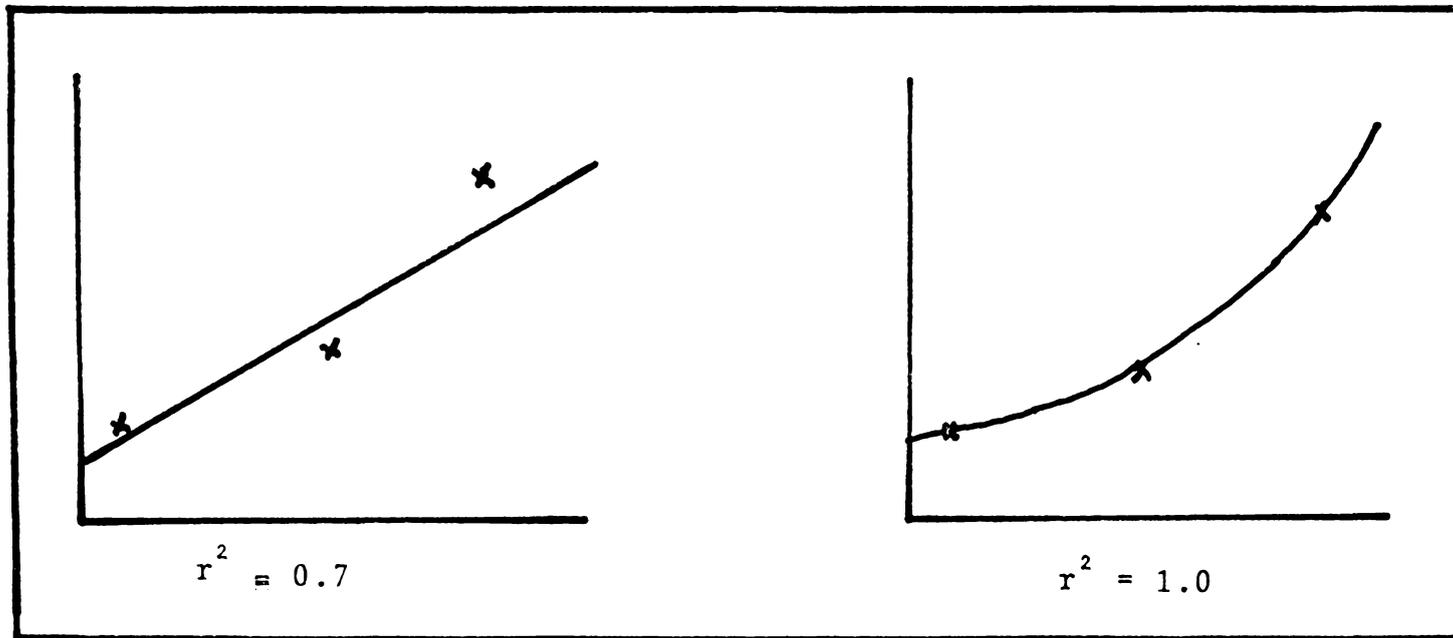
Figure 4.7. Inaccuracies caused by using curvilinear regression analysis where 'n' is low.

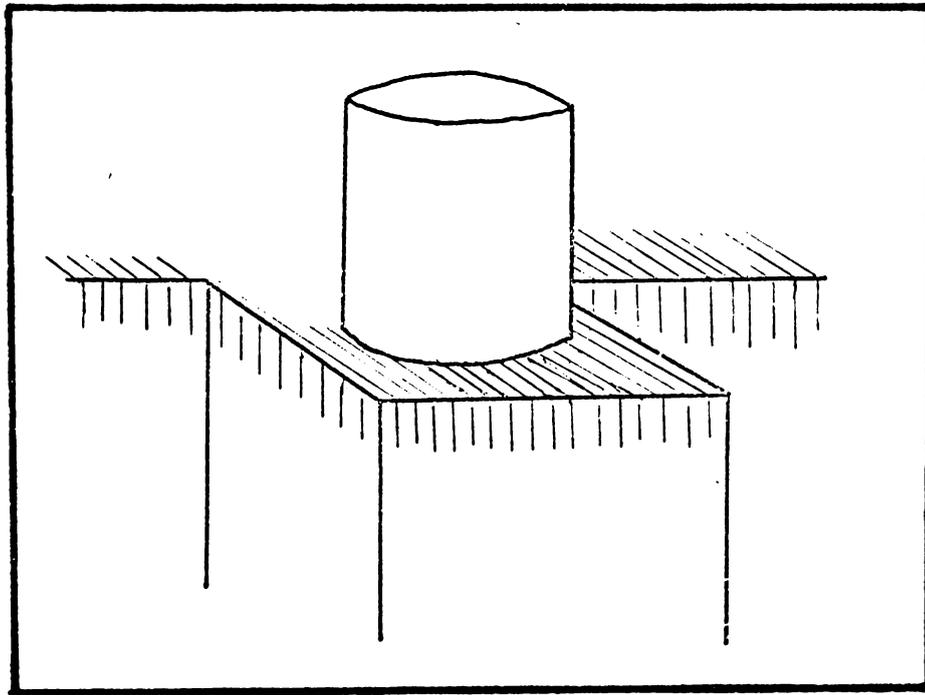
Figure 4.8. Obtaining triaxial test samples from a small monolith.

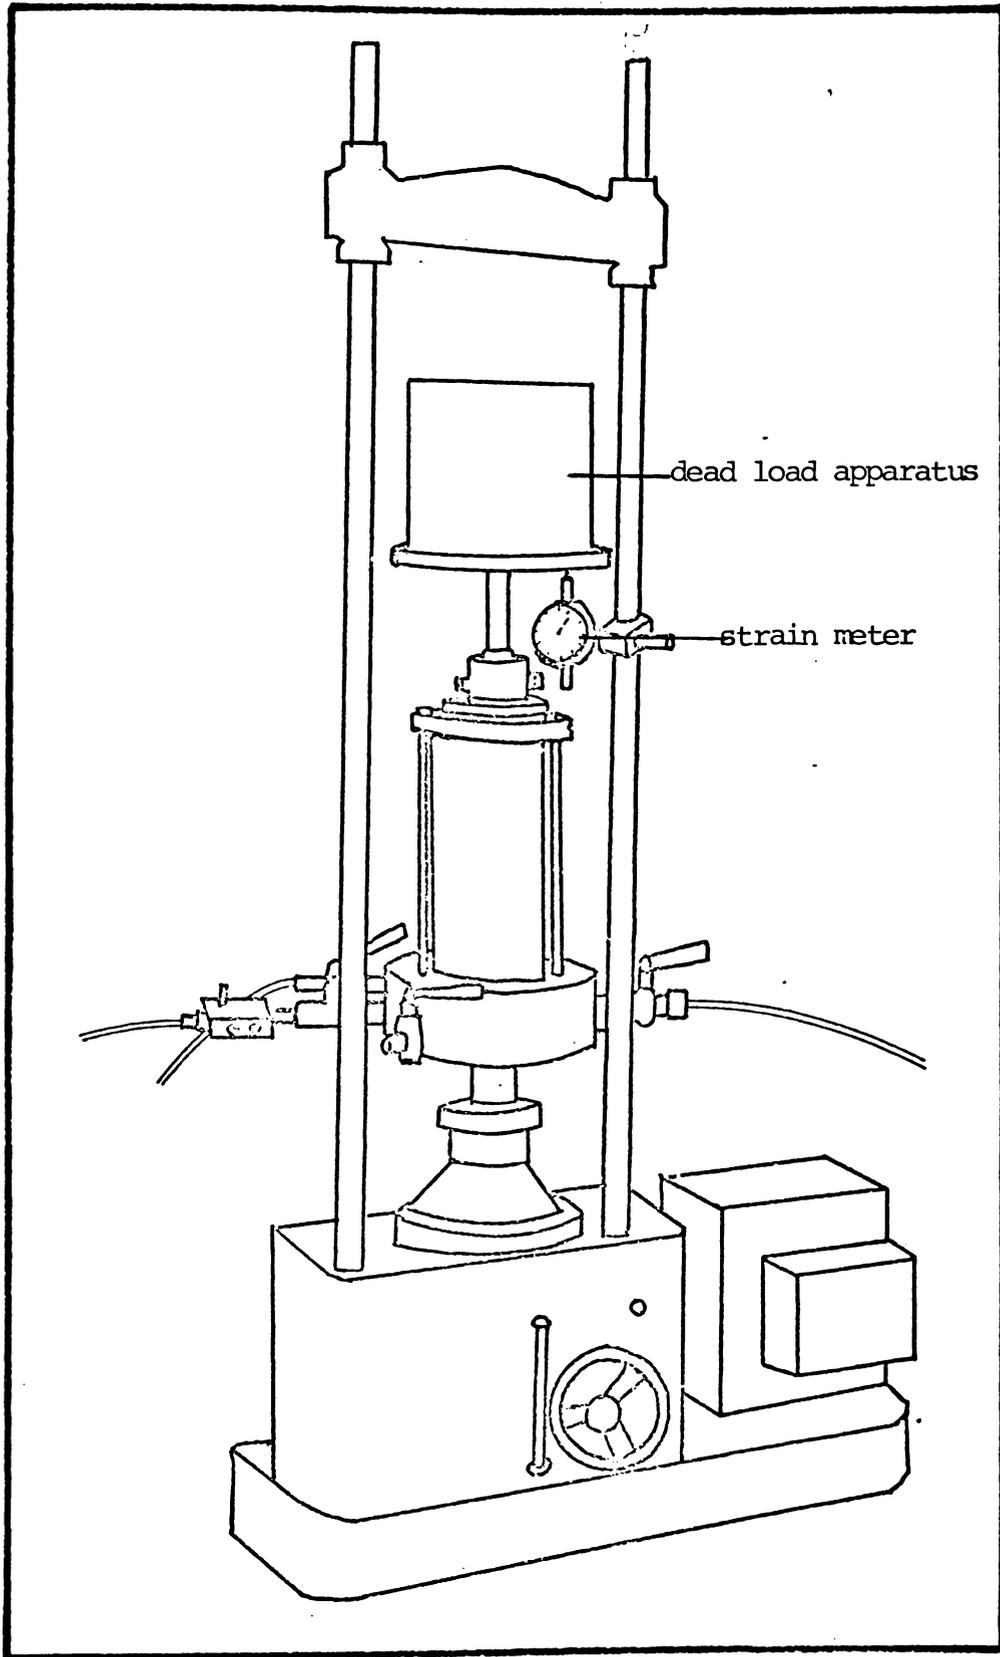
Figure 4.9. Triaxial apparatus modified for dead-load testing.

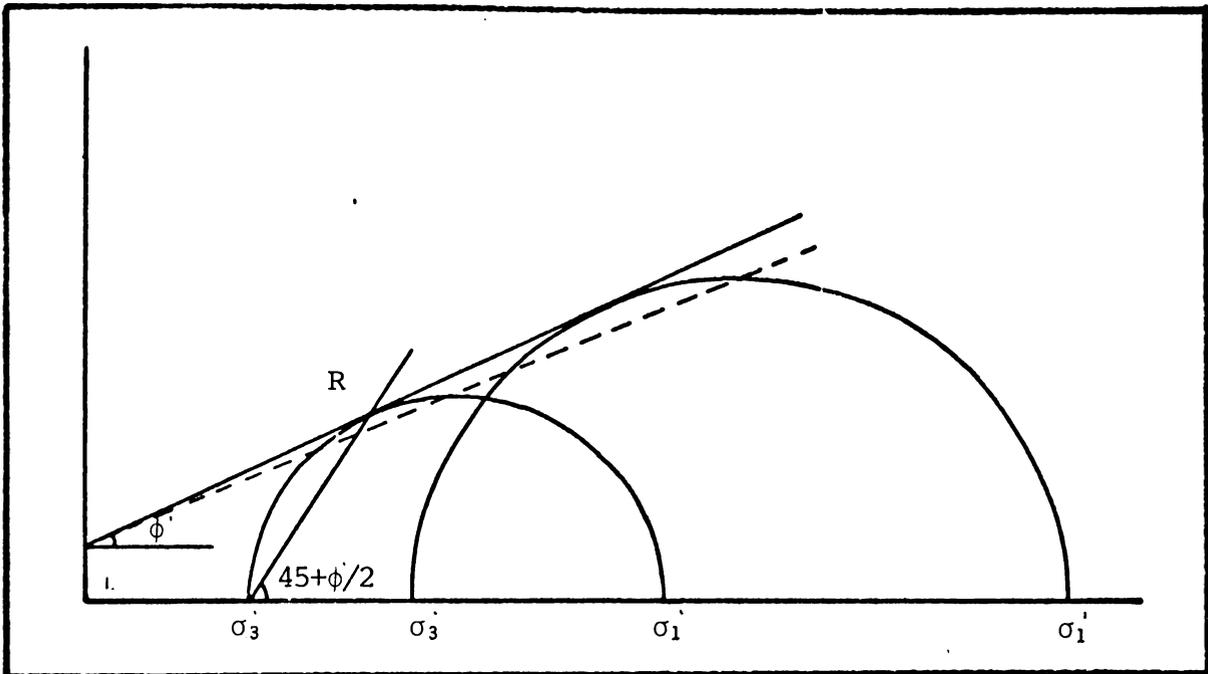
Figure 4.10. Linear regression analysis used to approximate the Mohr-Coulomb envelope.

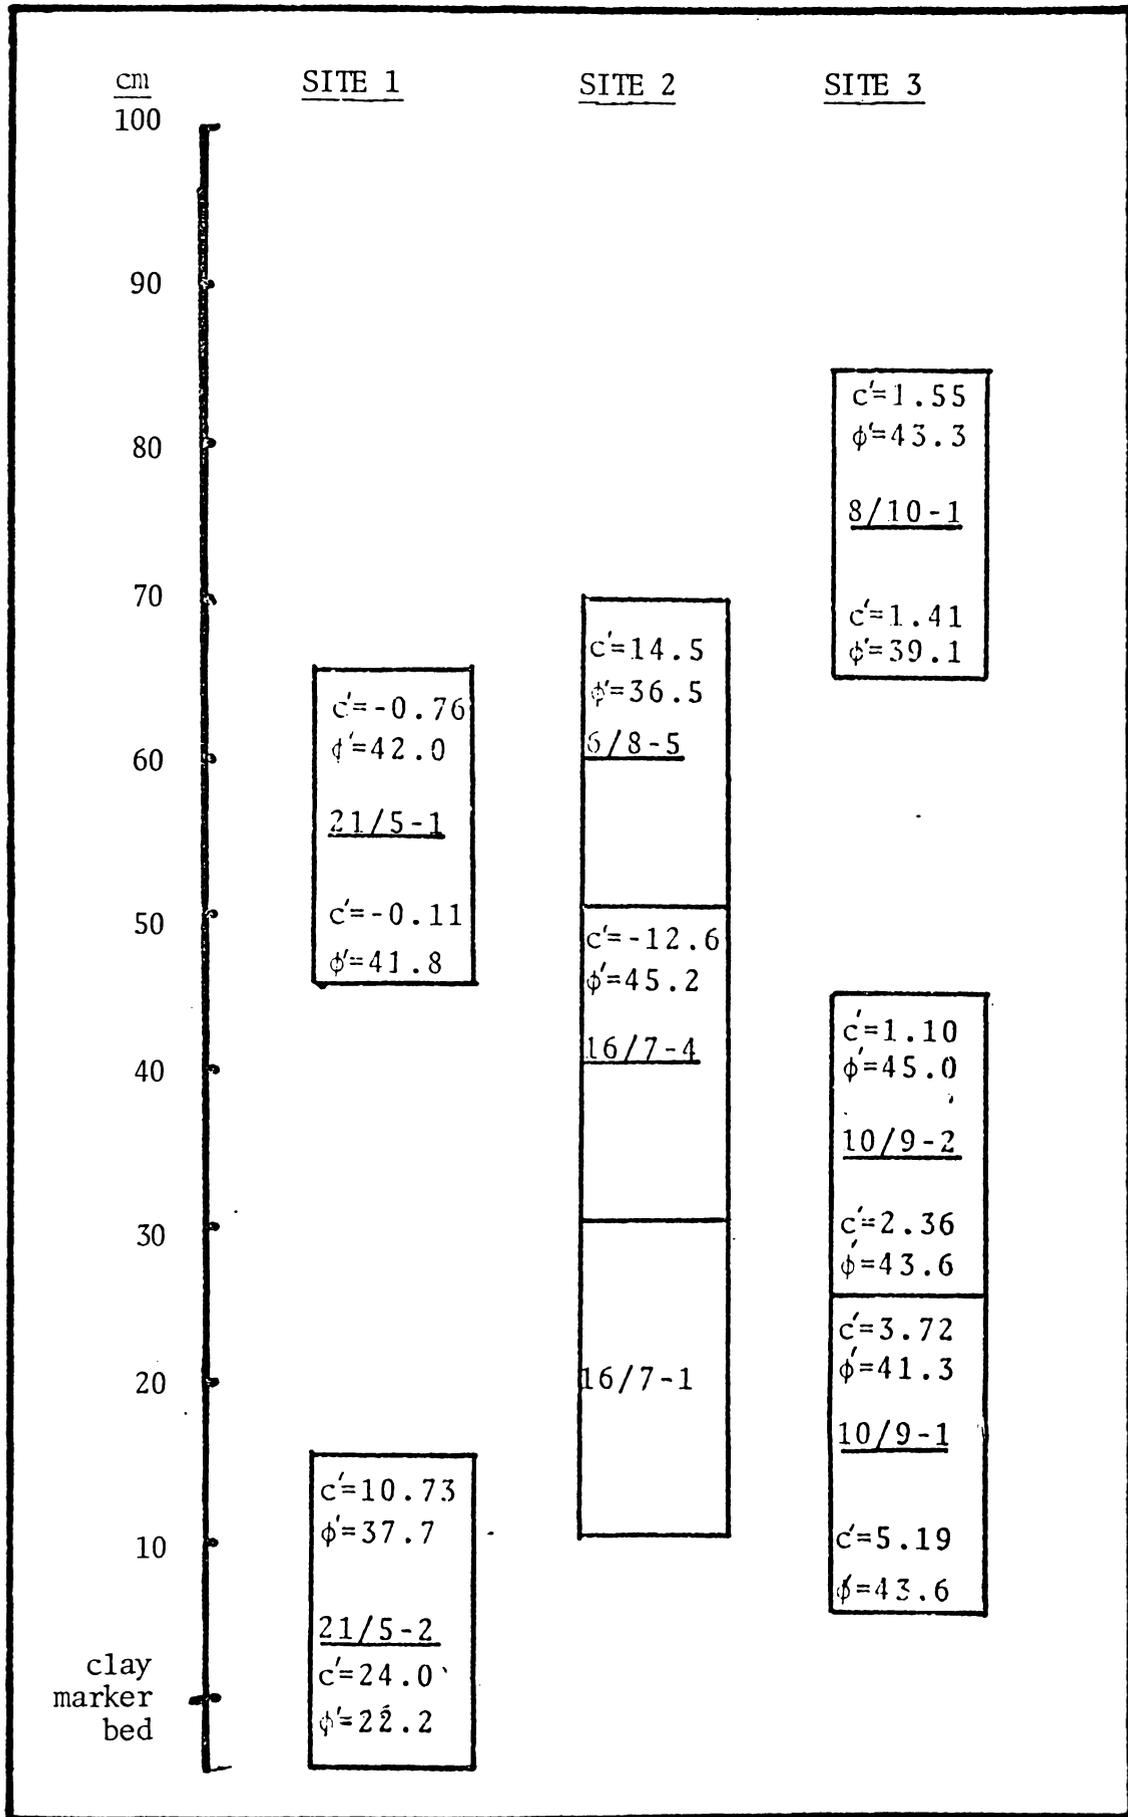
Figure 4.11. Stratigraphic relationships of the triaxial samples, and the strength parameters derived from them. ( $c'$  in kPa,  $\phi'$  in degrees)

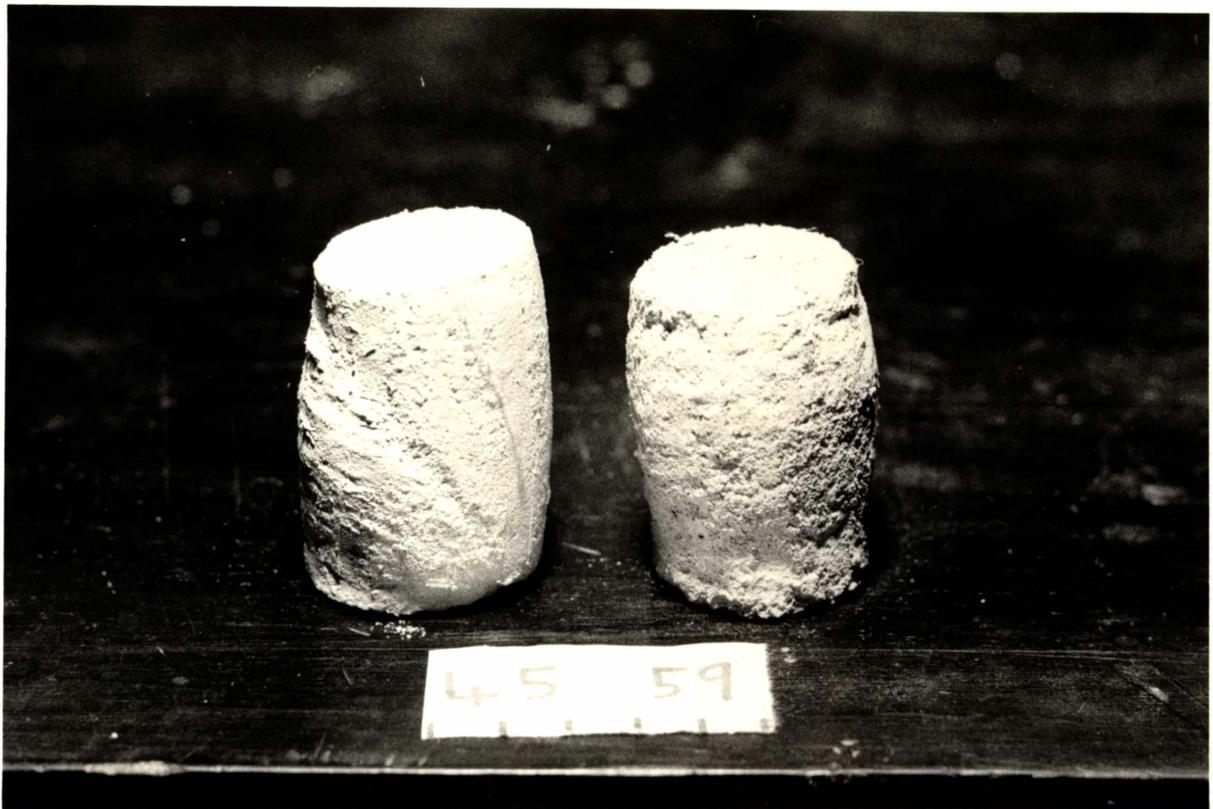
Fig 4.12 Triaxial shear samples from tests 45 (sandy mud, brittle failure) and 59 (silty sand, plastic failure).

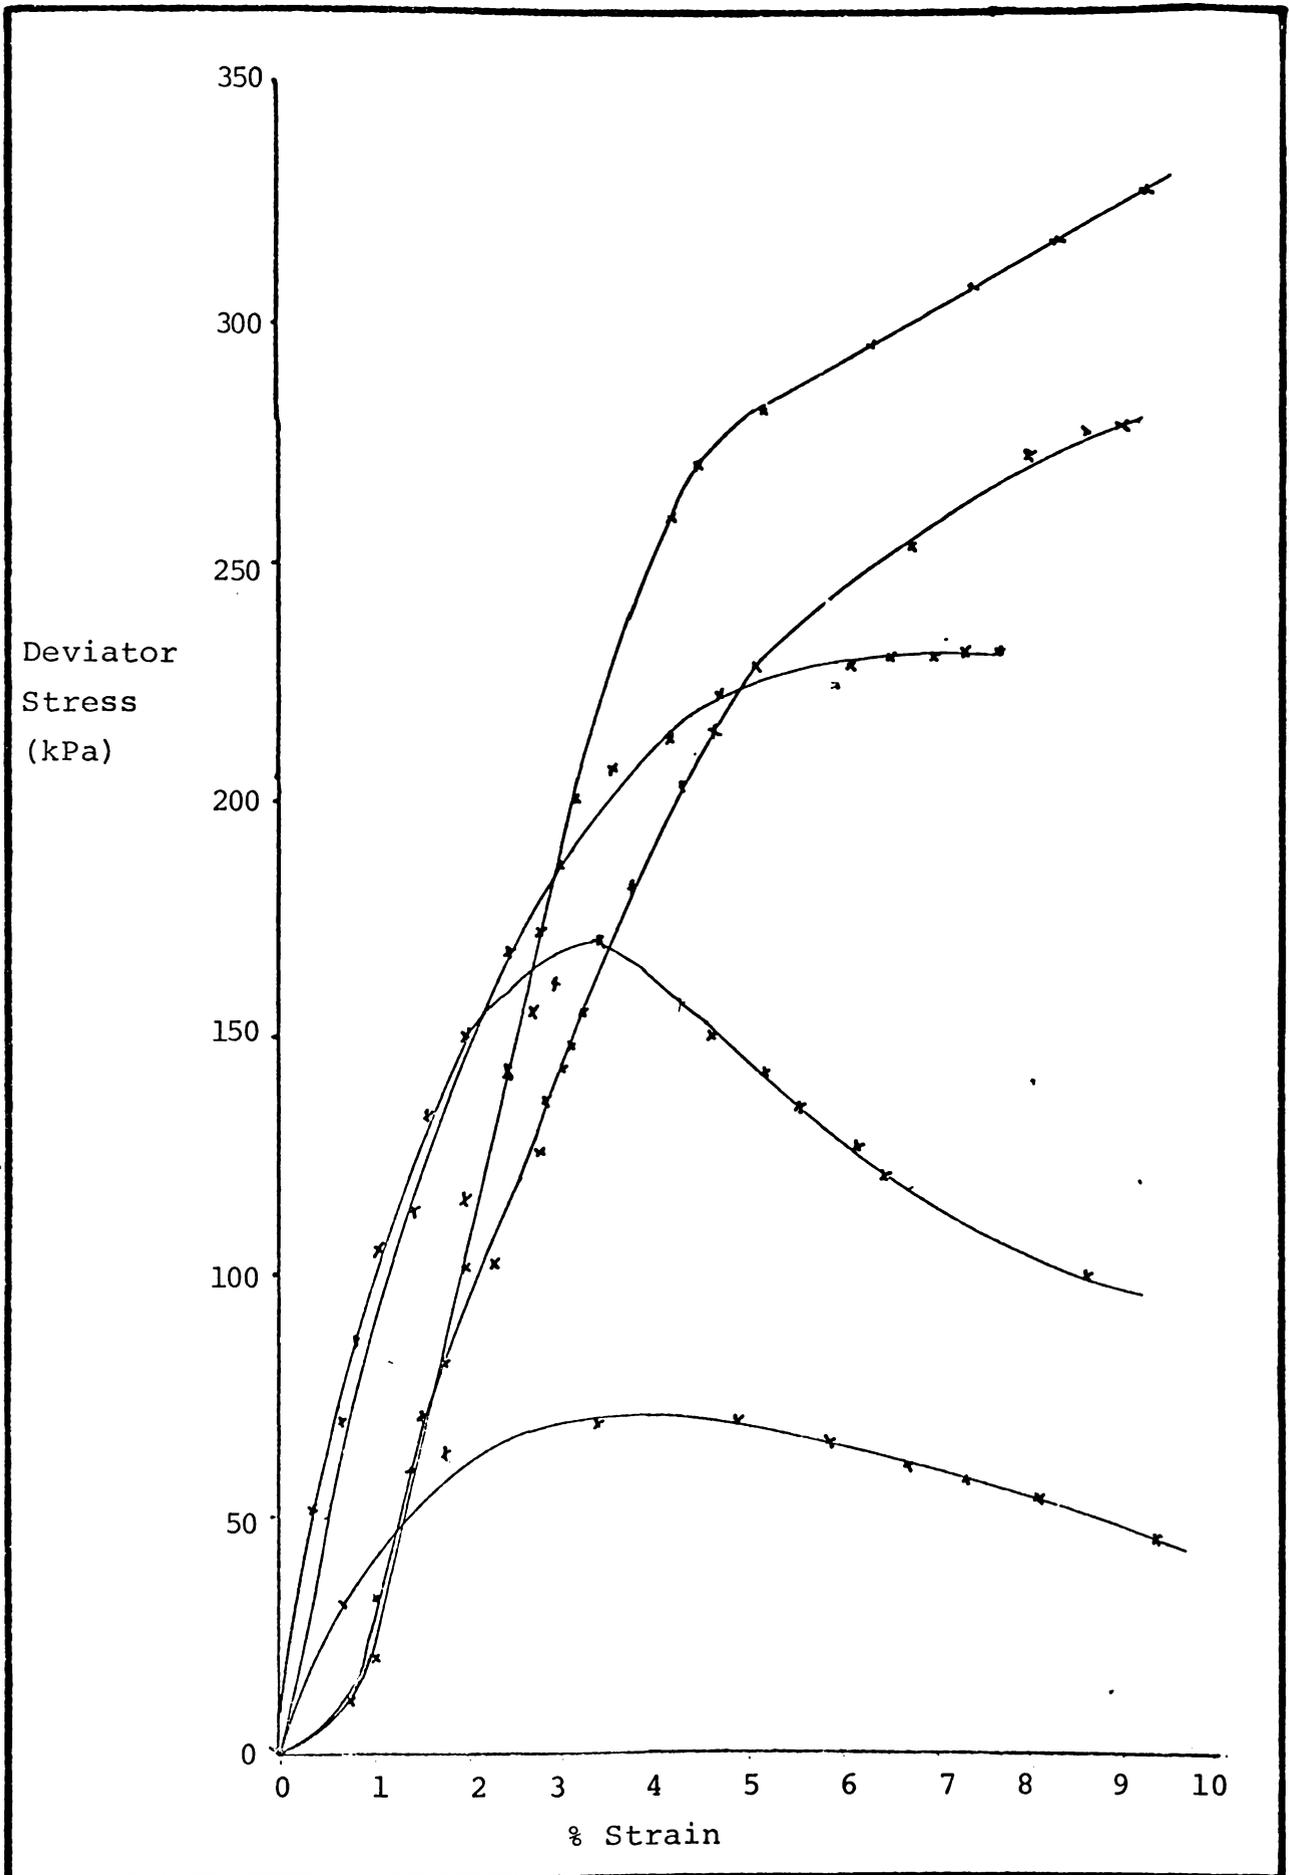
Figure 4.13. Deviator stress curves for high bulk density samples.

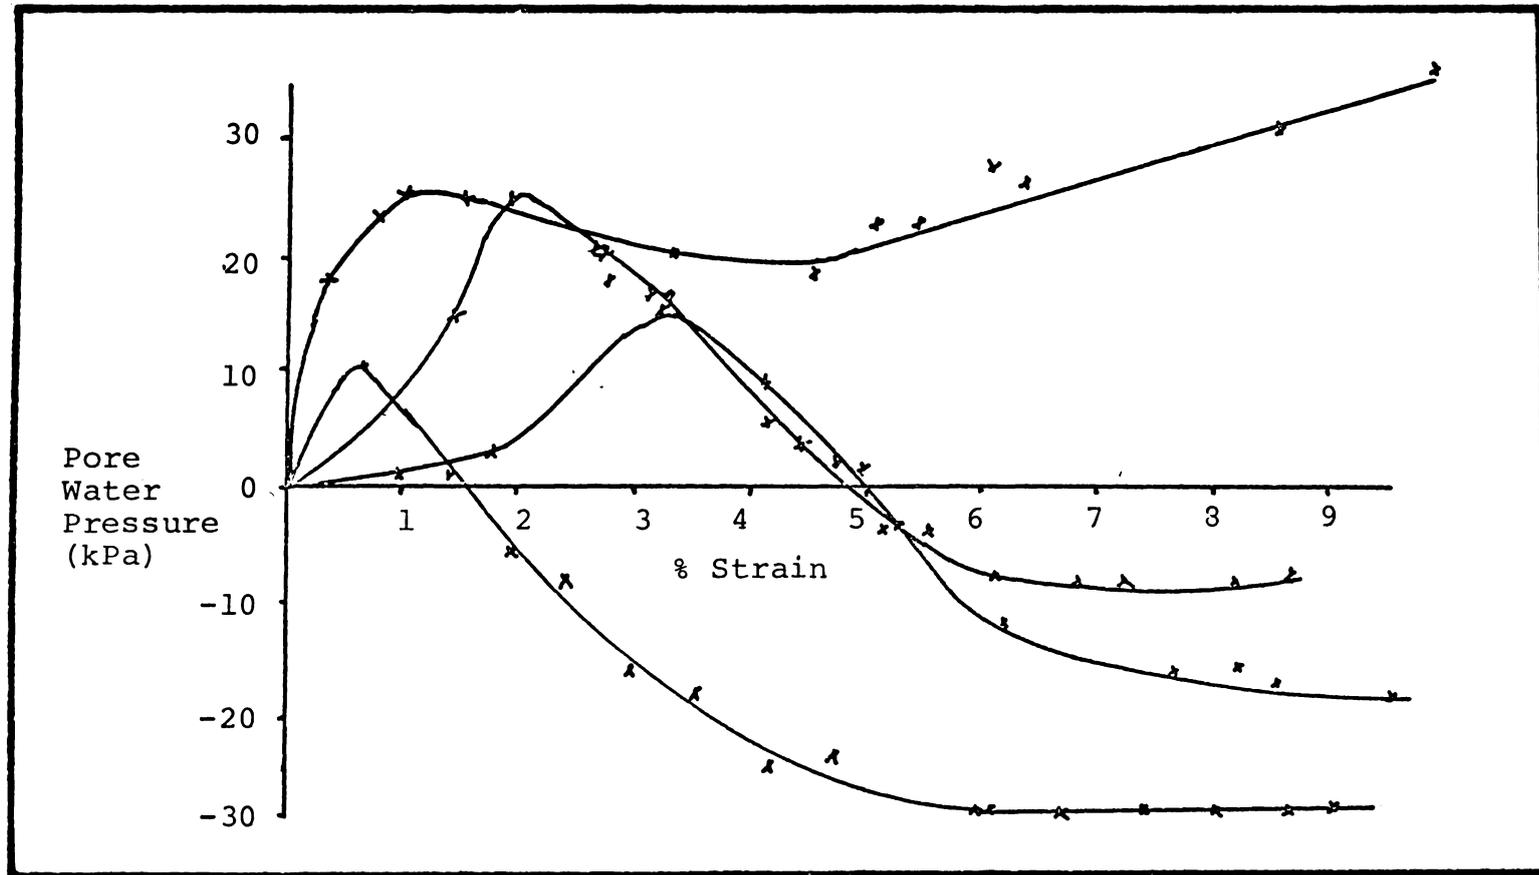
Figure 4.14. Pore water pressures recorded during triaxial shear testing of high bulk density samples.

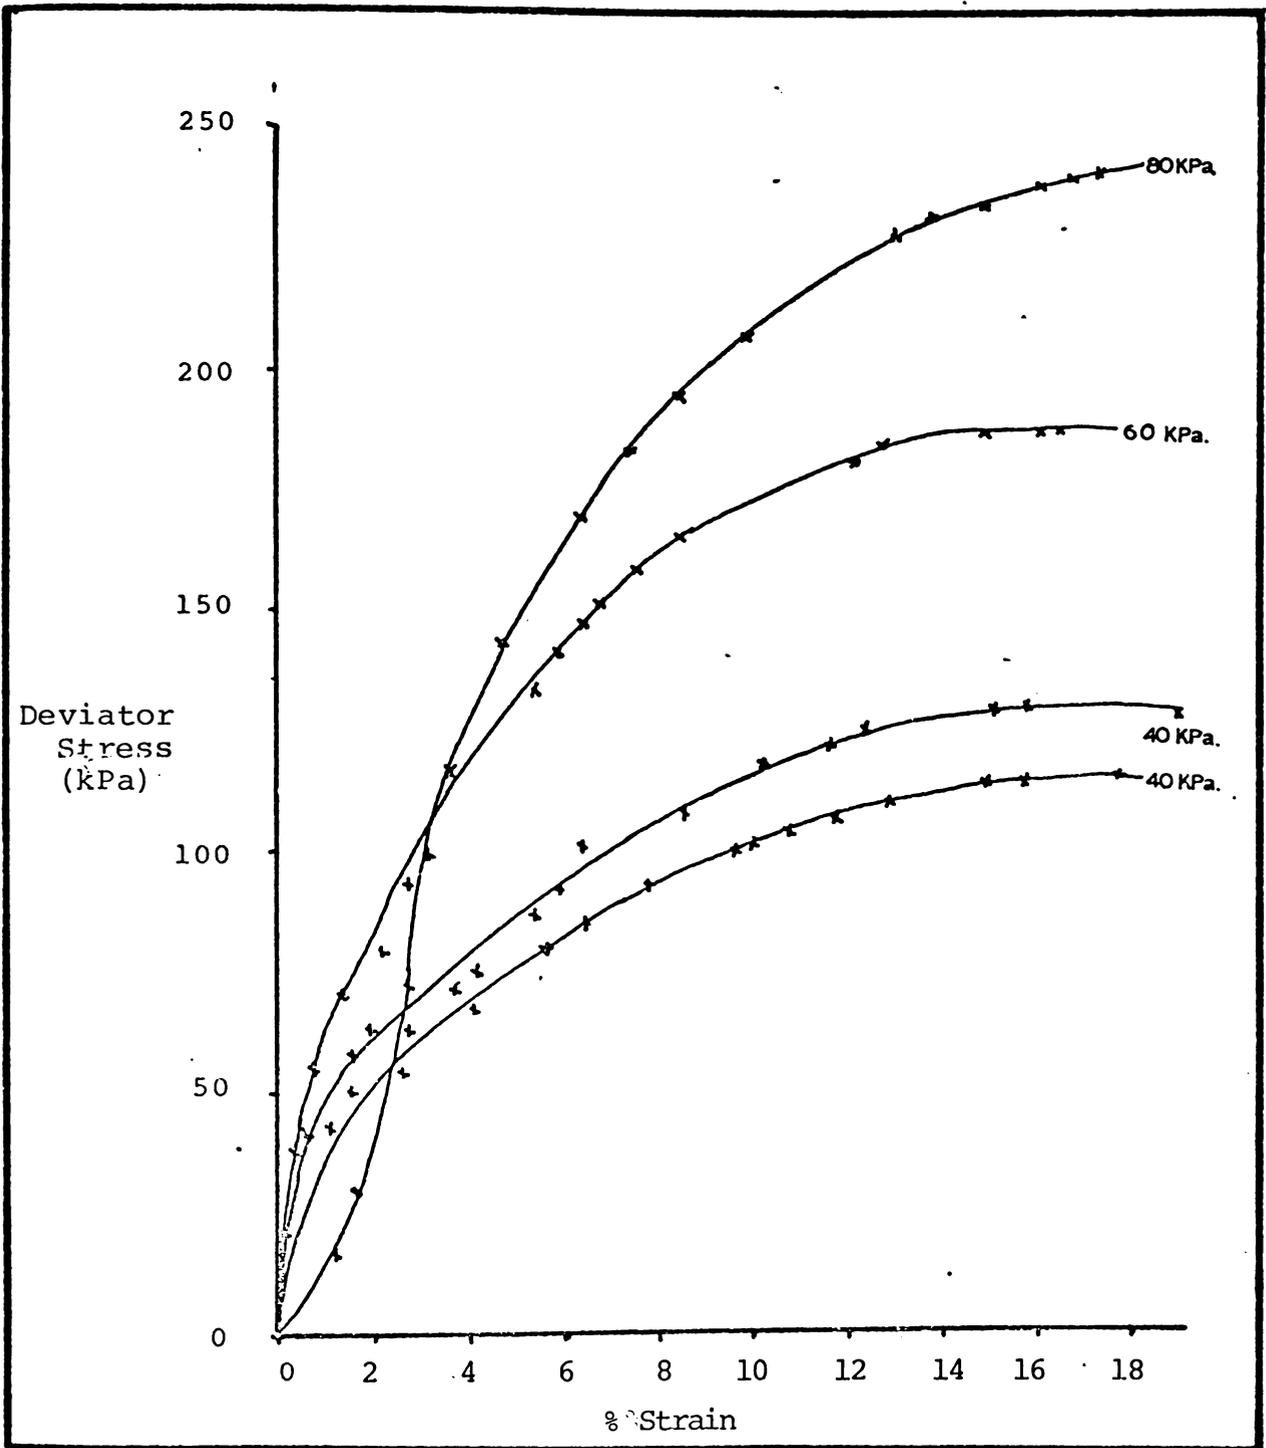
Figure 4.15. Deviator stress curves for low bulk density samples.
