THE NATURE AND CAUSES OF  
COASTAL LANDSLIDING ON  
THE MAUNGATAPU PENINSULA,  
TAURANGA, NEW ZEALAND.

A thesis submitted in partial fulfilment of the  
requirements for the Degree of Master of Science  
in Earth Sciences

University of Waikato

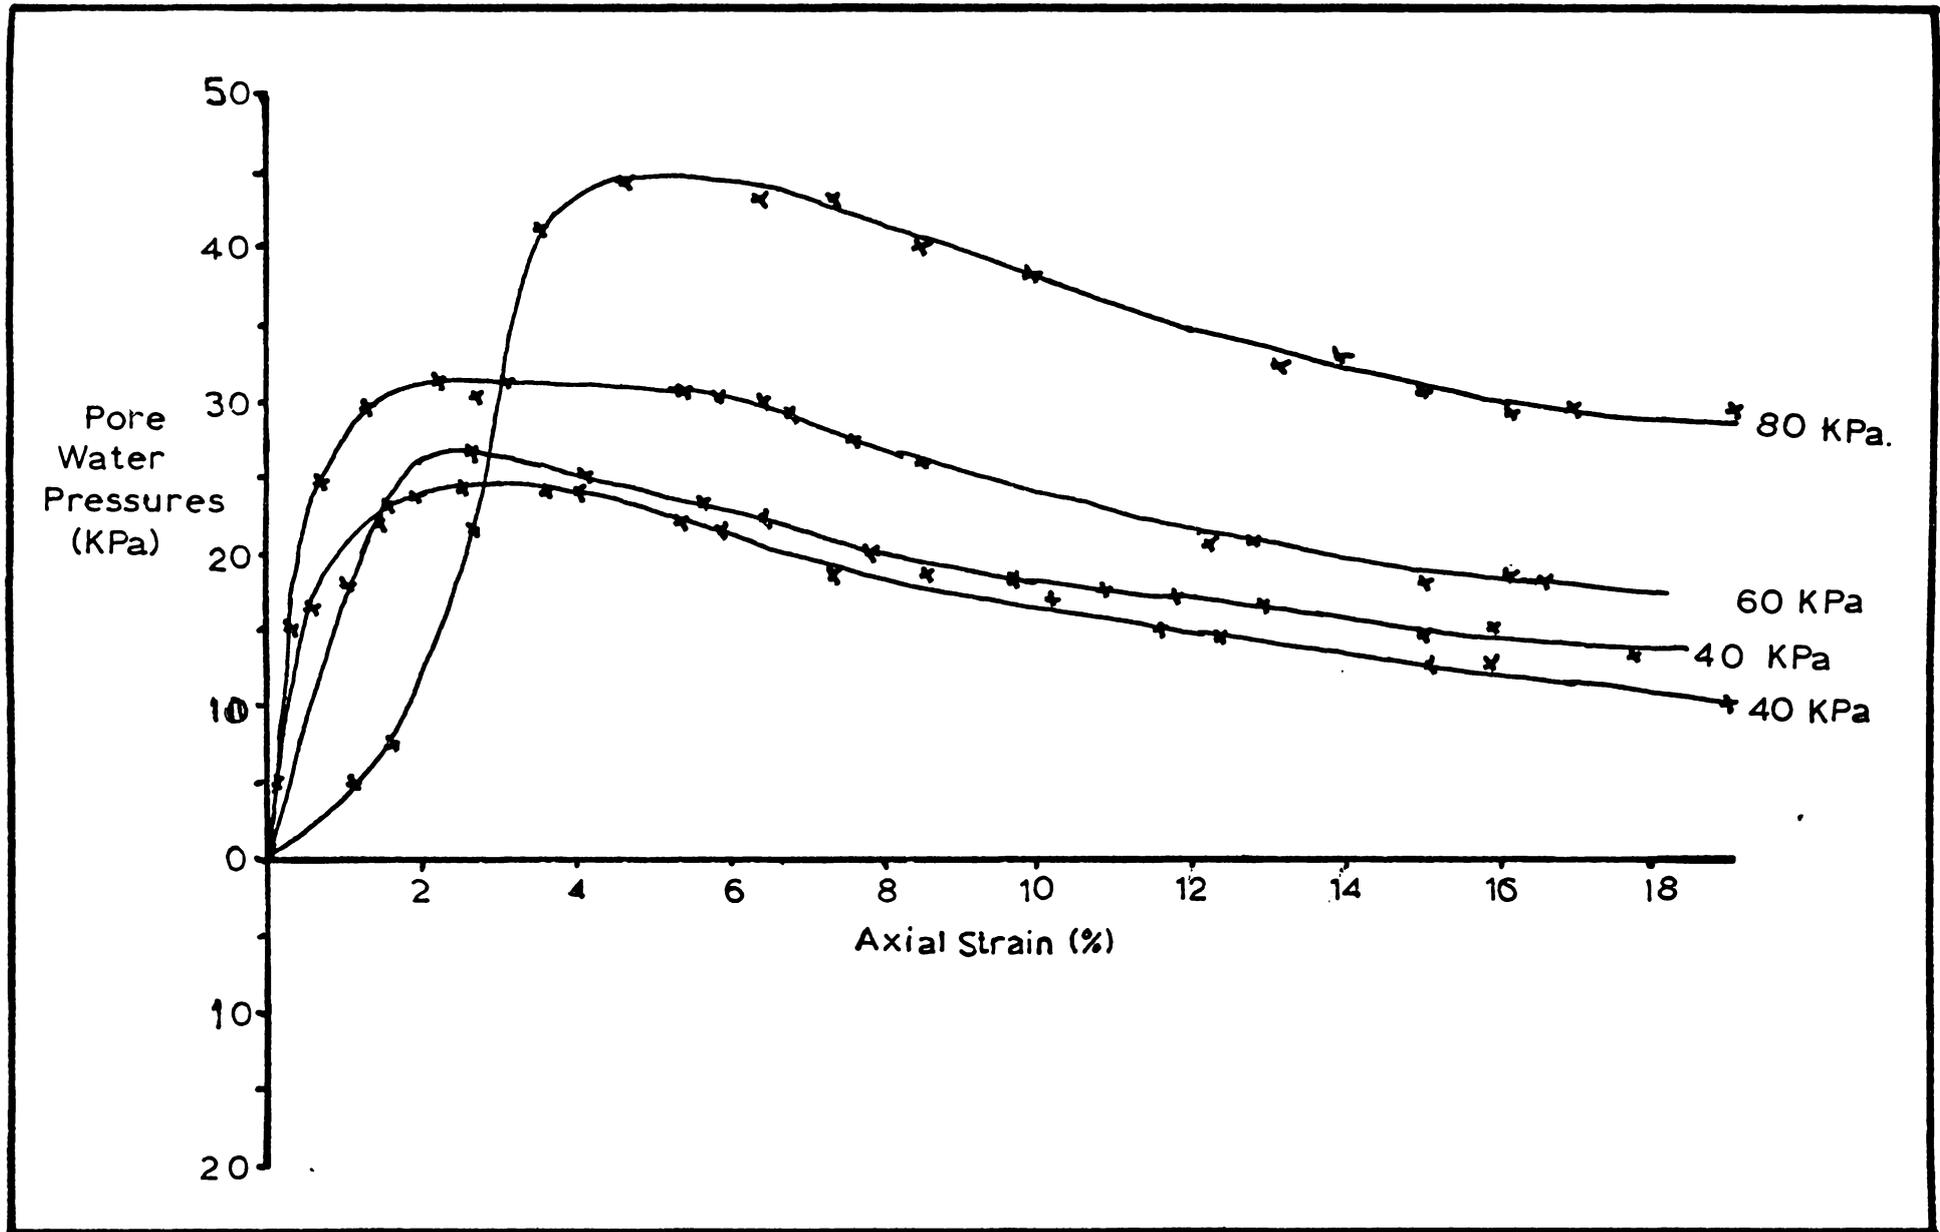
Figure 4.16. Pore water pressures recorded during triaxial testing of the low bulk density samples.

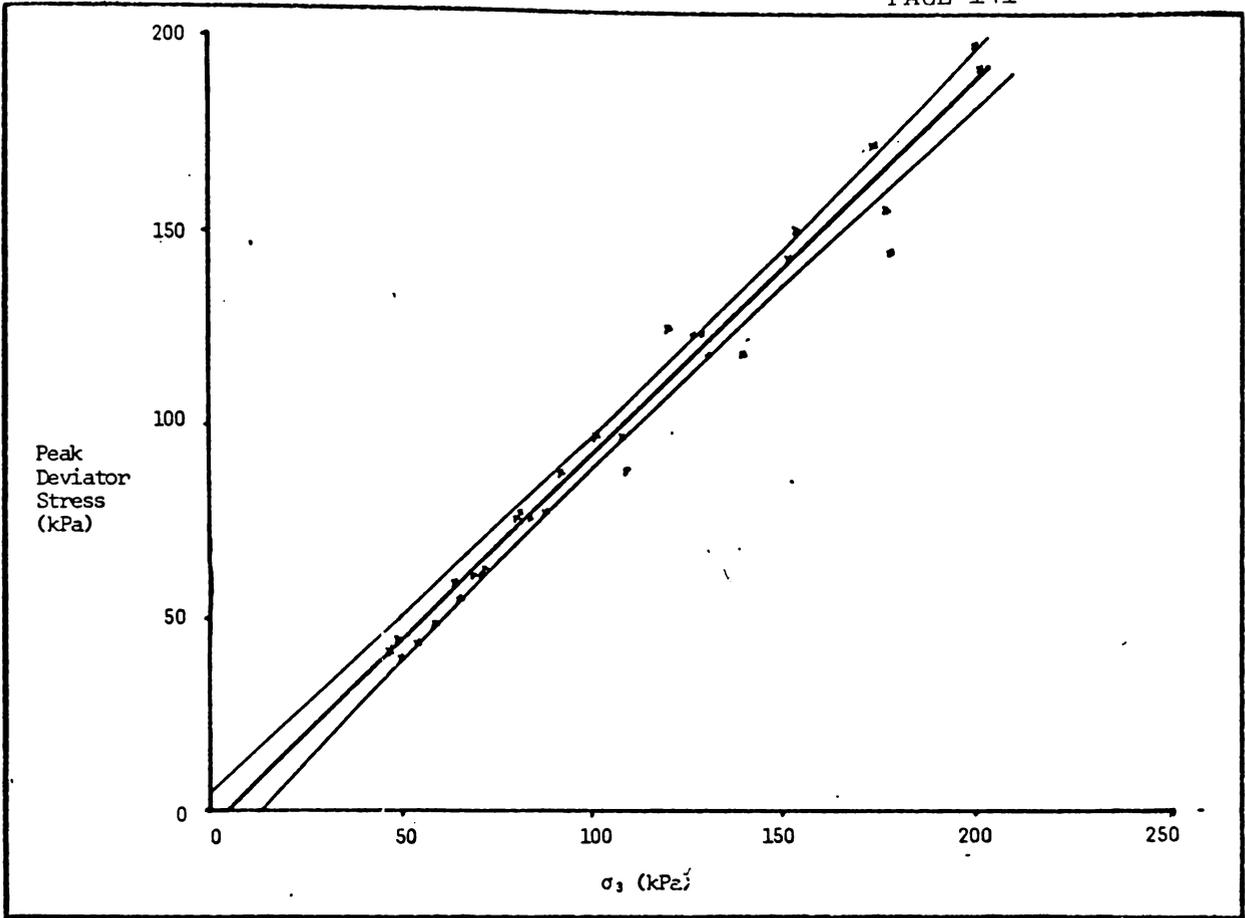
Figure 4.17. Best fit linear regression line and 95% confidence intervals for the low bulk density data.

When the data points and best fit lines were plotted (fig. 4.17&18) the similarity of the two data groups, indicated by the overlapping confidence intervals, was striking (table 4.6). To quantify the differences between the two best fit

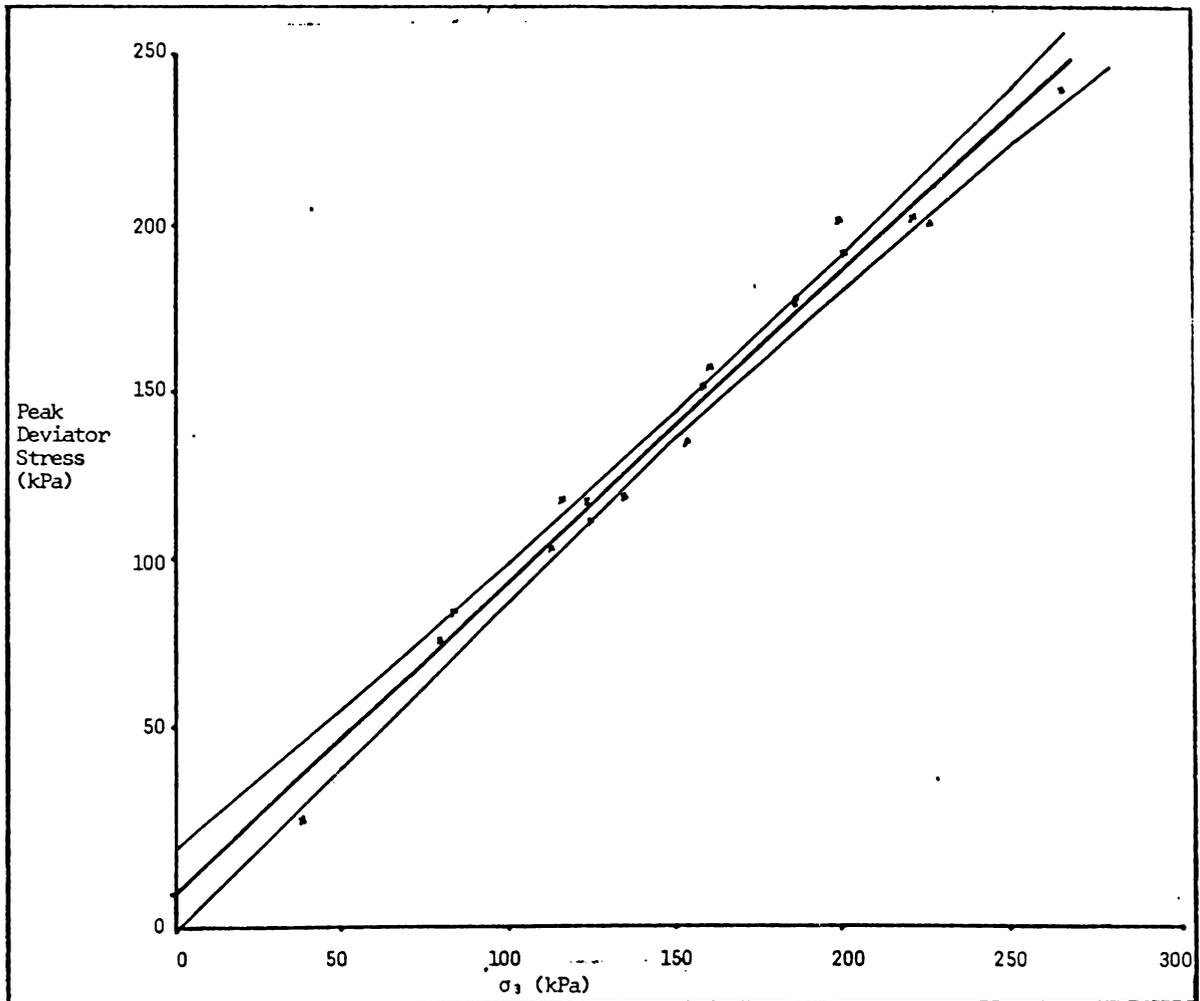
Figure 4.18. Best fit linear regression line and 95% confidence intervals for high bulk density data.

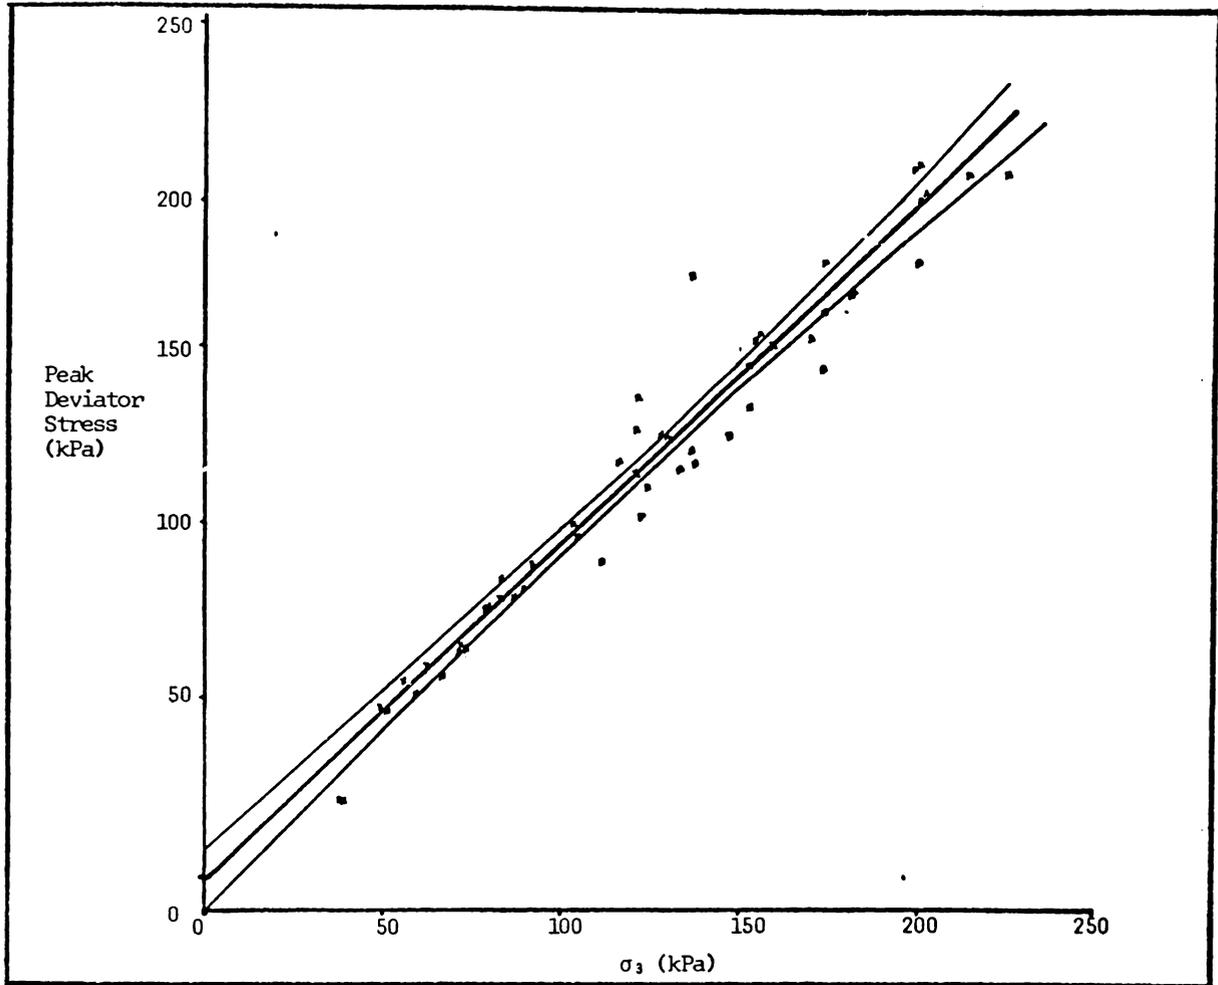
Figure 4.19. Best fit linear regression line and 95% confidence intervals for all data.

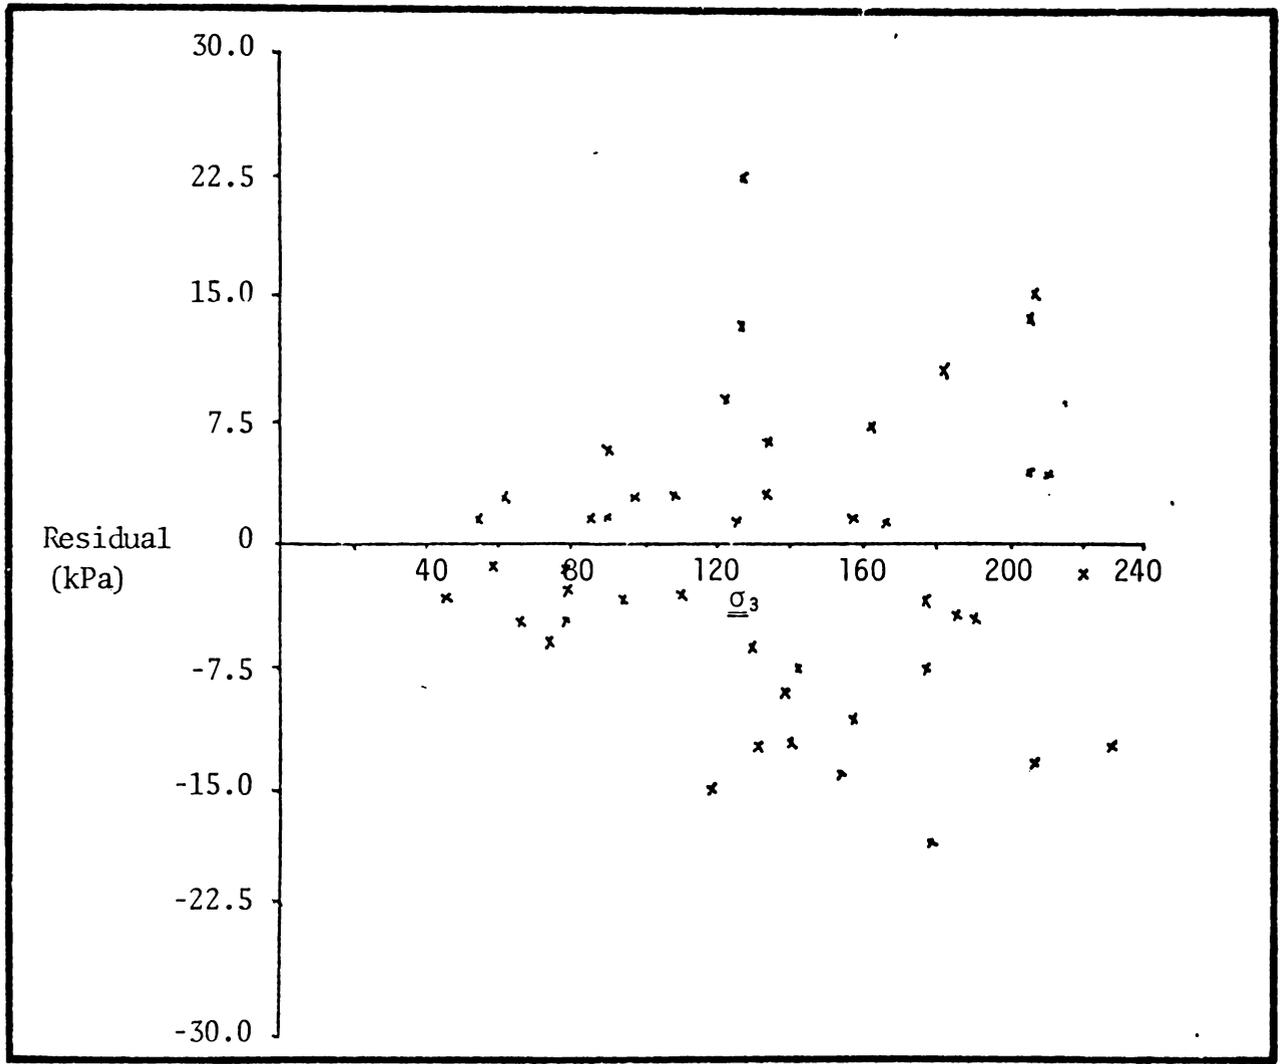
Figure 4.21. Linear regression residuals plot for all triaxial data grouped.

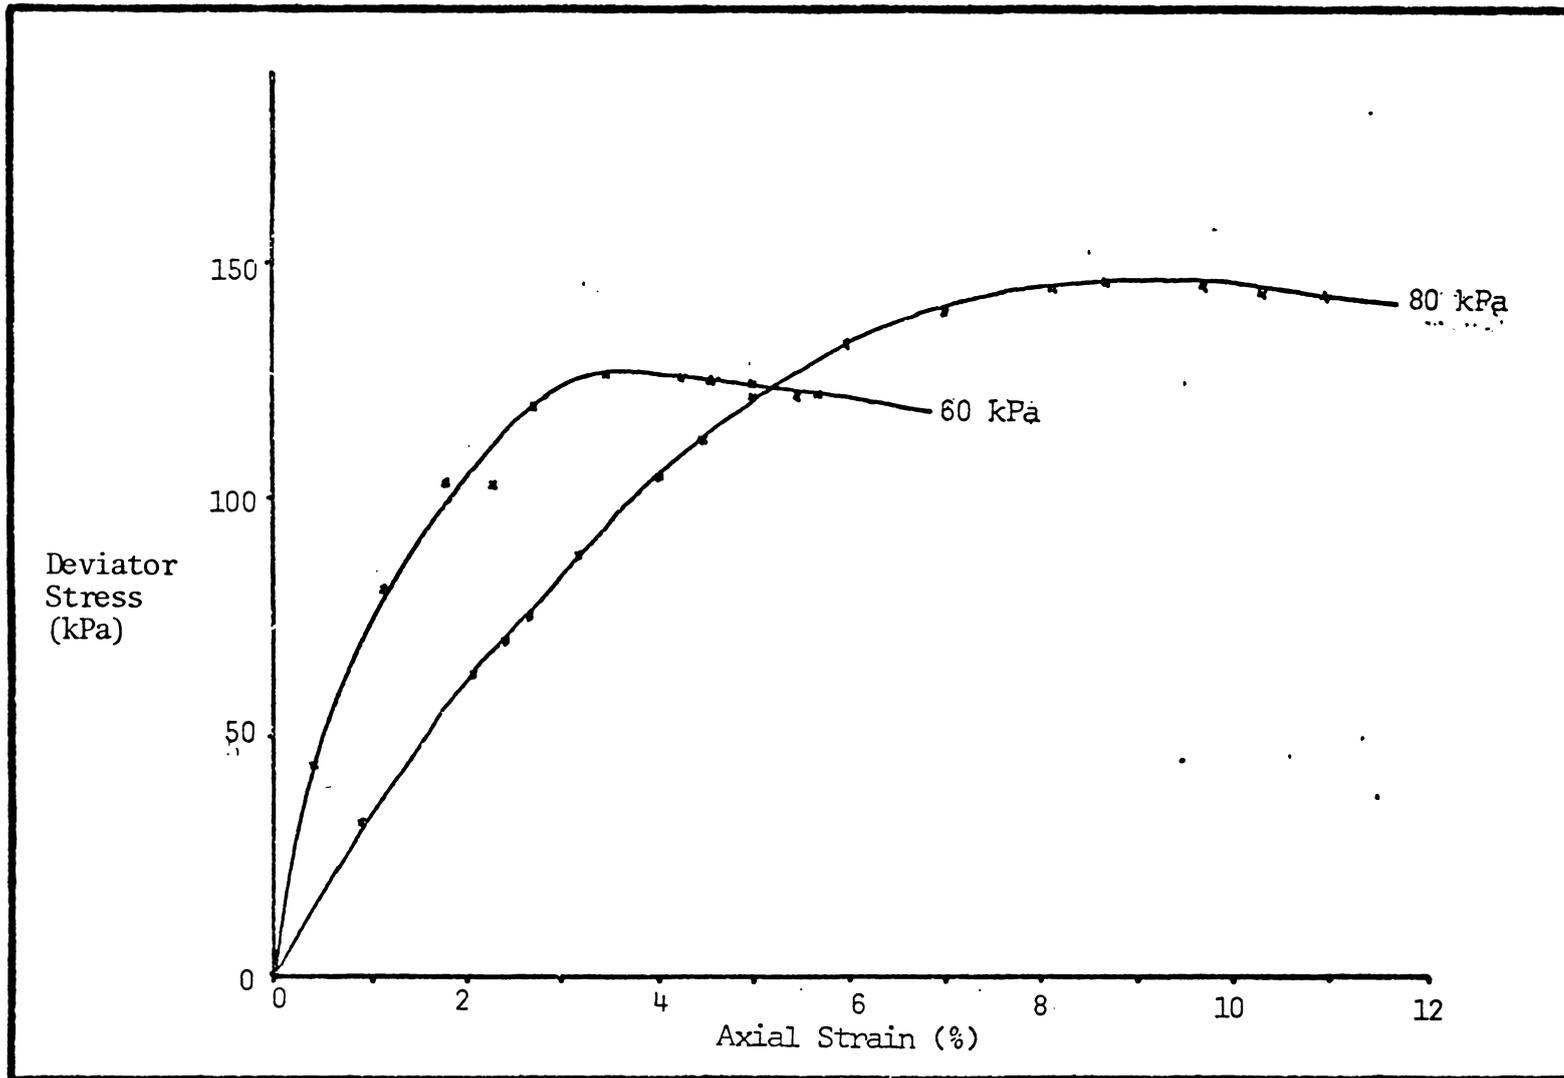
Figure 4.22. Deviator stress vs. strain curves for the clay marker bed.

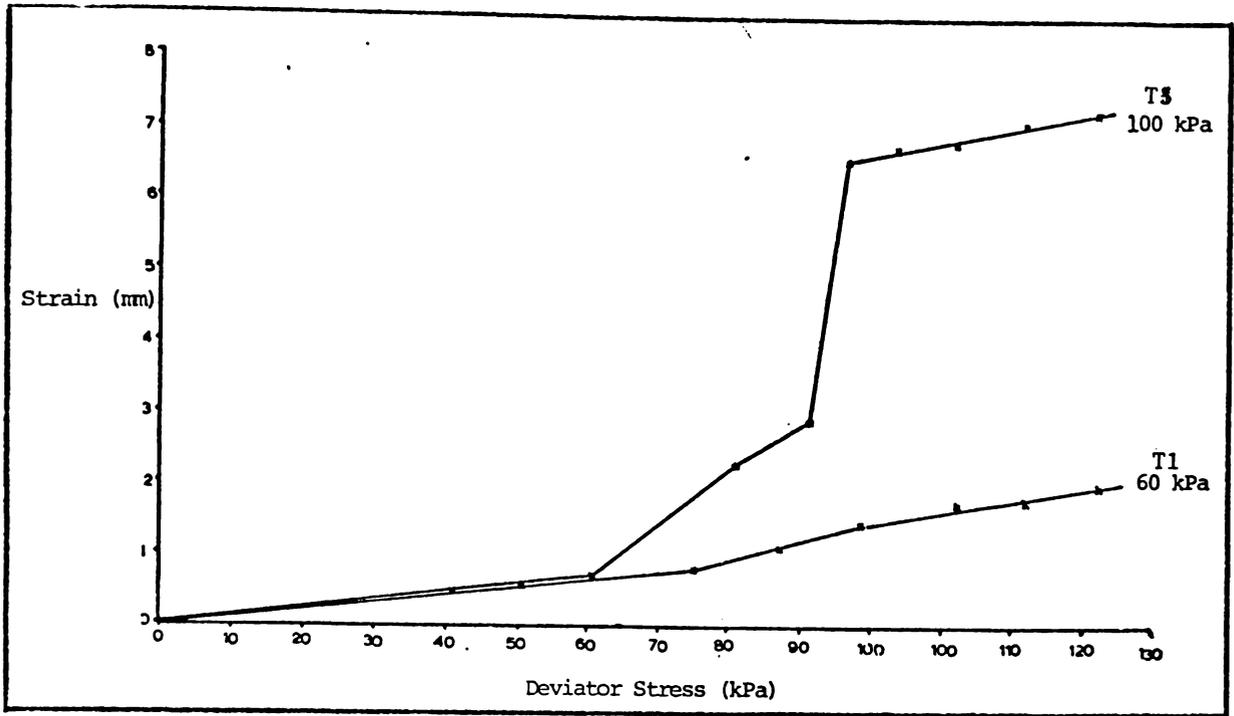
Figure 4.23. Stress controlled tests; strain curves.

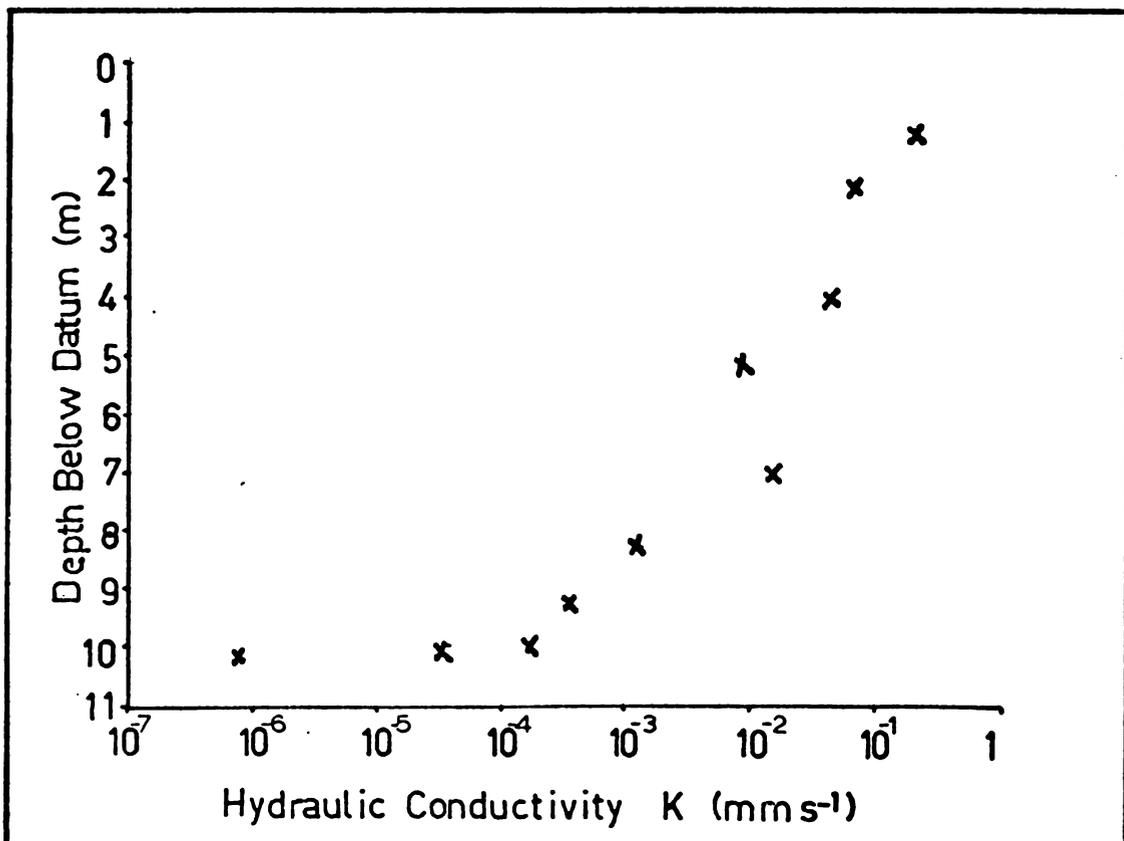
Figure 4.25. Hydraulic Conductivity results.

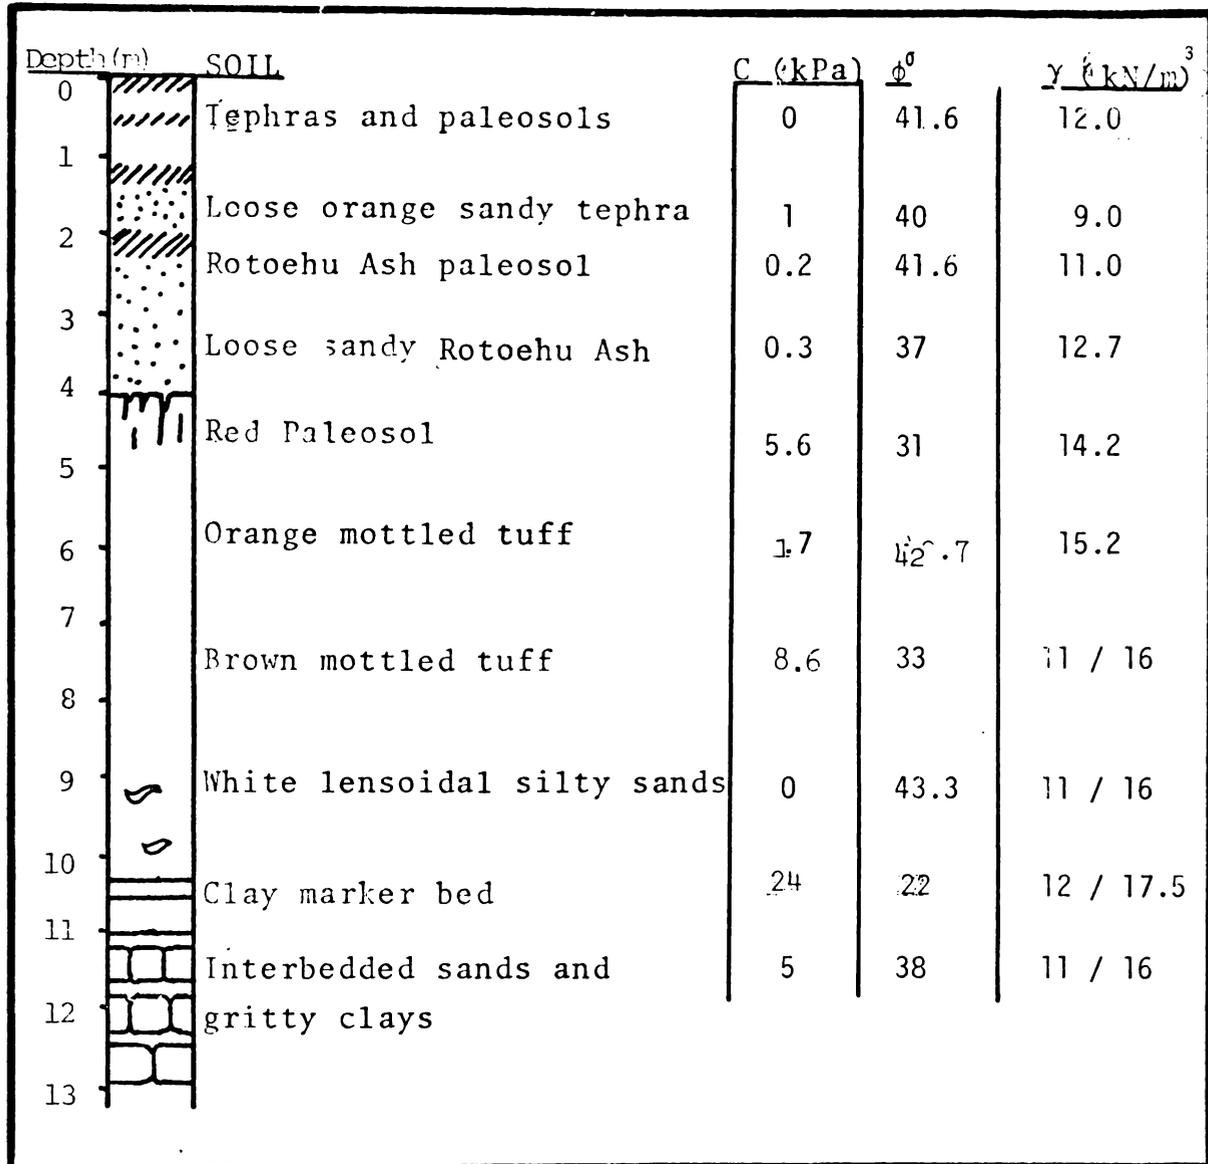
Figure 4.27. Idealised soil profile. Note: Where two values are given for  $\gamma$  the first value is dry unit weight, the second is saturated unit weight

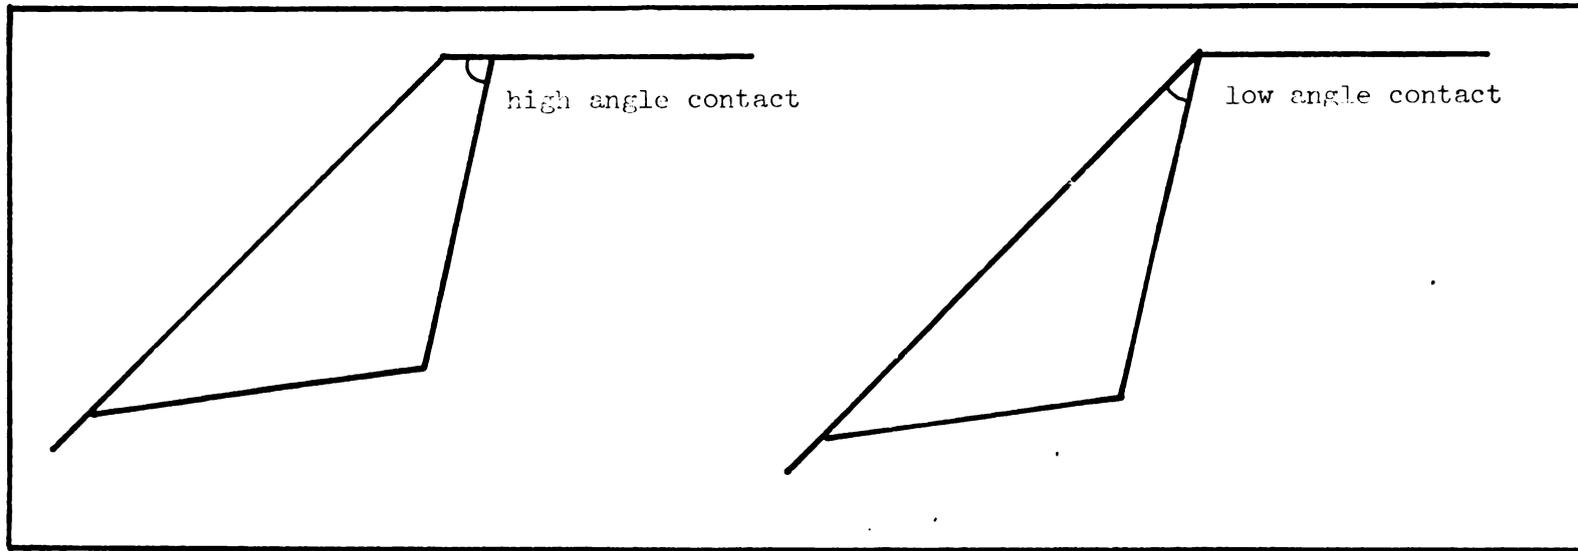
Fig. 5.1. The upper slope - failure surface contact, which may be regarded as high angle or low angle.

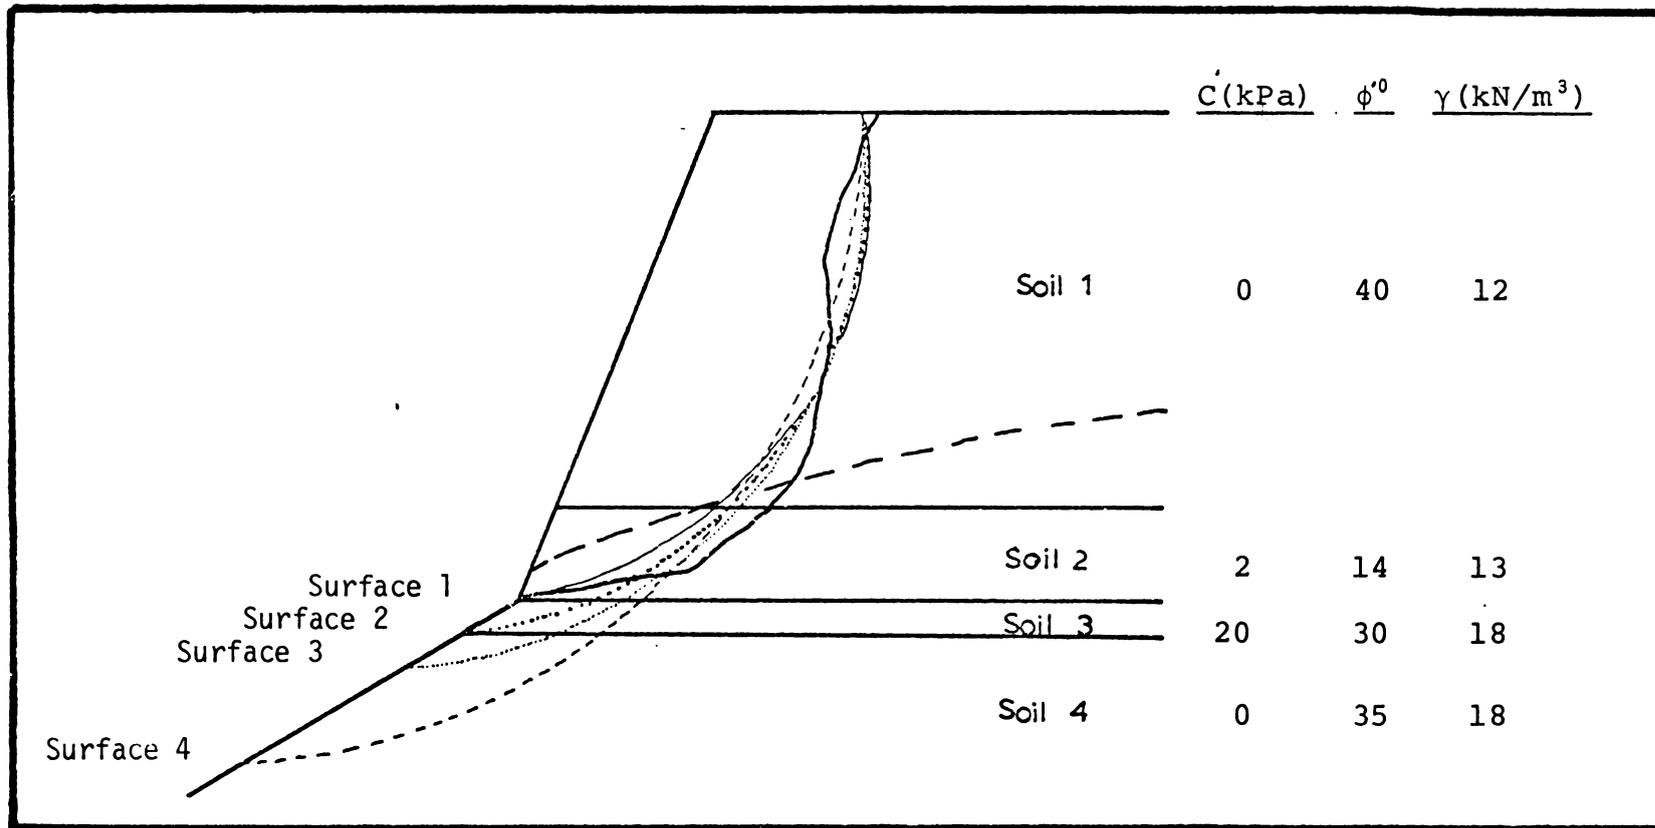
Figure 5.2. Investigation of the effect of the presence of the clay marker bed using multiple failure surfaces.

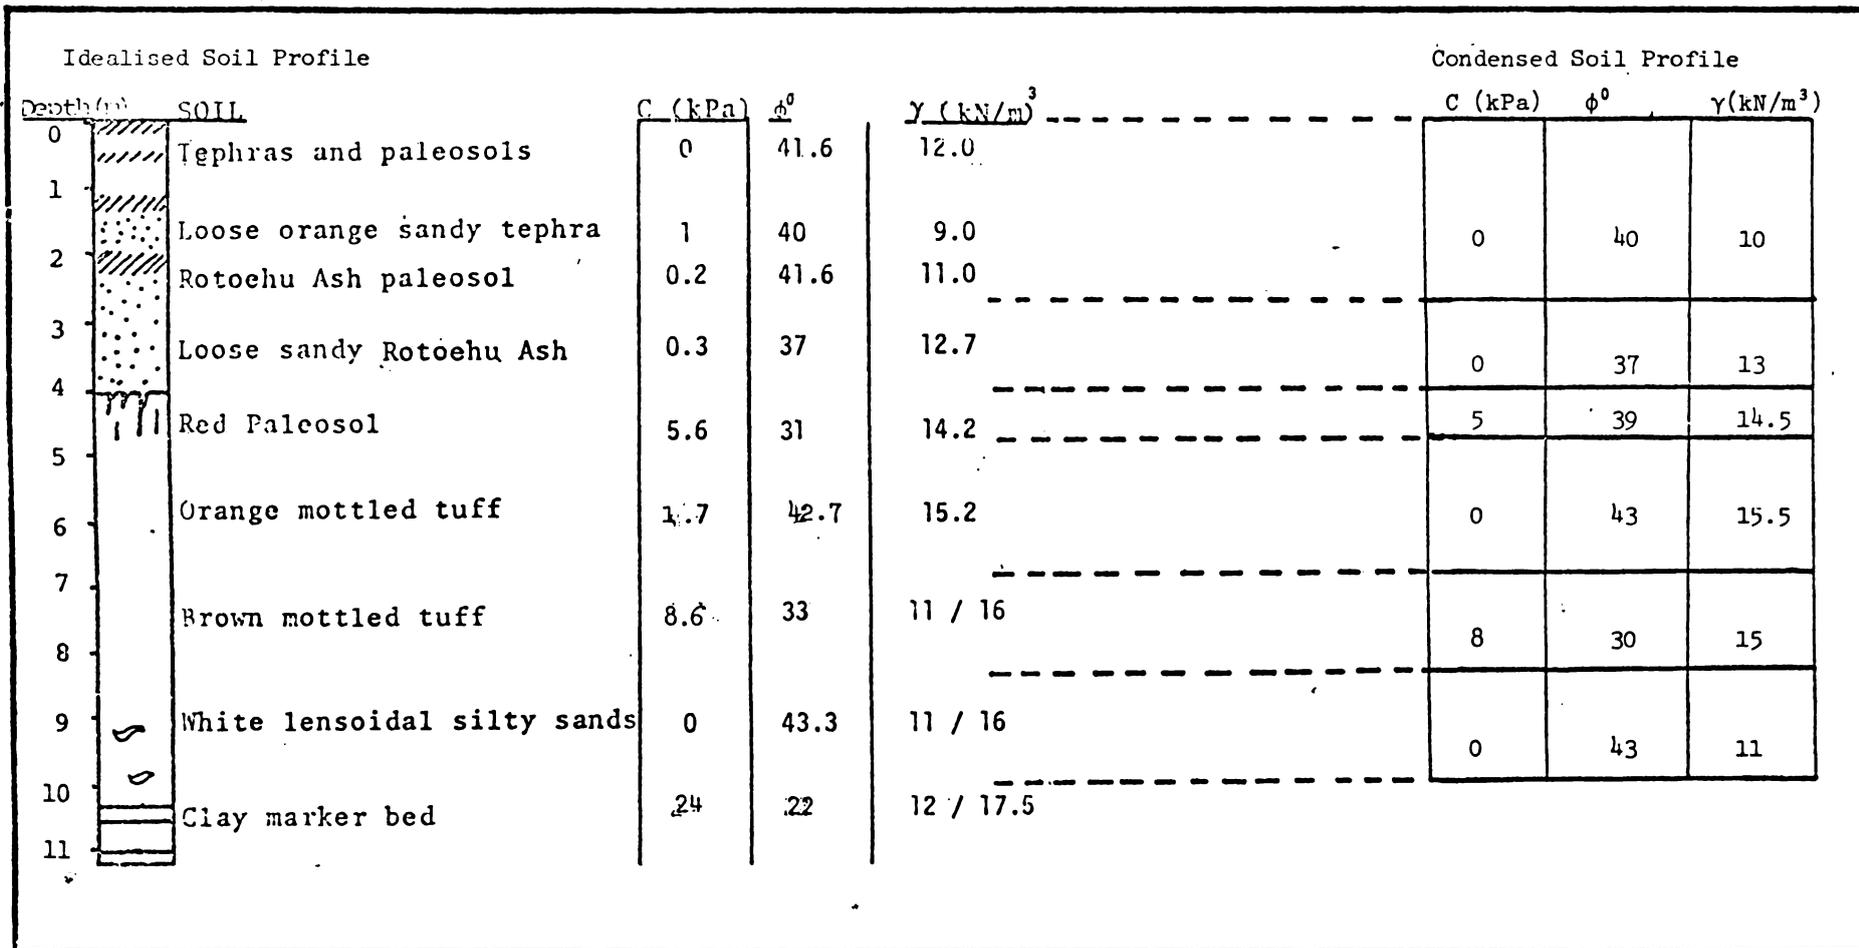
Fig. 5.3. Condensation of idealised soil profile to a test case soil profile.

In preparing site specific soil profiles, the idealised soil profile obtained from field and laboratory studies (fig.

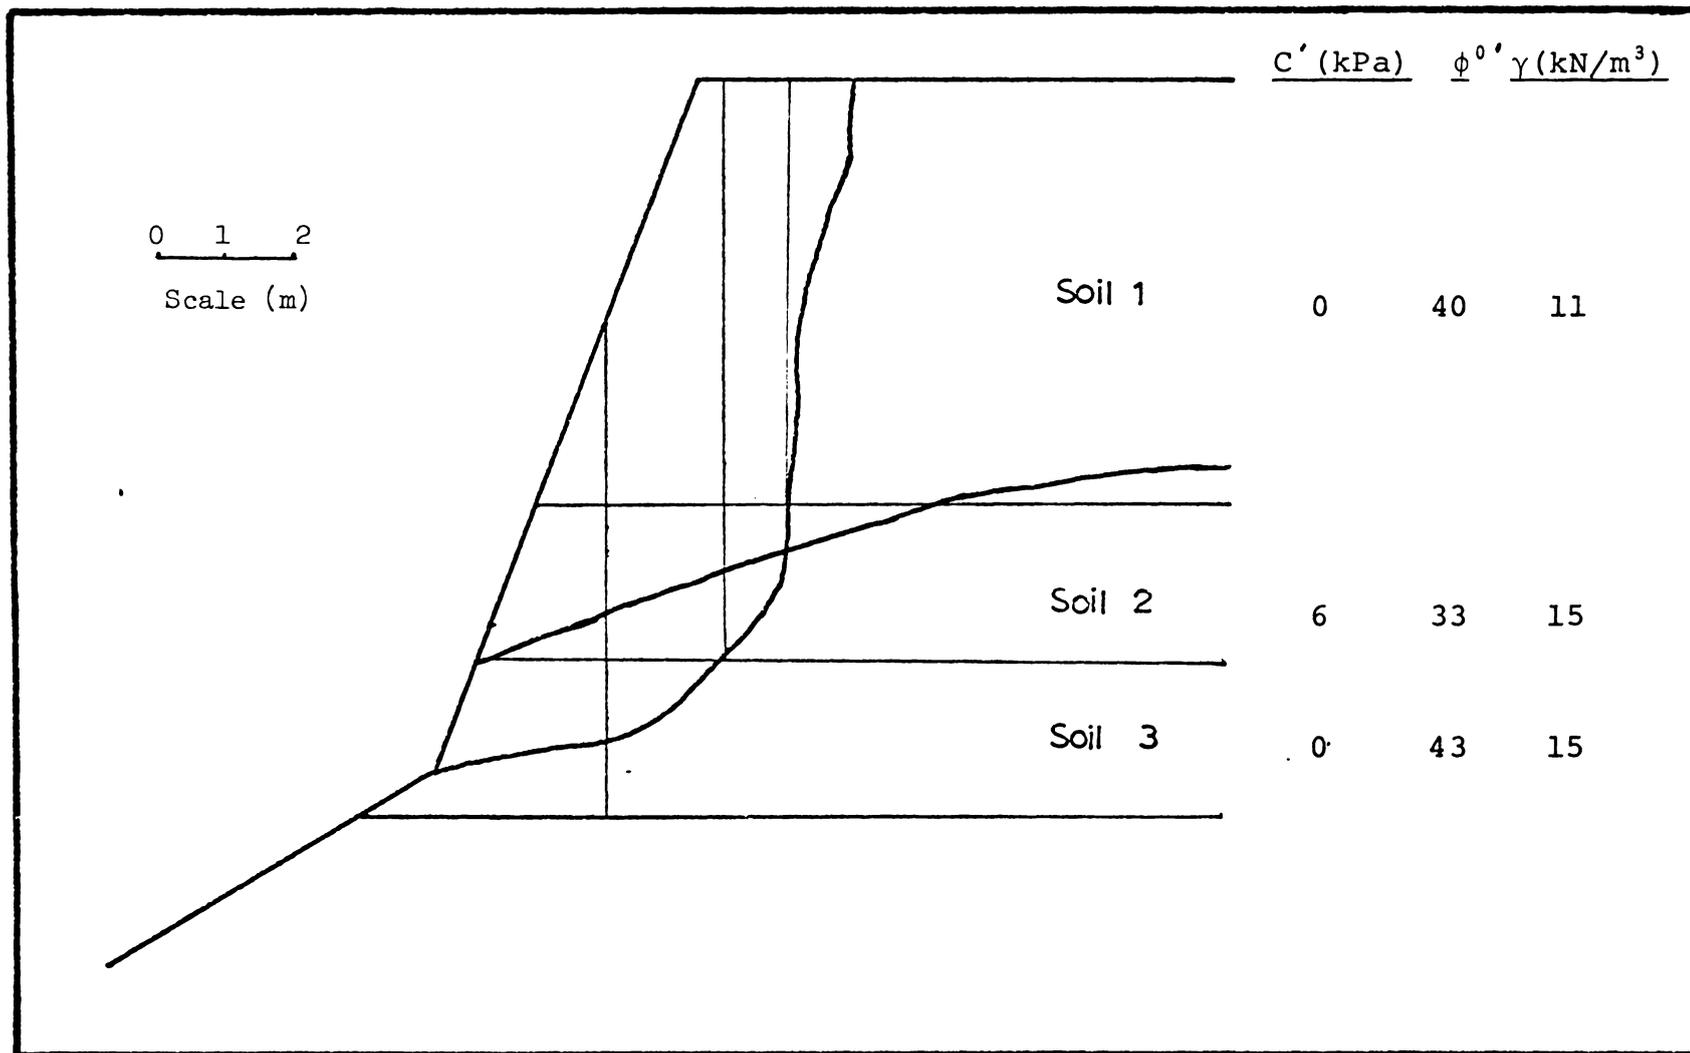
Figure 5.4(a). Test profile for site 1.

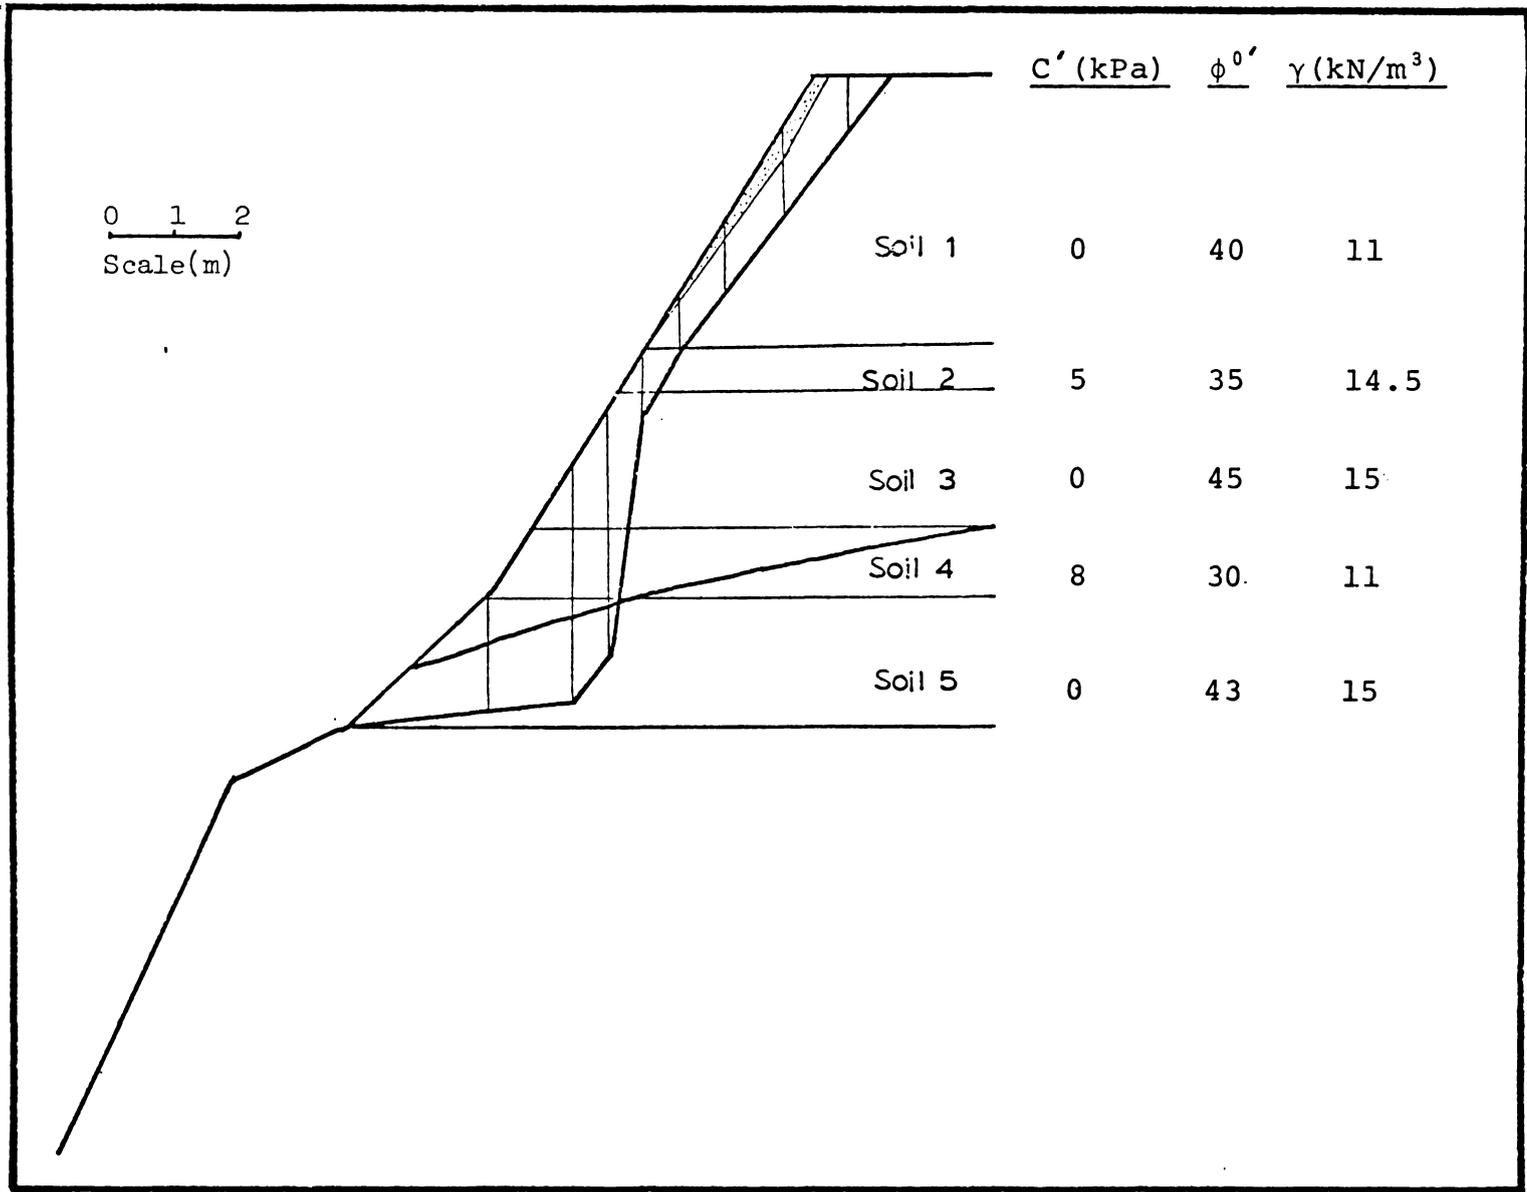
Figure 5.4(b). Test profile for site 2.

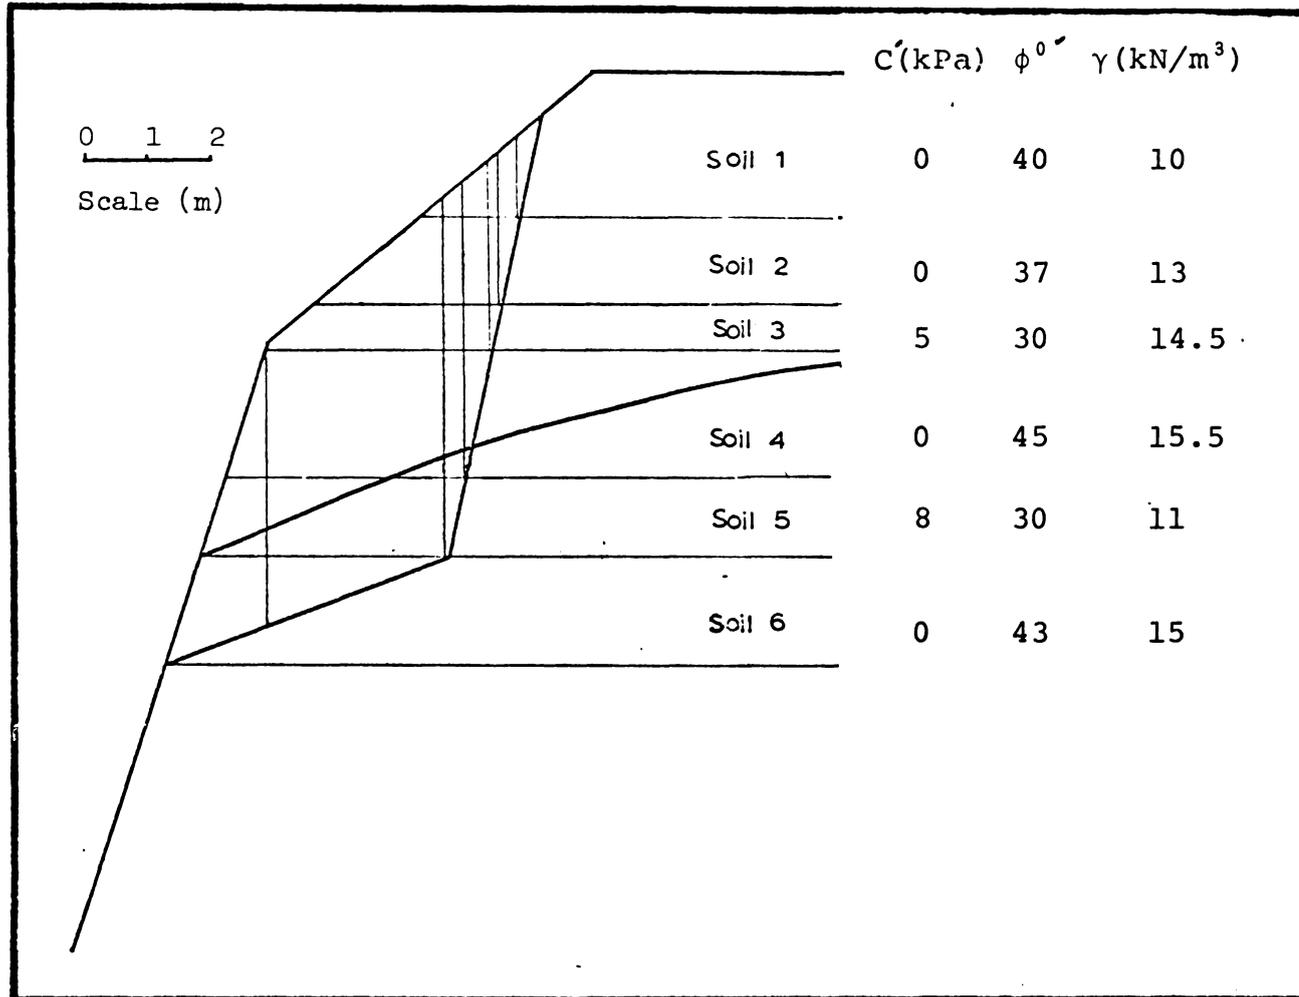
Figure 5.4(c). Test profile for site 3.
