THE NATURE AND CAUSES OF  
COASTAL LANDSLIDING ON  
THE MAUNGATAPU PENINSULA,  
TAURANGA, NEW ZEALAND.

A thesis submitted in partial fulfilment of the  
requirements for the Degree of Master of Science  
in Earth Sciences

University of Waikato

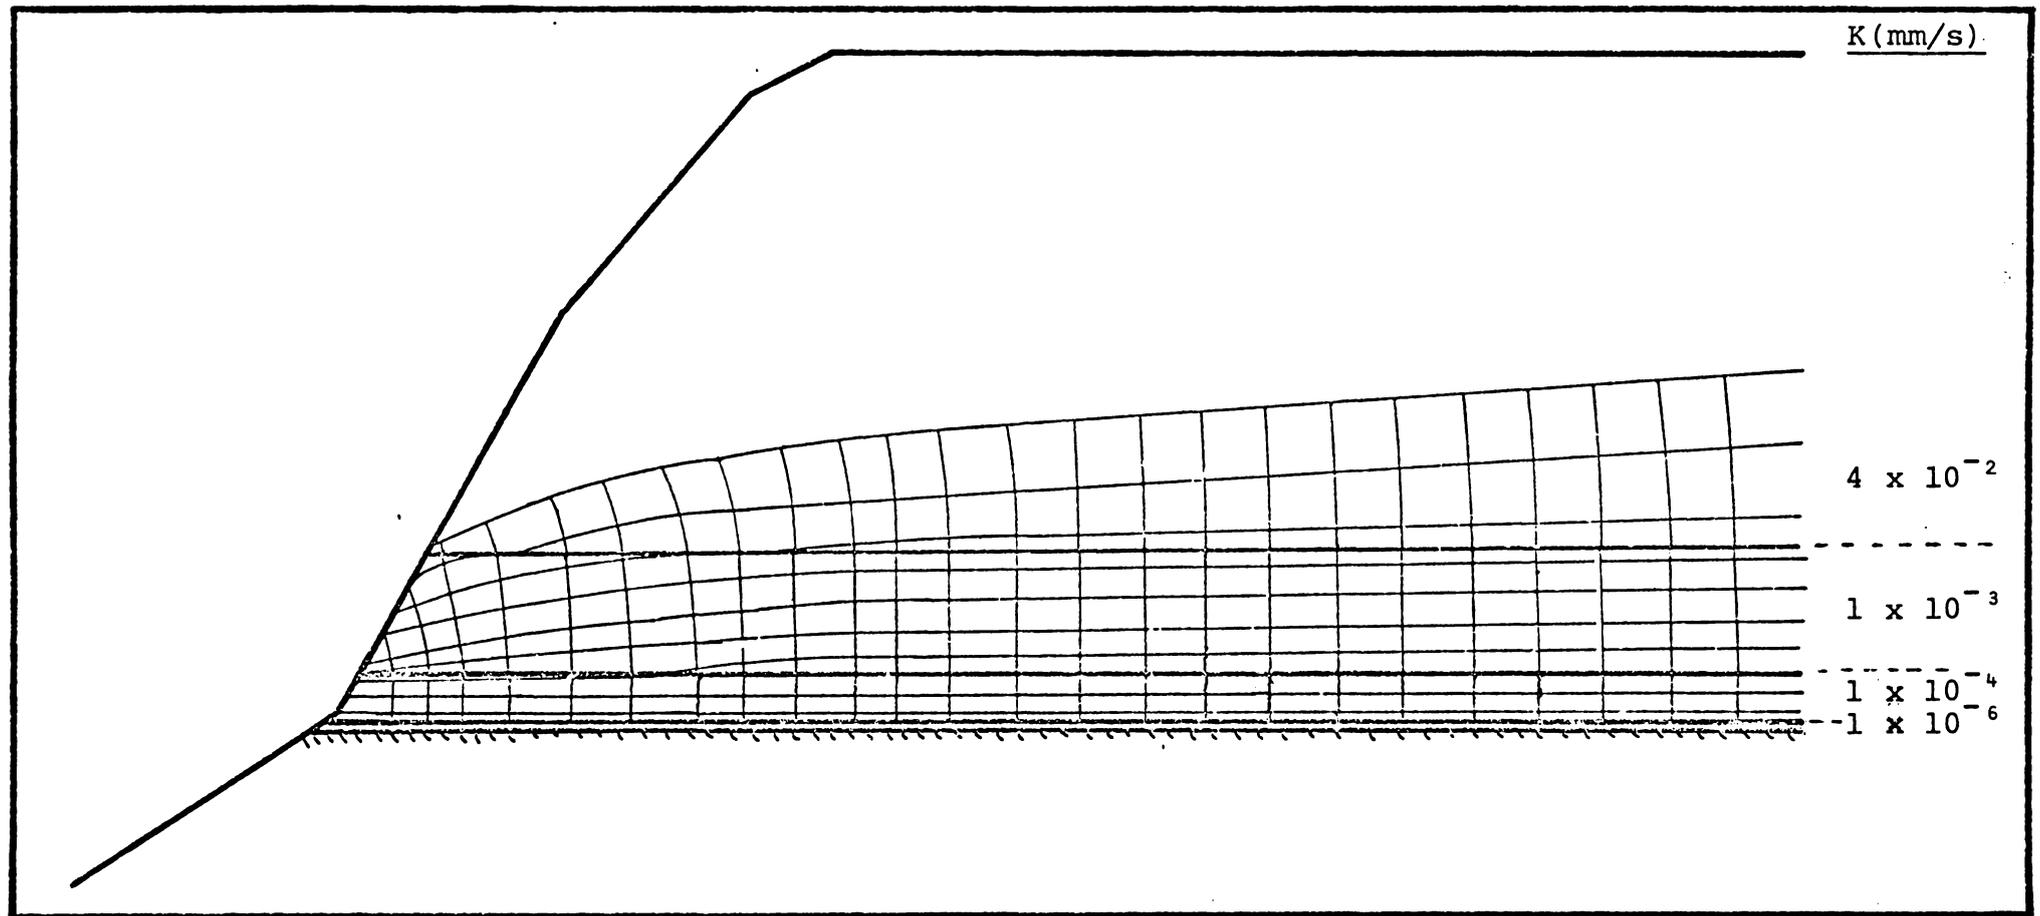
Figure 5.5. Flow net drawn from hydraulic conductivity data for an idealised soil profile.

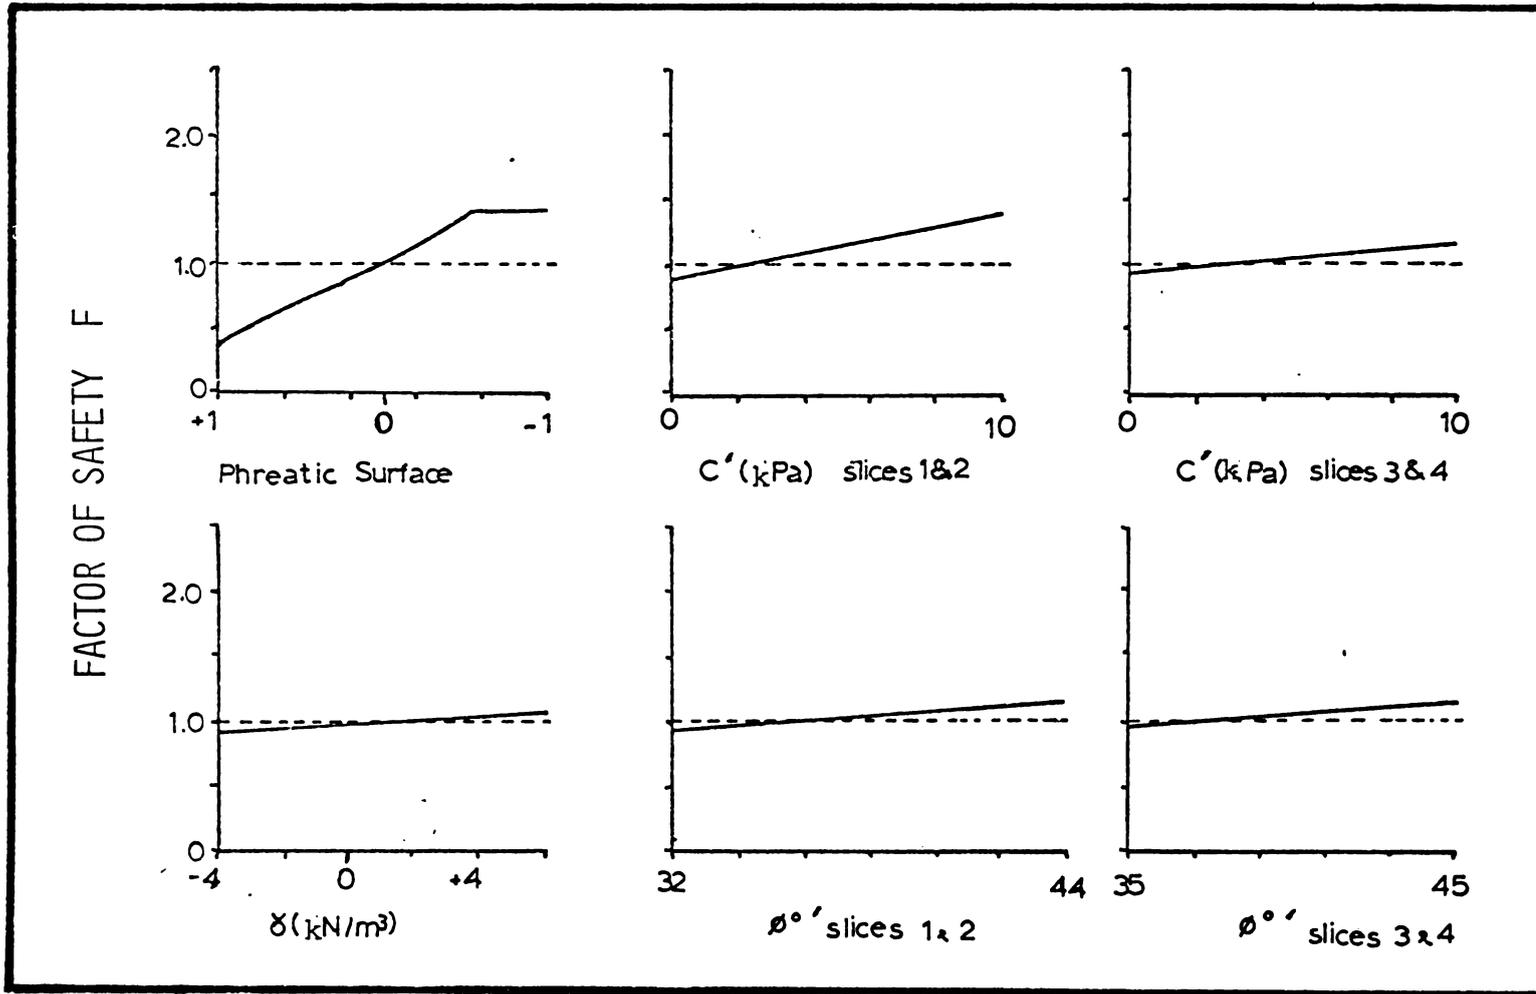
Figure 5.6. Effects of changes in soil and pore water pressure parameters on the factor of safety F for test site 1.

The solutions obtained are shown in the form of factor of safety versus parameter graphs (figs. 5.6 to 5.8). Two questions must be considered in sensitivity analysis; what

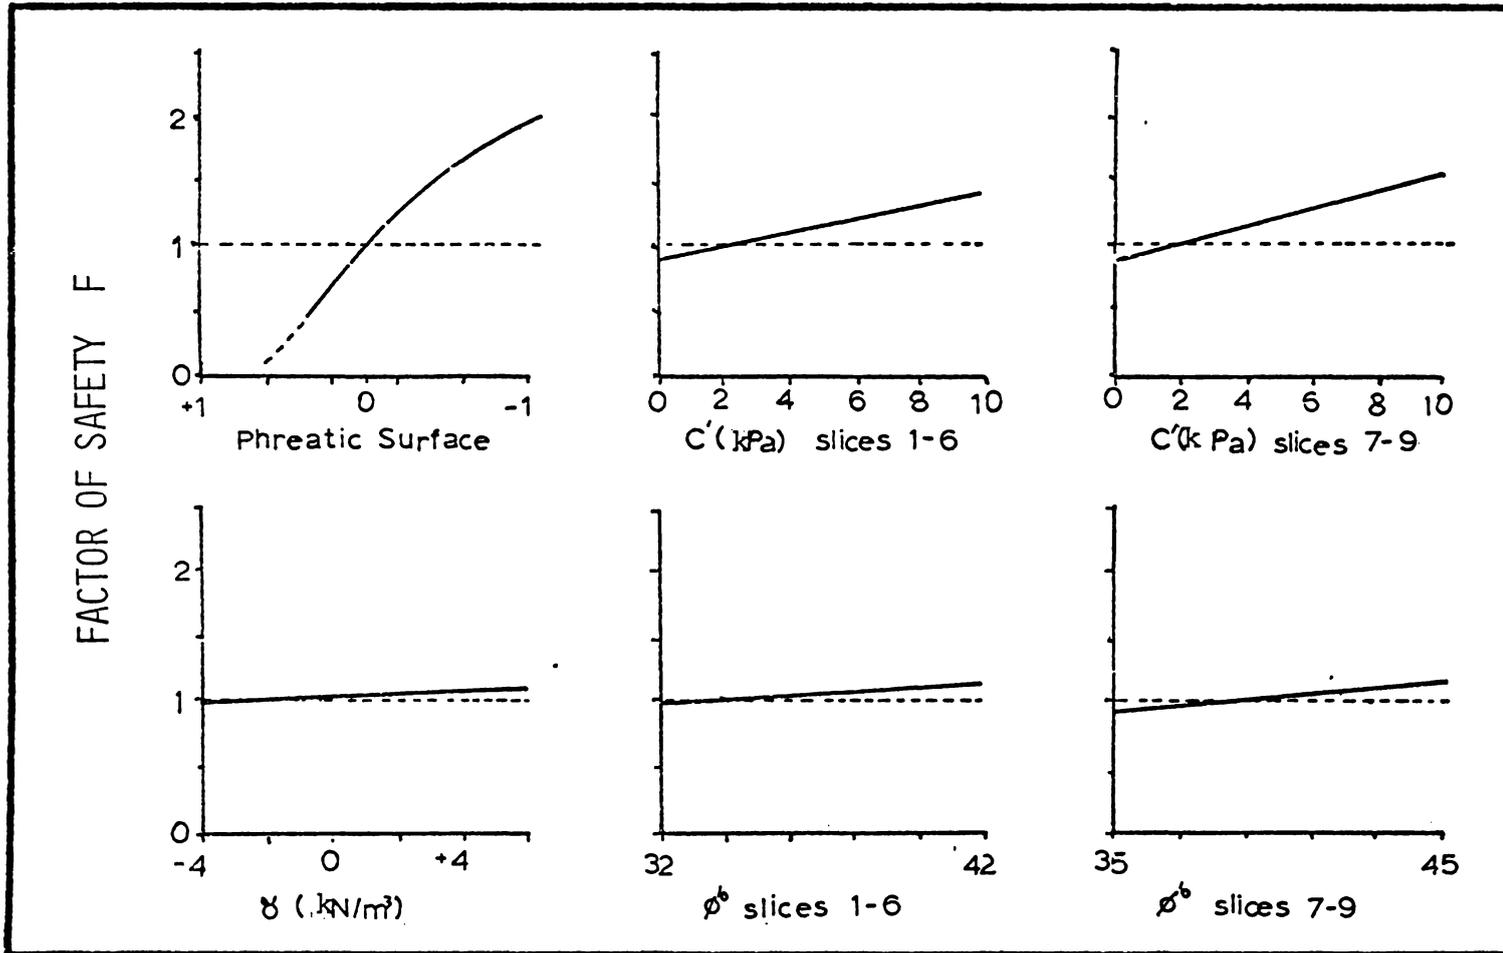
Figure 5.7. Effects of changes in in soil and pore water pressure parameters on the factor of safety F for test site 2.

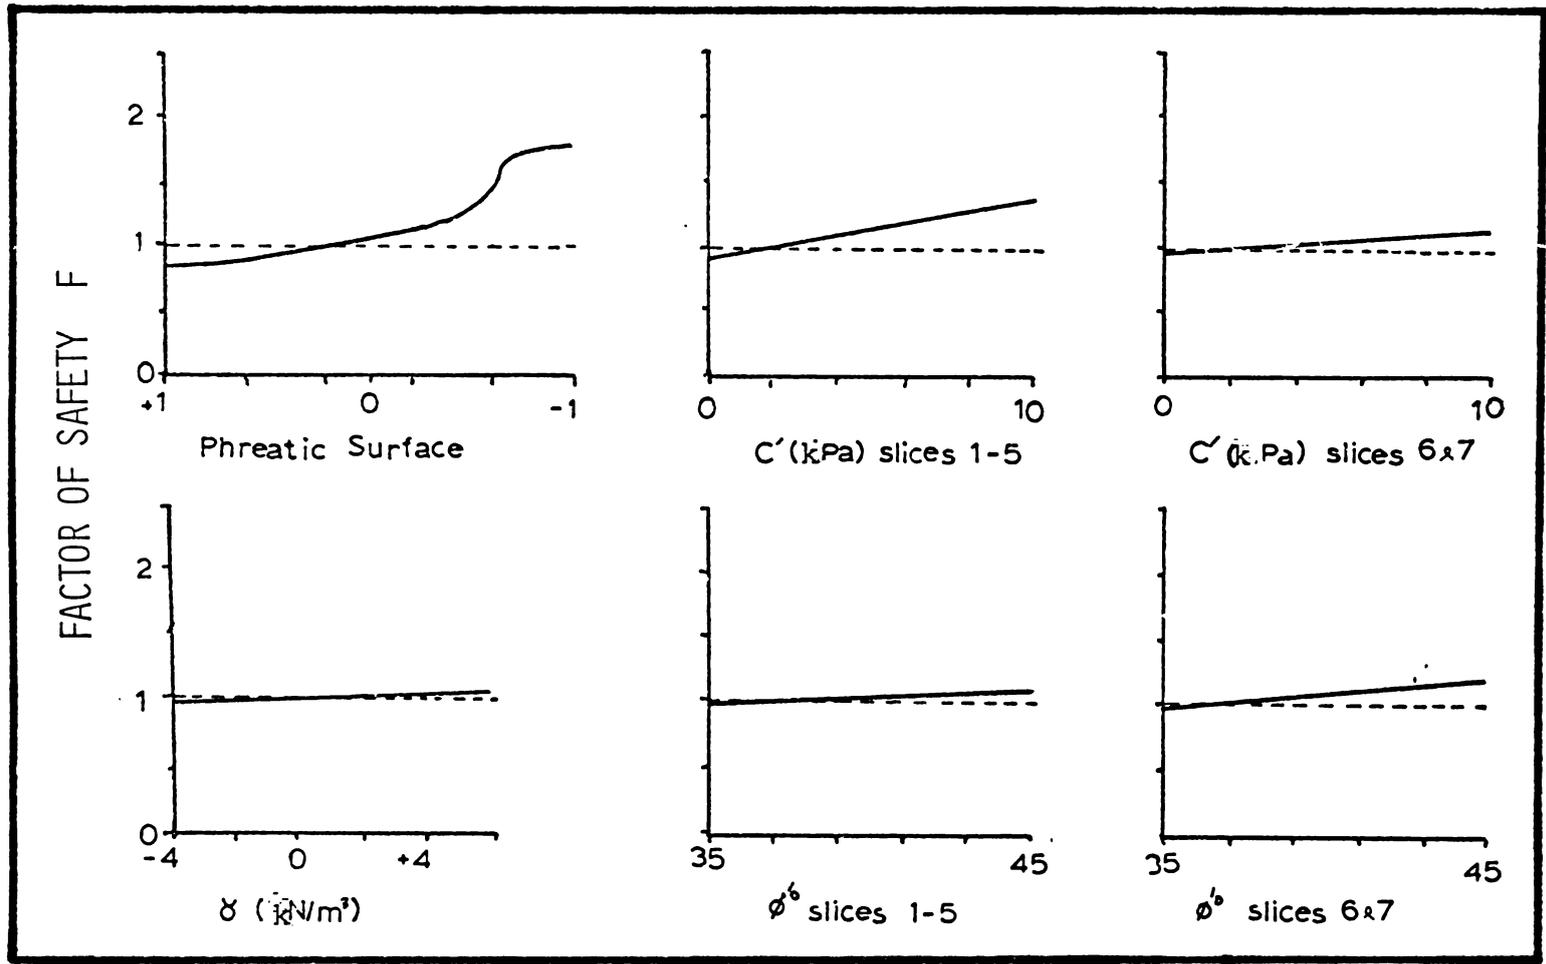
Figure 5.8. Effects of changes in soil and pore water pressure parameters on the factor of safety F for test site 3.

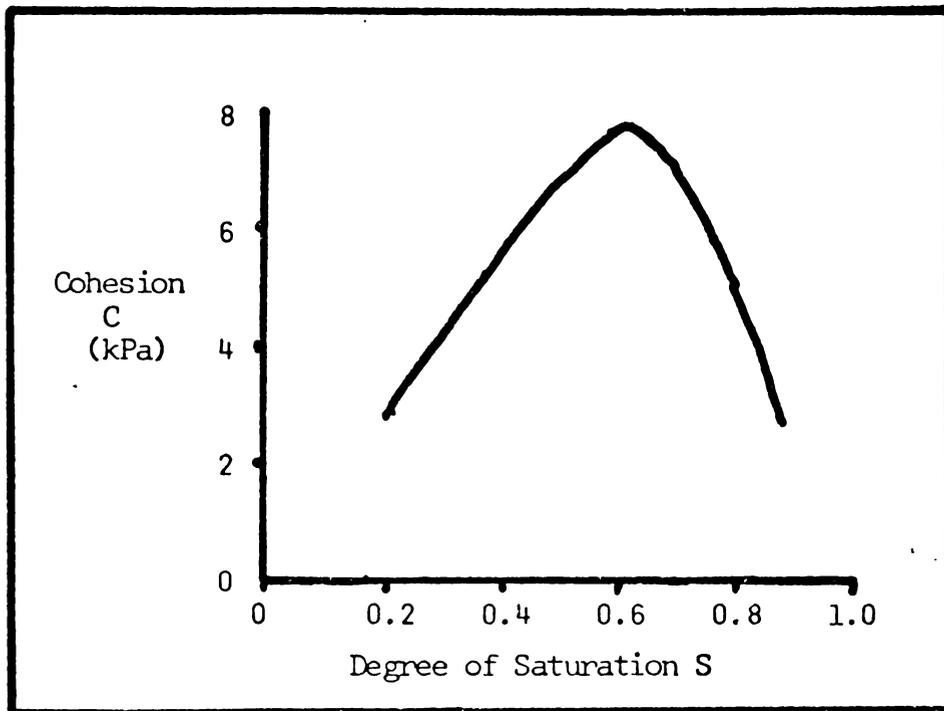
Figure 5.9. Change in effective cohesion with saturation for a medium sand. (after Kezdi, 1979).

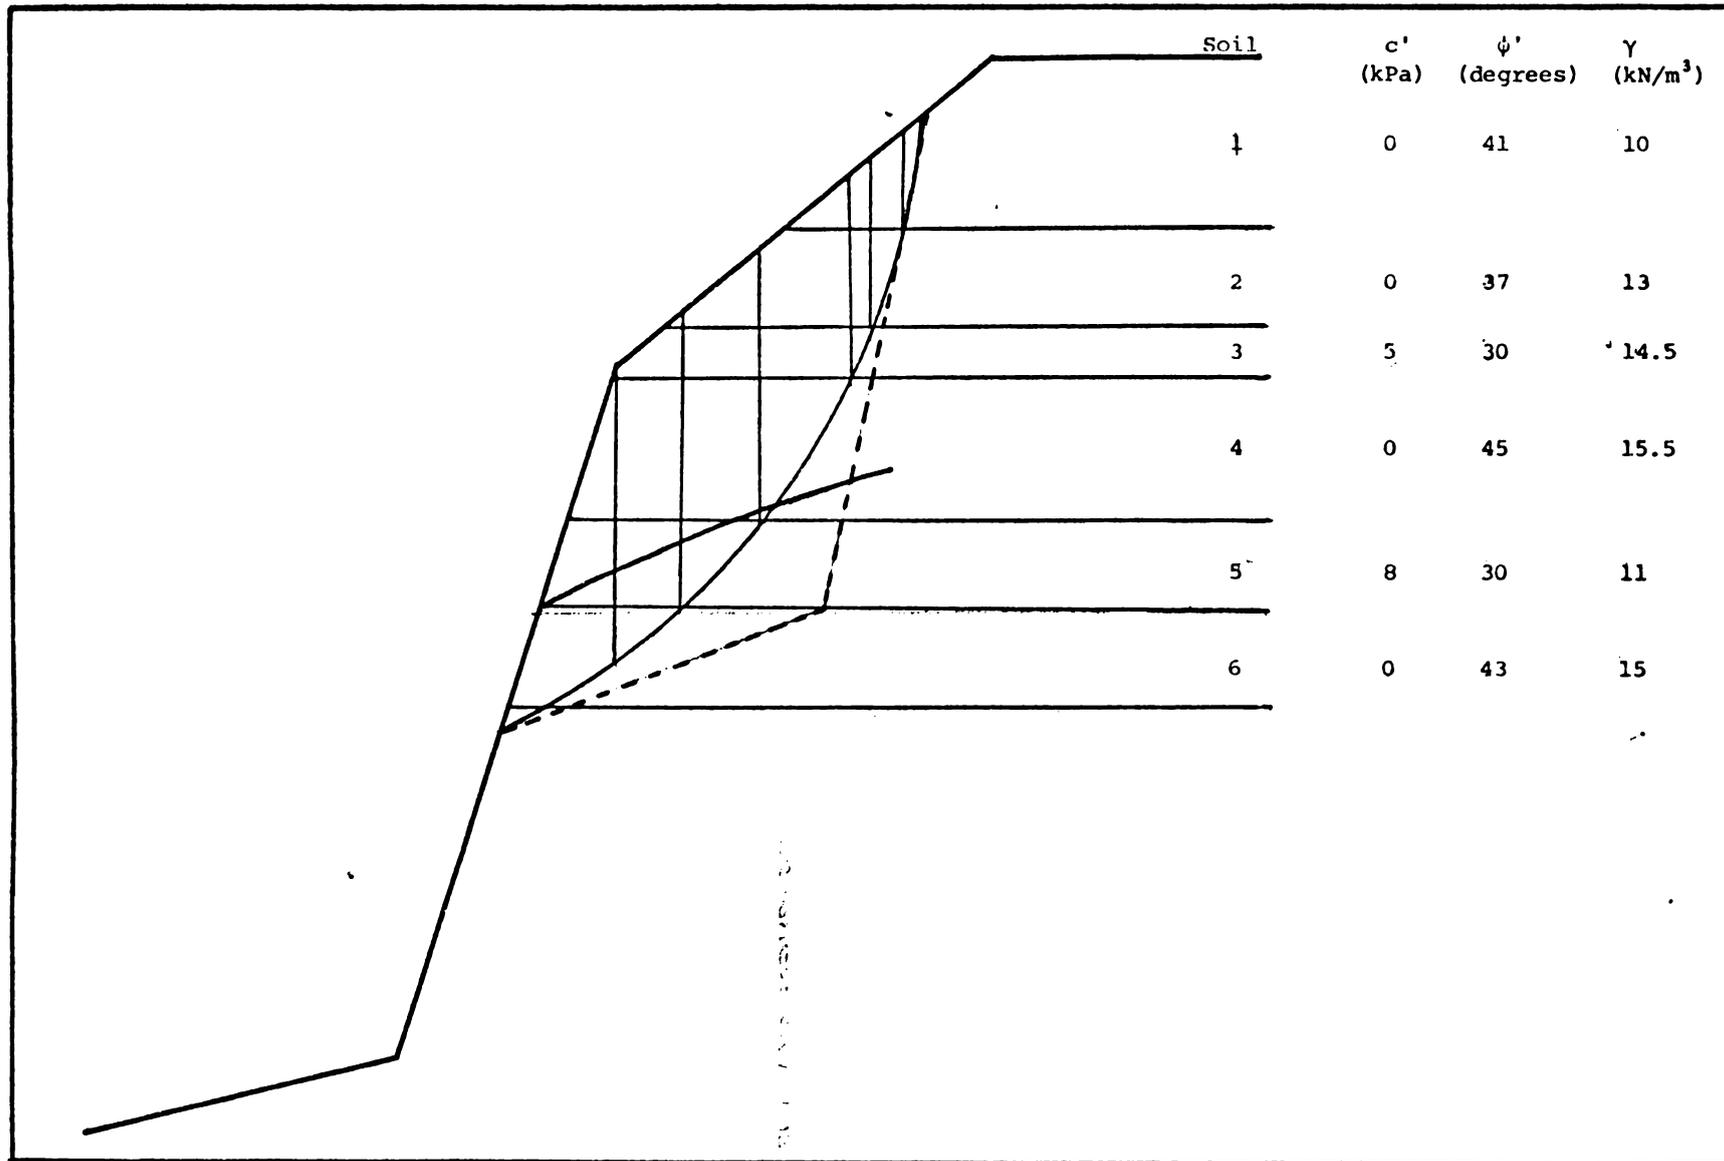
Fig. 5.10 An alternate potential failure surface with a shorter length in the lensoidal silty sand/sandy mud material.

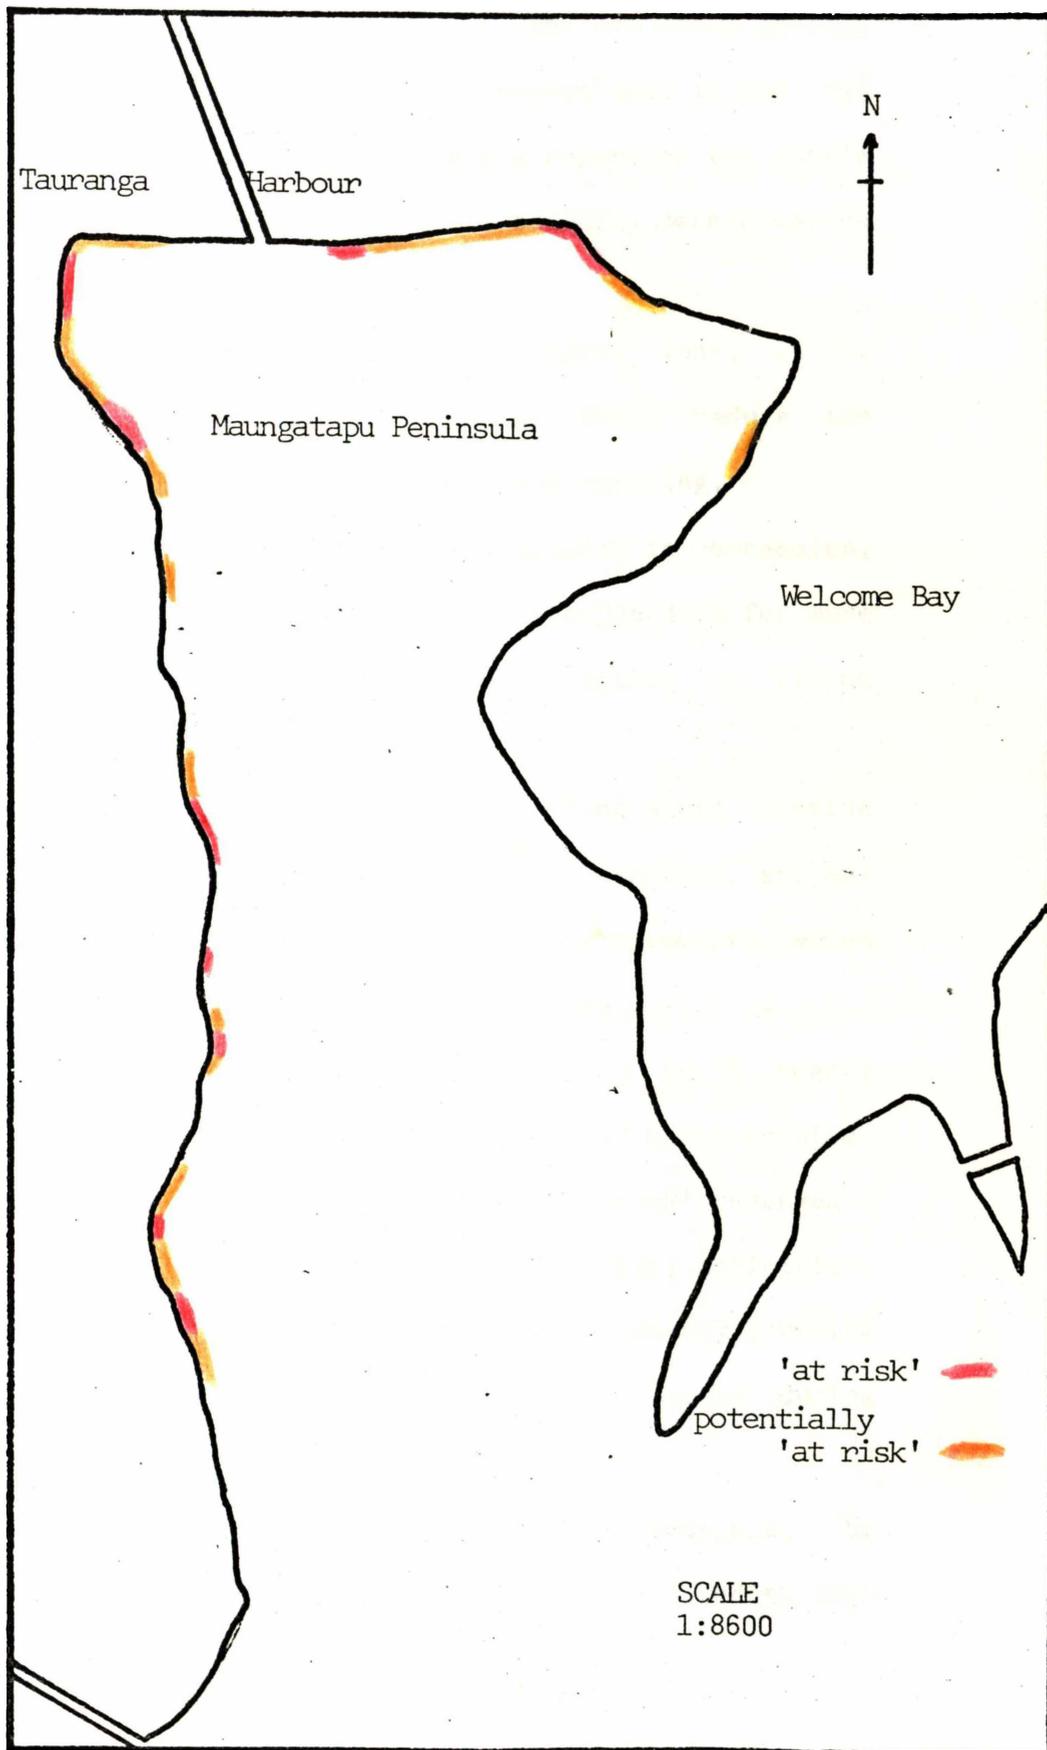
Fig. 6.1. The distribution of 'at risk' and potentially 'at risk' lengths of coastal cliffs on the Maungatapu Peninsula.

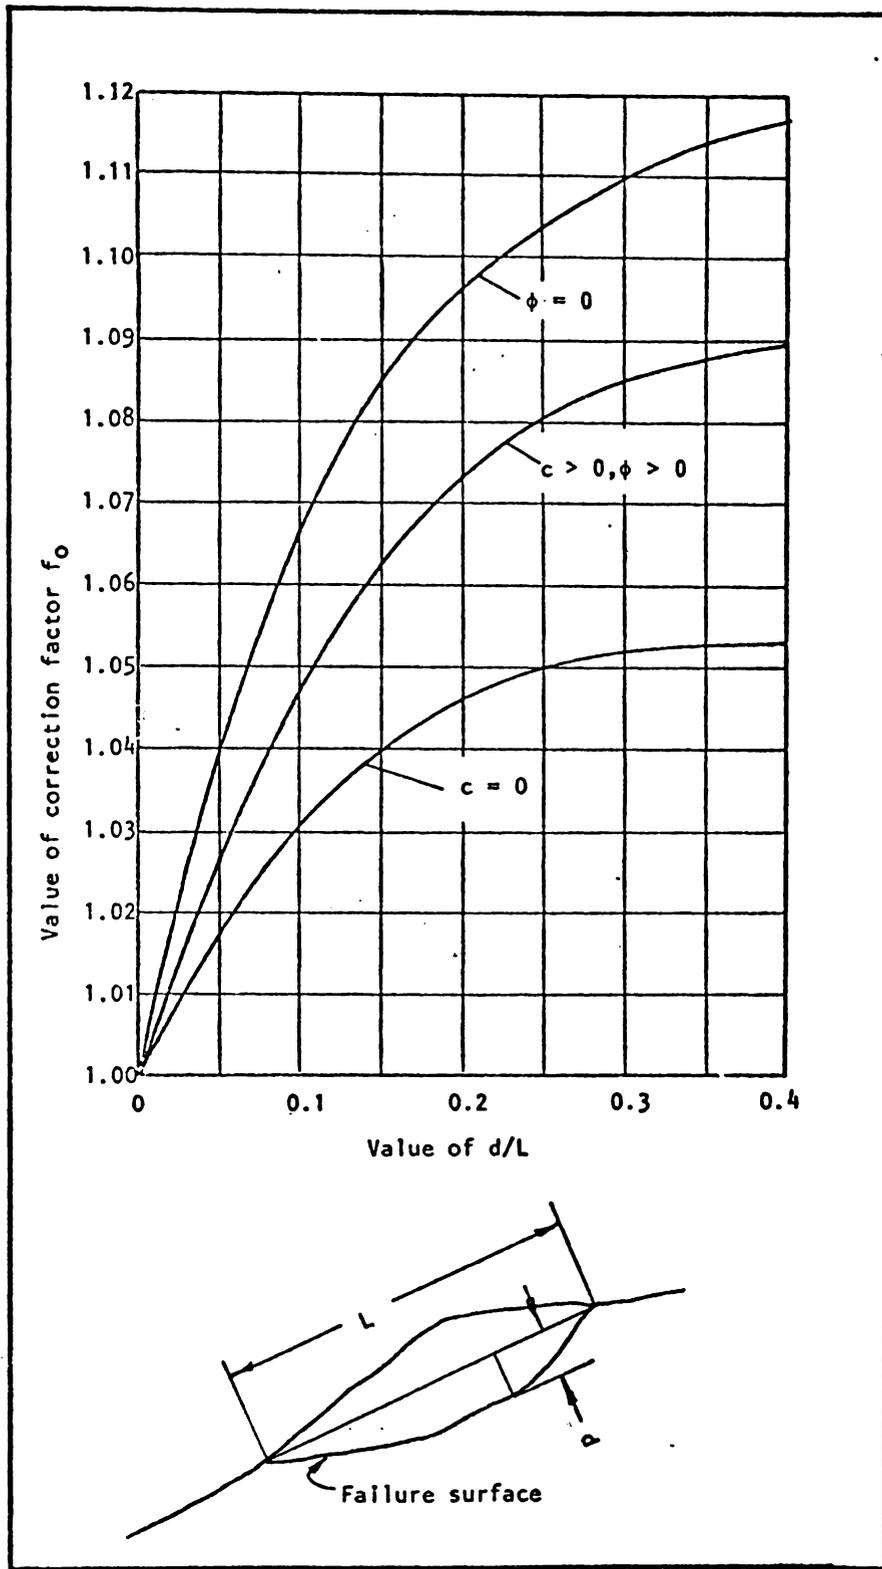
Figure A3.1. Determination of correction factor ( $f_0$ ).  
(after Hoek and Bray, 1977)

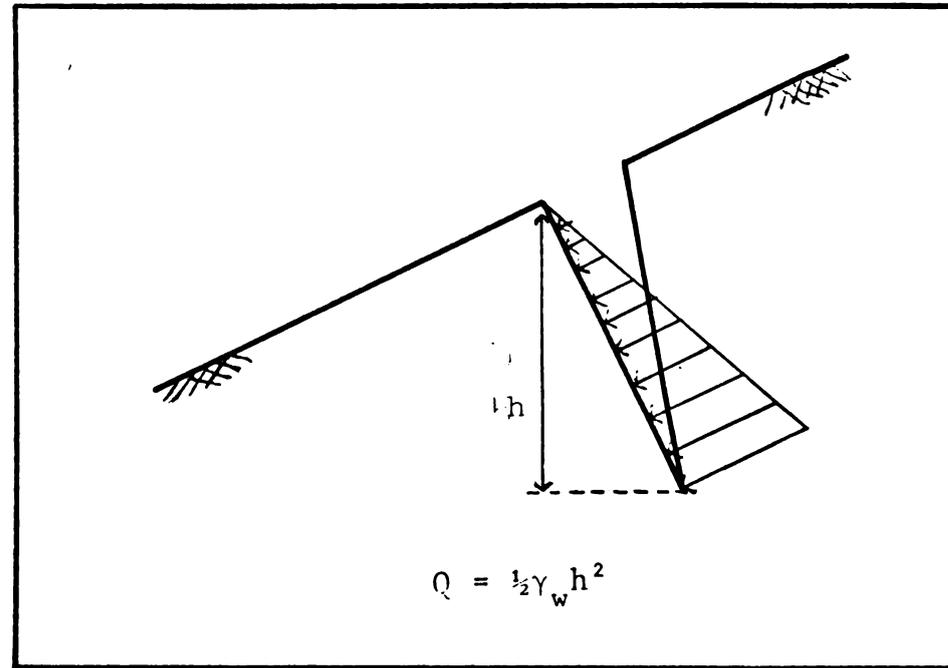
Figure A3.2. Calculation of water pressure in a tension crack.

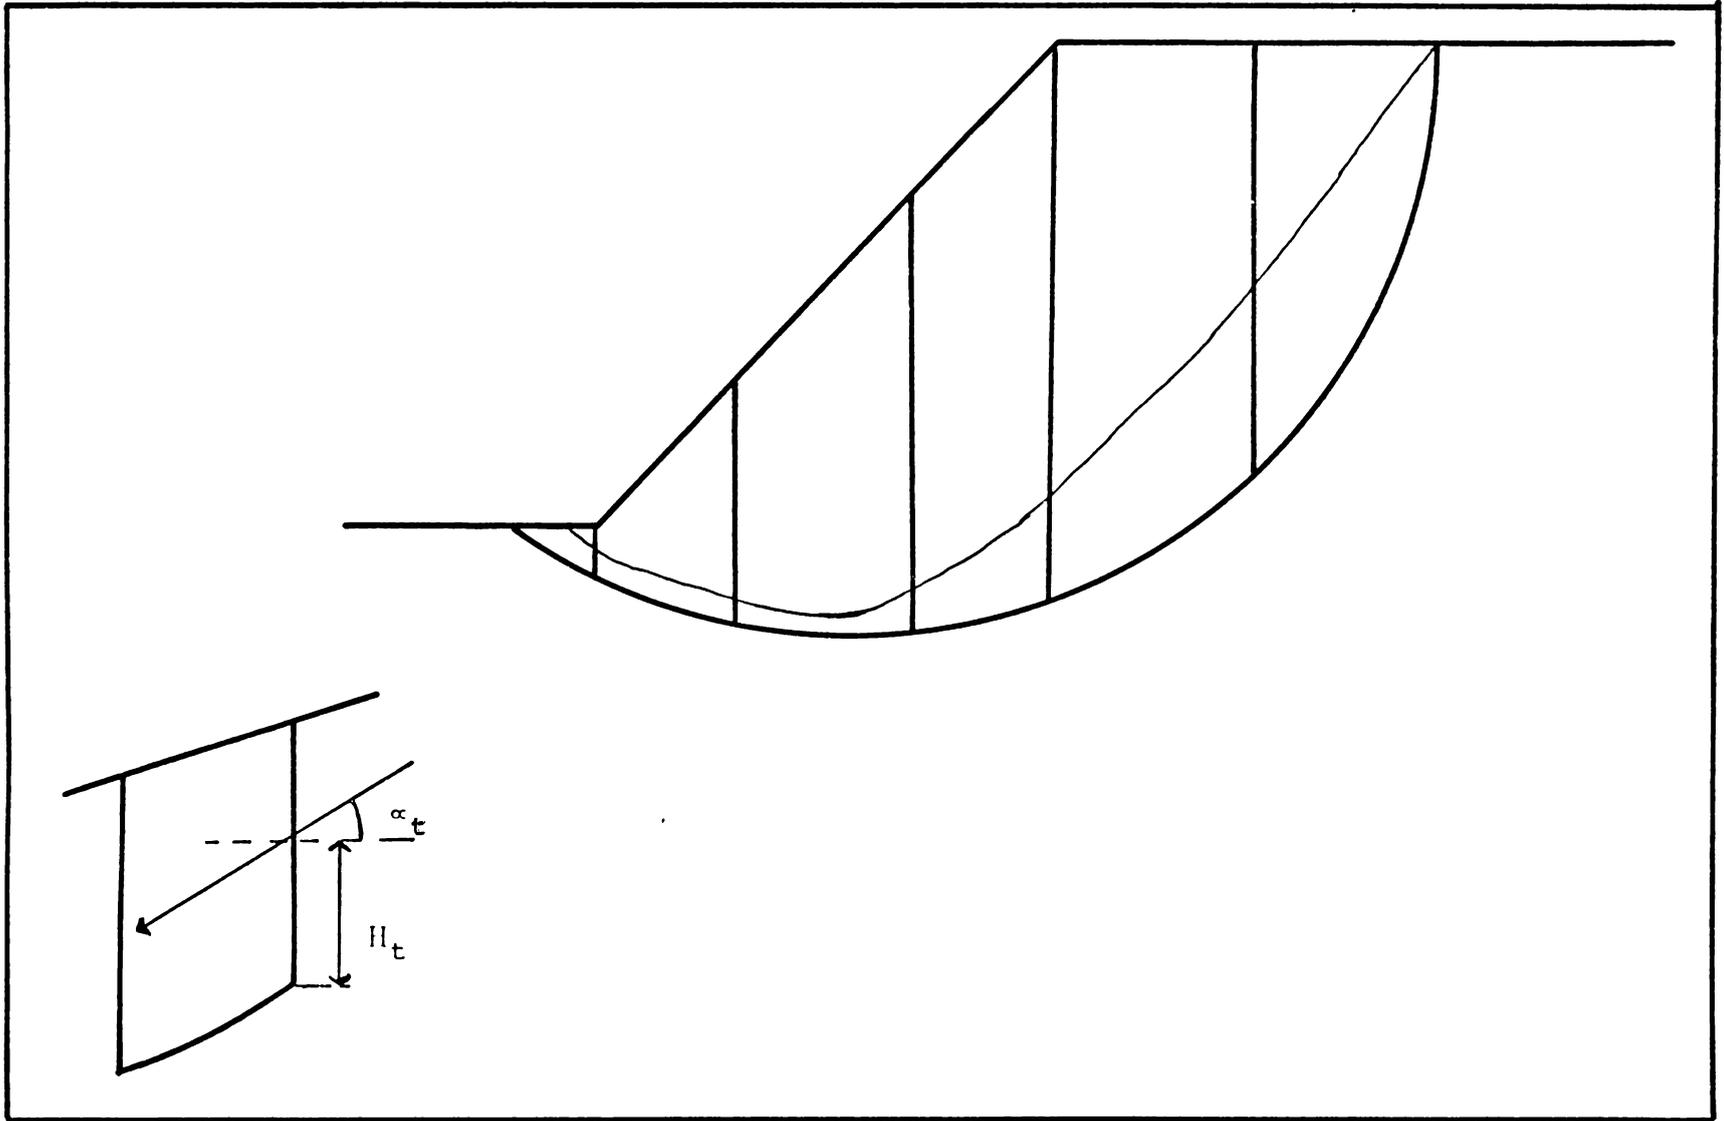
Figure A3.5. Definition of the line of thrust.

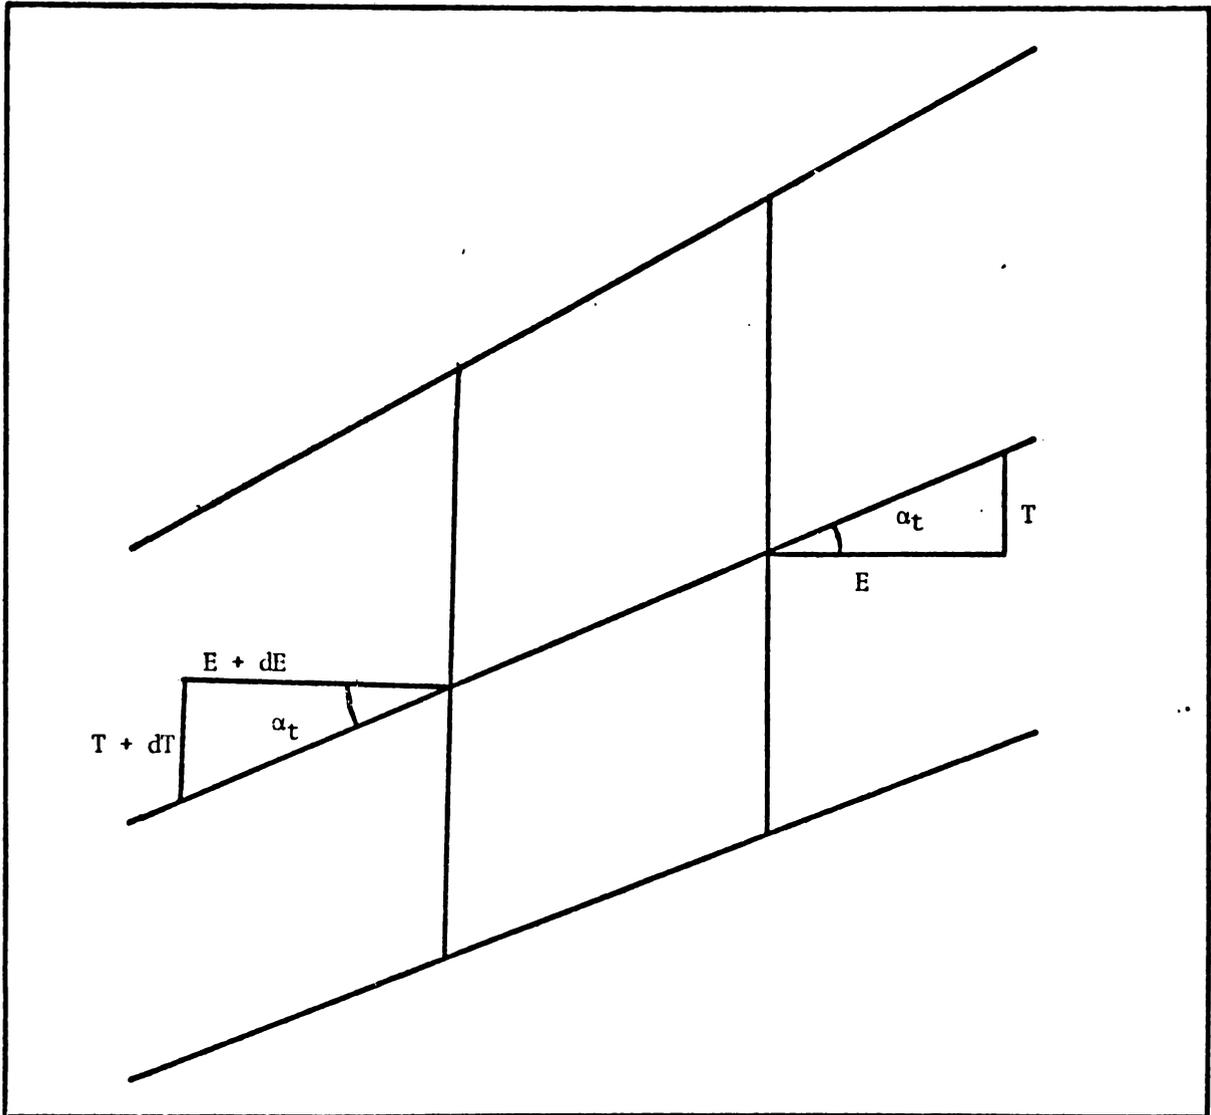
Figure A3.4. Magnitude relationships of interslice forces assumed when  $\alpha_t$  values are assumed.

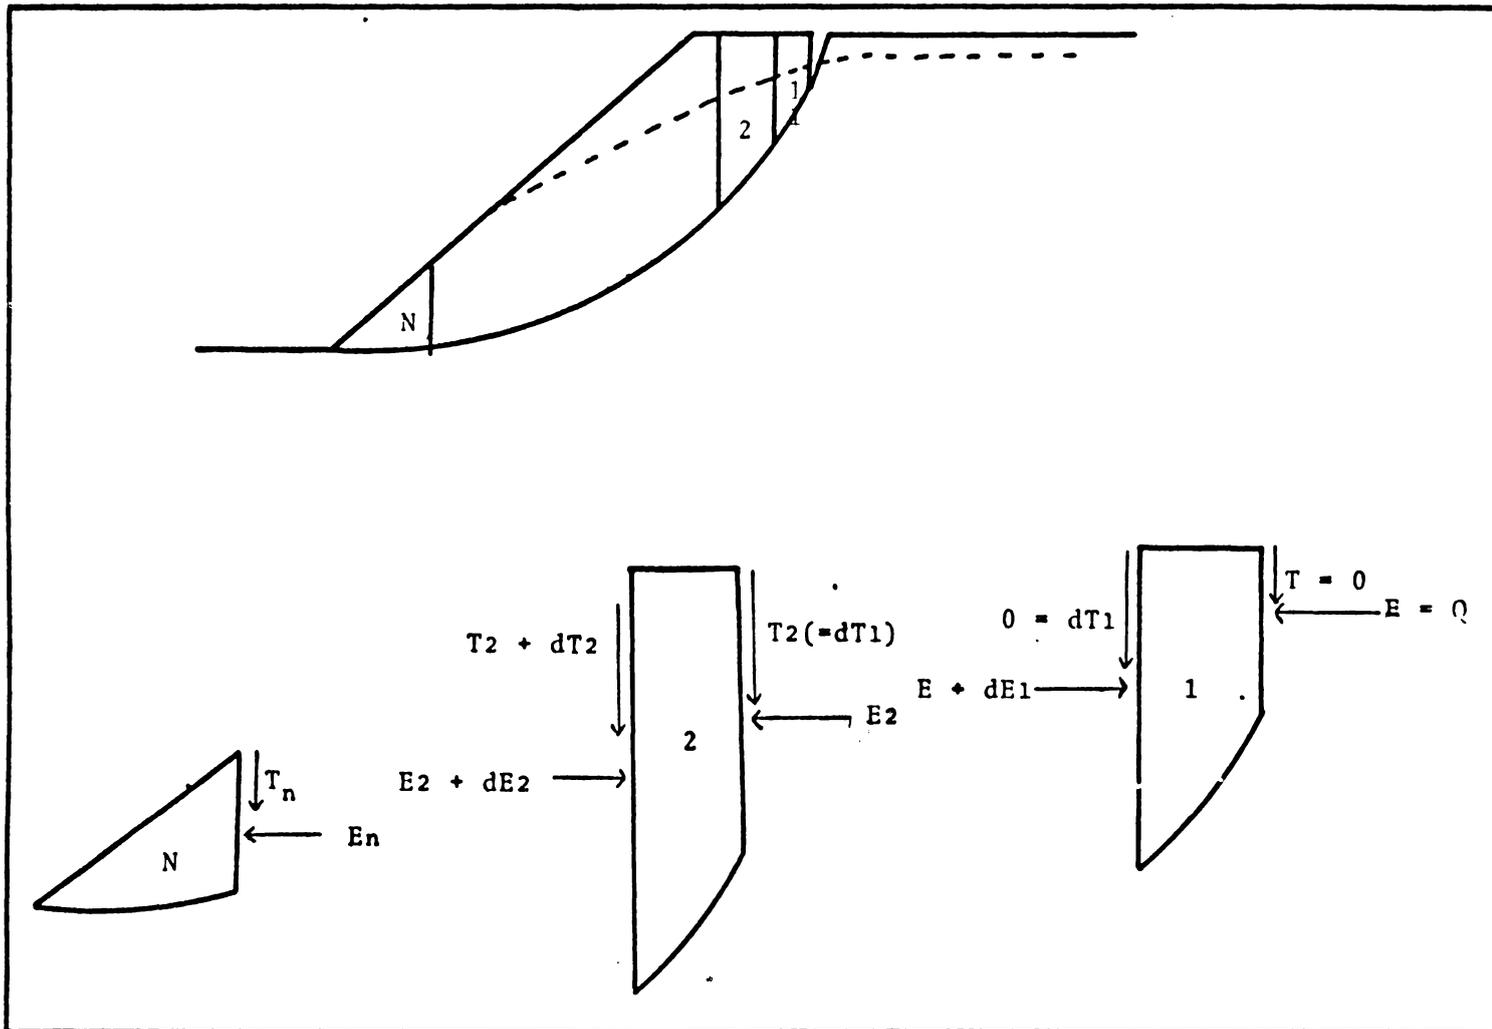
Figure A3.5. Calculation of normal and shear side forces.
