**A GEOTECHNICAL
CHARACTERISATION OF VOLCANIC
SOILS IN RELATION TO COASTAL
LANDSLIDING ON THE MAUNGATAPU
PENINSULA, TAURANGA, NEW
ZEALAND**

A Thesis
submitted in partial fulfillment
of the requirements for the Degree
of
Master of Science in Engineering Geology
at the
University of Canterbury
by
Robert Craig Oliver

**University of Canterbury
1997**

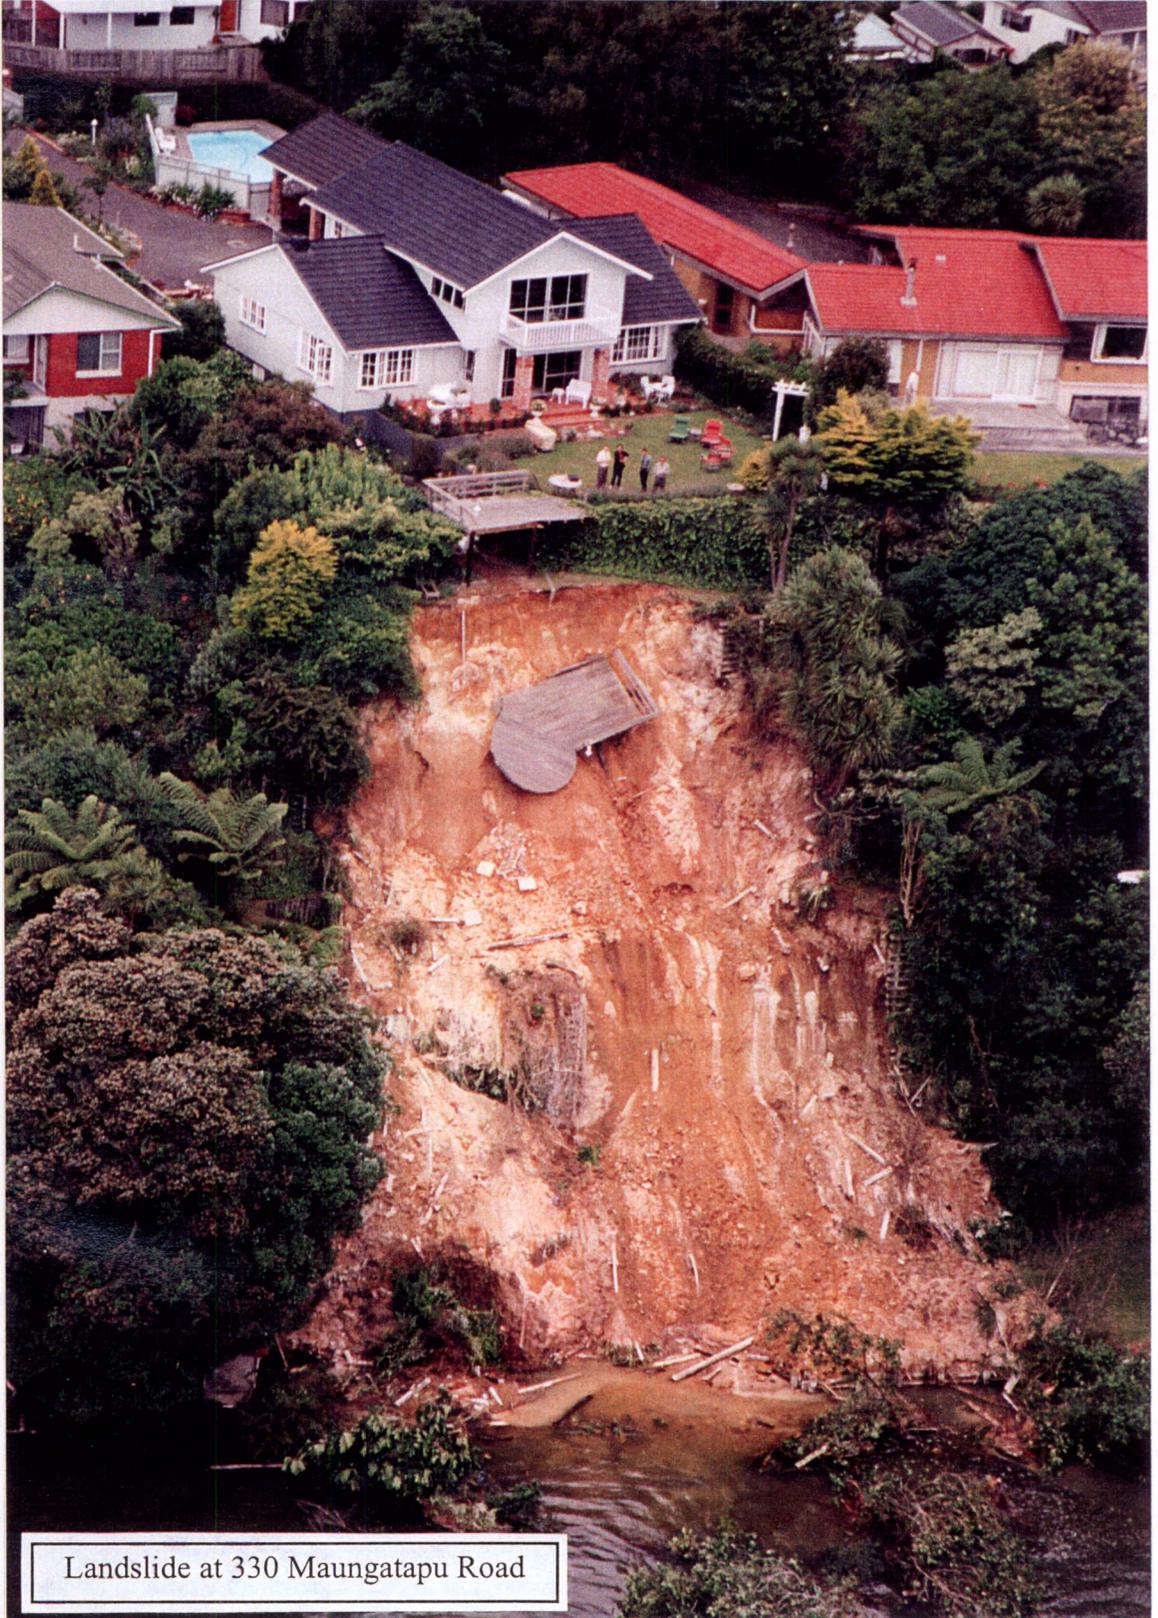
Landslide at 330 Maungatapu Road

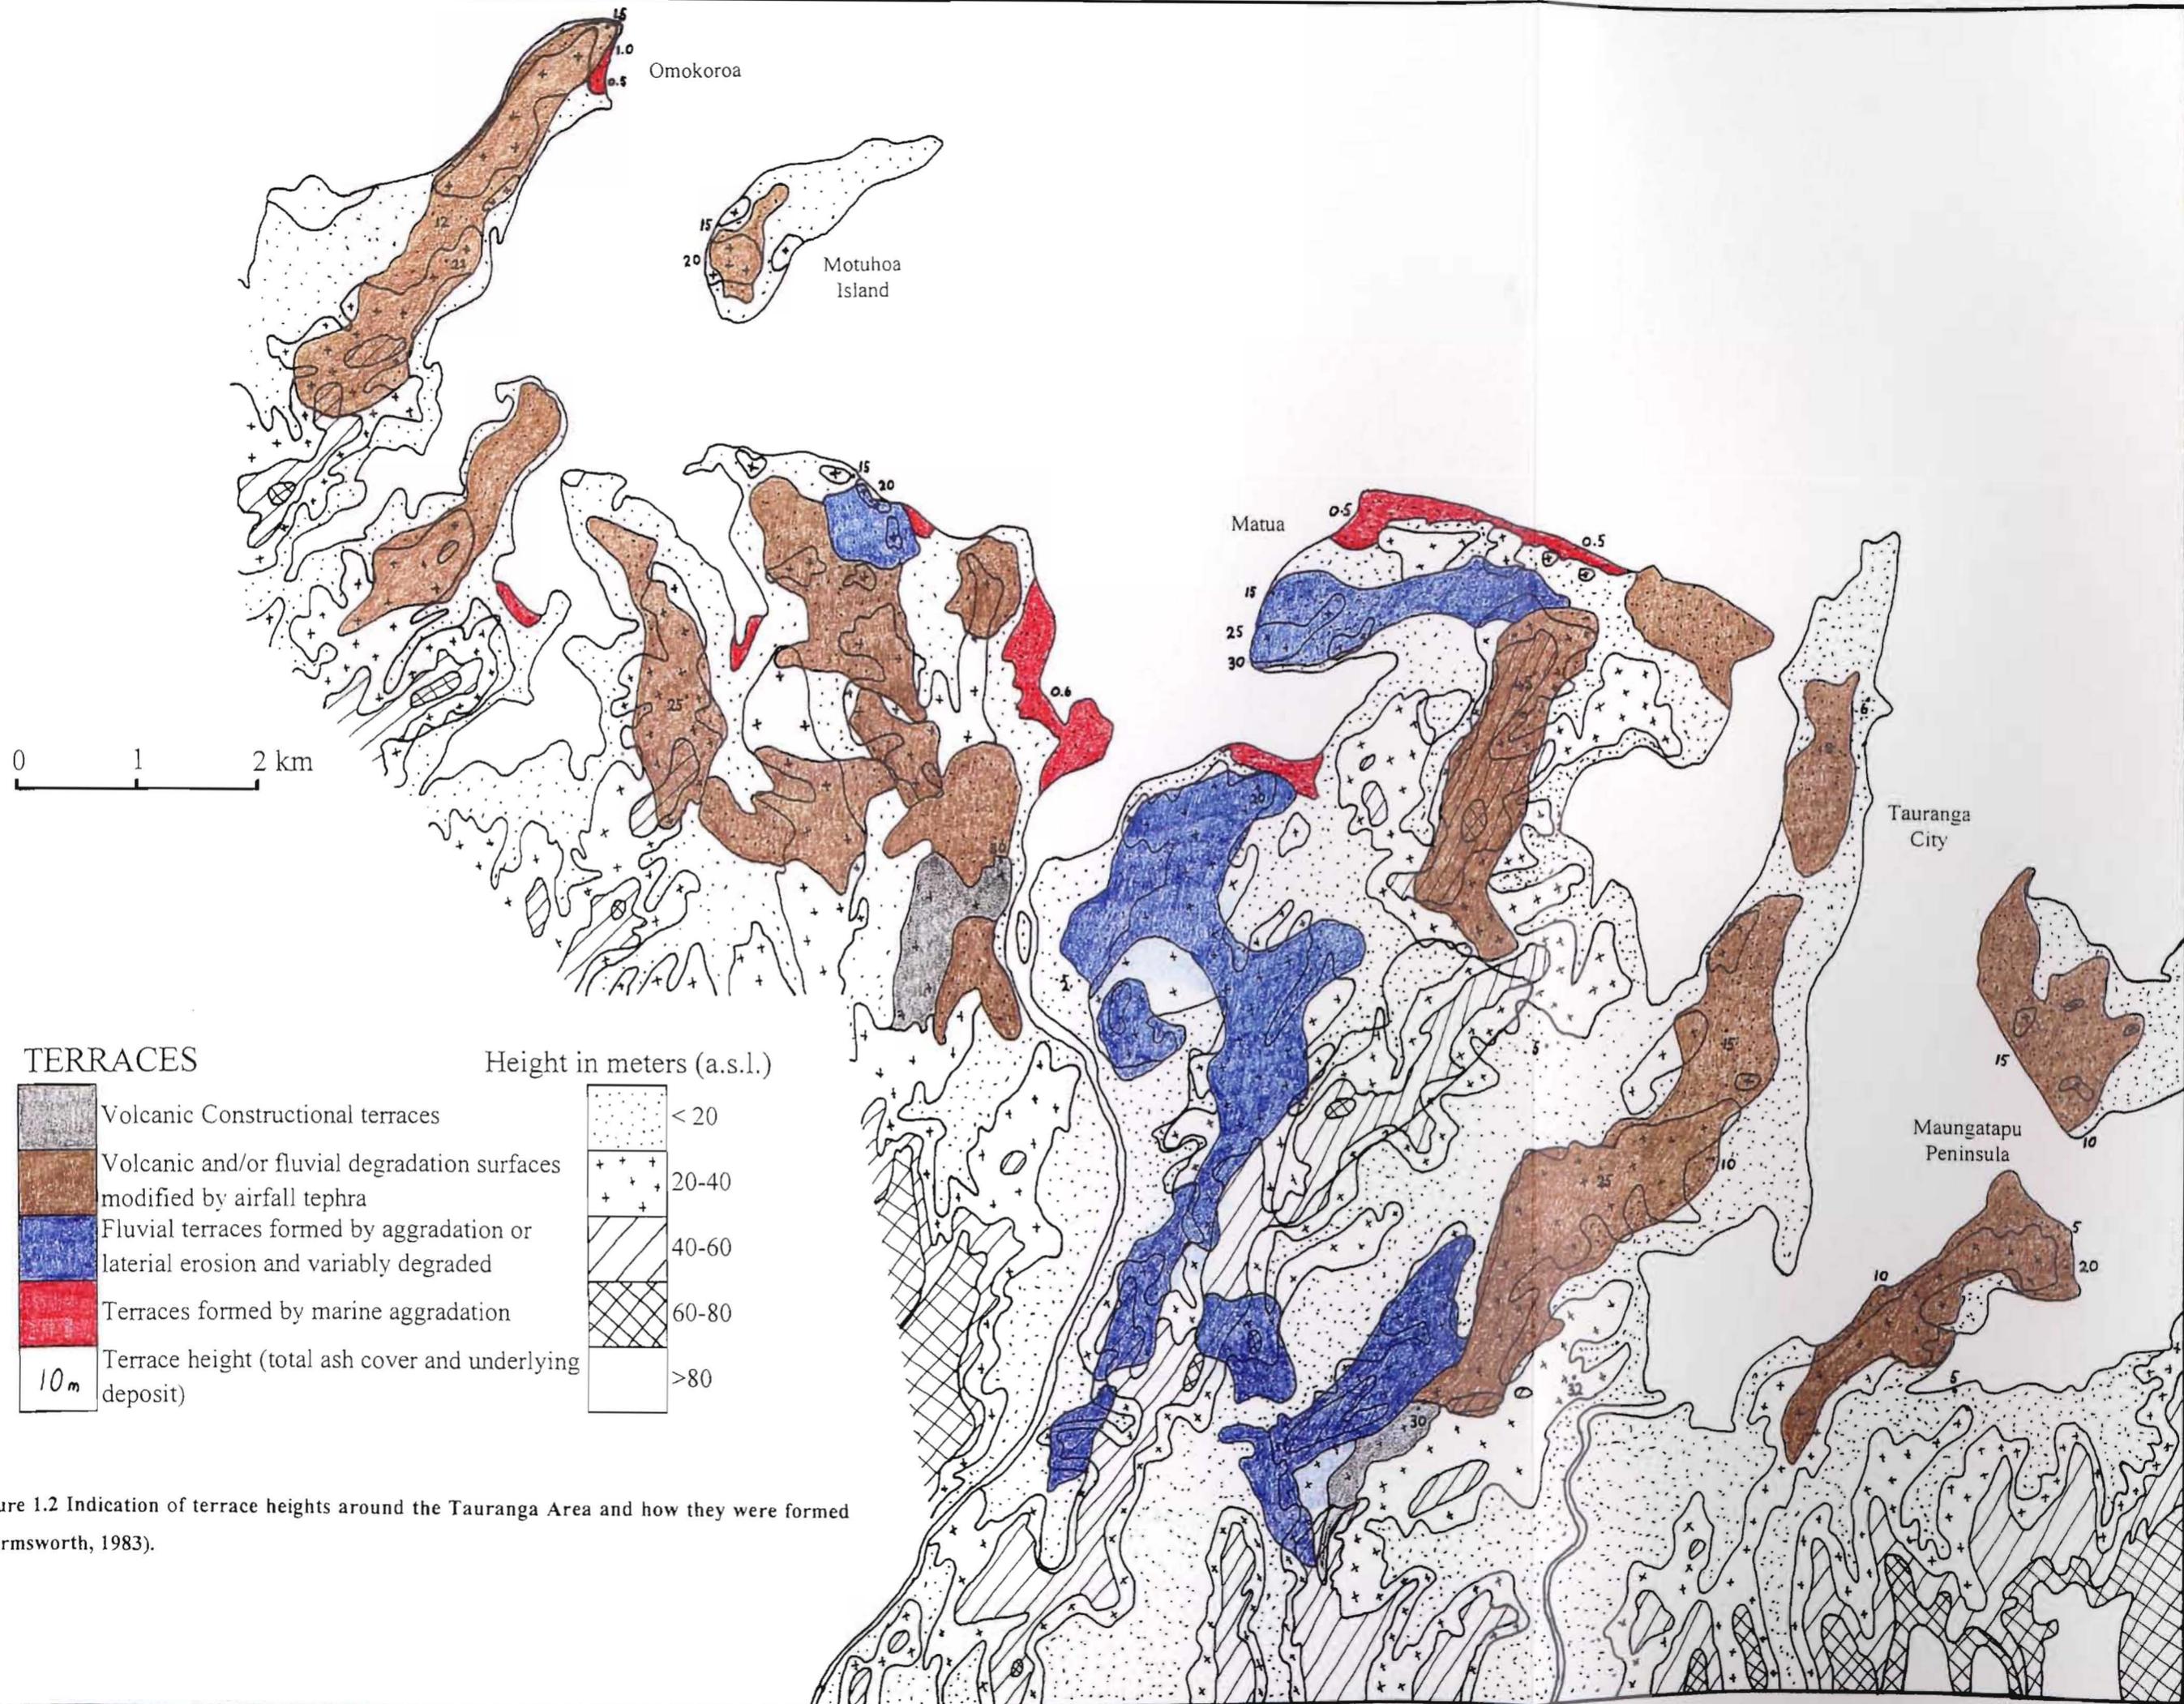
Figure 1.2 Indication of terrace heights around the Tauranga Area and how they were formed (Harmsworth, 1983).

The Tauranga Basin contains a number of terraces that are generally preserved as peninsulas that trend in a NE or NNE direction (Figure 1.2; Briggs et al., 1996). These terraces are in-turn intersected by broad shallow valleys and generally terminate seawards in low cliffs or steep slopes. Omokoroa, Tauranga City and Greerton, Matua, Matapihi, and Maungatapu are examples of terraces noted by Harmsworth (1983), (Figure 1.2). Several terrace levels have been delineated by Healy et al. (1964) at 80 m, 30-60 m, 12-22 m, 5 m, 0.5-1.0 m above present sea level, most of which dip between 1° and 4° towards the NE or N.

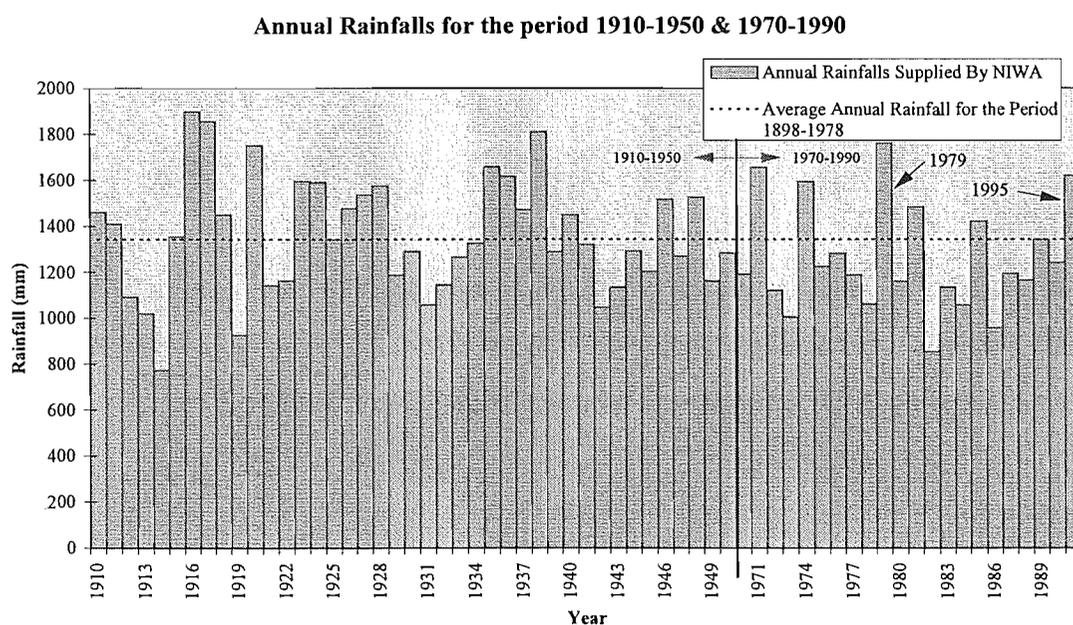
Figure 1.3 Annual rainfall for the period 1910-1950 and 1970-1990, indicating higher than average rainfalls for 1979, and 1995.

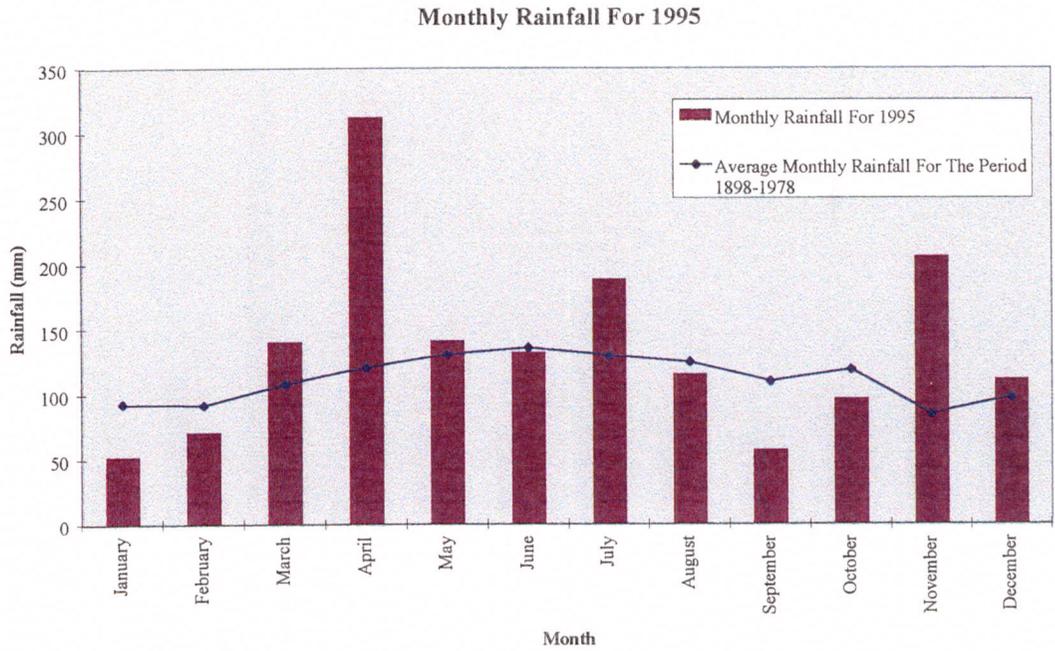
Figure 1.4 Monthly rainfall for 1995 in conjunction with average monthly rainfall for the period 1898-1978 to indicate the higher than average rainfall for the months of March, April and May.

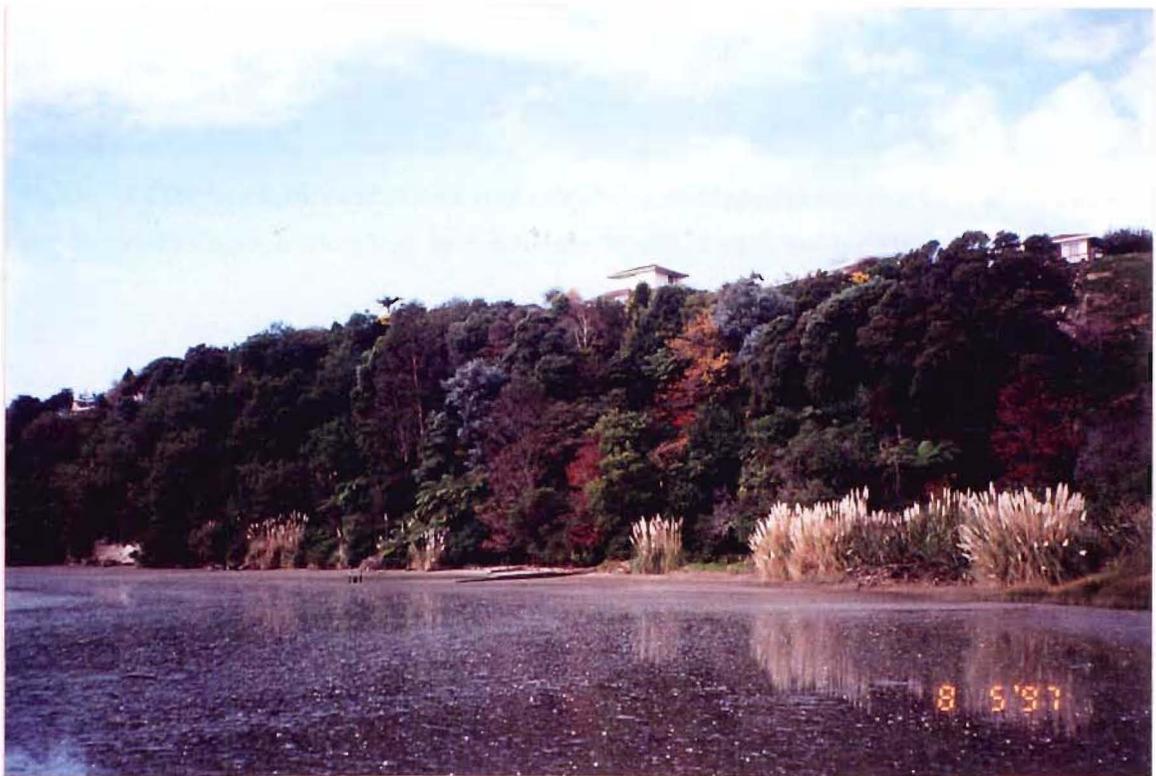
Figure 1.7 Vegetation which has been partially altered by human through planting (photograph taken from grid reference 704400, 273800 looking ENE).

The vegetation along Maungatapu Peninsula cliff faces has been highly modified by both human and natural processes (Figure 1.7 & 1.8). As tree and shrub cover has been disturbed by slipping, weed species have revegetated the cliff face (Figure 1.8). In other areas man has replanted using more ornamental species (Figure 1.7). The following plants have been identified as existing cover:

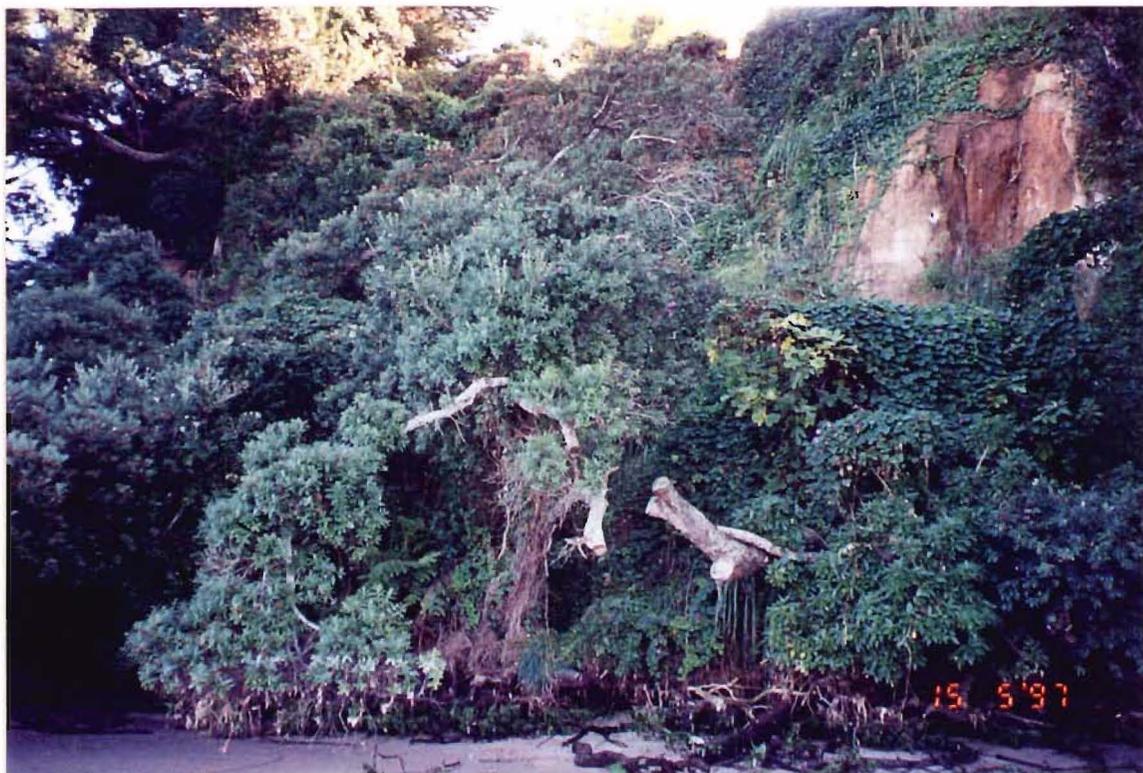
Figure 1.8 Cliff face in its natural state with introduced weed species covering some of the native vegetation (Photograph taken from grid reference 705600, 275100 looking SW).

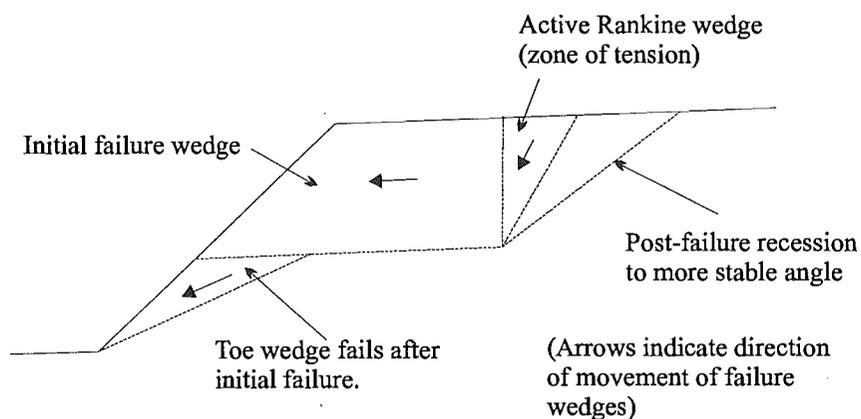
Figure 1.9 Two-dimension model for wedge failure at Omokoroa Point (Tonkin and Talyor, 1980).

clay mineralogy analysis. Atterberg testing showed that while the liquid limits were high, plasticities were low (liquid limits (LL) = 101 & 76 and Plastic limits 54 and 50 respectively). Triaxial testing of five samples produced a of cohesion (c') = 0 kPa and friction angle (ϕ) = 29.5°, testing of a sample from a failure zone indicated $c' = 90$ kPa and $\phi = 10^\circ$. Clay mineralogy determined that the main constituent was halloysite. In addition to engineering properties, Tonkin and Talyor developed a failure model for Omokoroa Point (Figure 1.9).

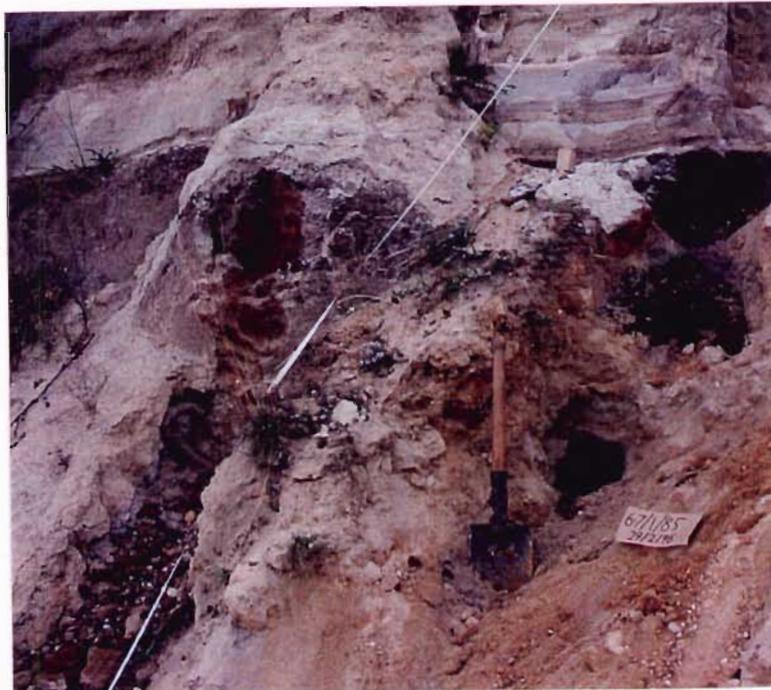
Figure 2.2 Hamilton Ash and associated palaeosol at 85 Te Hono Street

The Hamilton Ash Formation overlies the Matua Subgroup sediments and underlies the Rotoehu Ash (Figure 2.2). It consists of a number of strongly weathered clay-textured tephra beds and palaeosols which are well represented in the Waikato - South Auckland - Tauranga region (Ward, 1967 & Pain, 1975 in Briggs et al., 1996). The sequence has been divided into eight units numbered H1 (bottom) to H8 (top). However, it is virtually impossible in many situations to decide which unit is present due to extensive erosion of beds and palaeosols. At Maungatapu Peninsula the Hamilton Ash ranges in thickness from < 0.5 m to ~ 6 m in areas of ponding, with an average of 3 m. The Hamilton Ash ranges in age from 0.35 Ma - *c.* 0.1 Ma (Briggs et al., 1996).

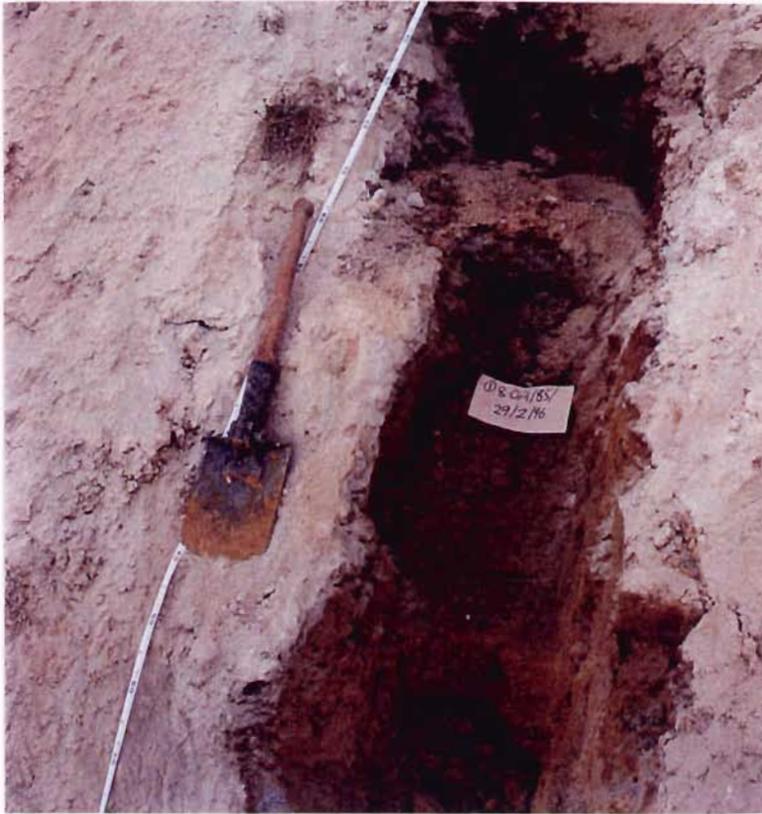
Figure 2.3 Photo showing variation in colour from a dark brown to the more commonly observed orangish brown of the Hamilton Ash at 85 Te Hono Street.

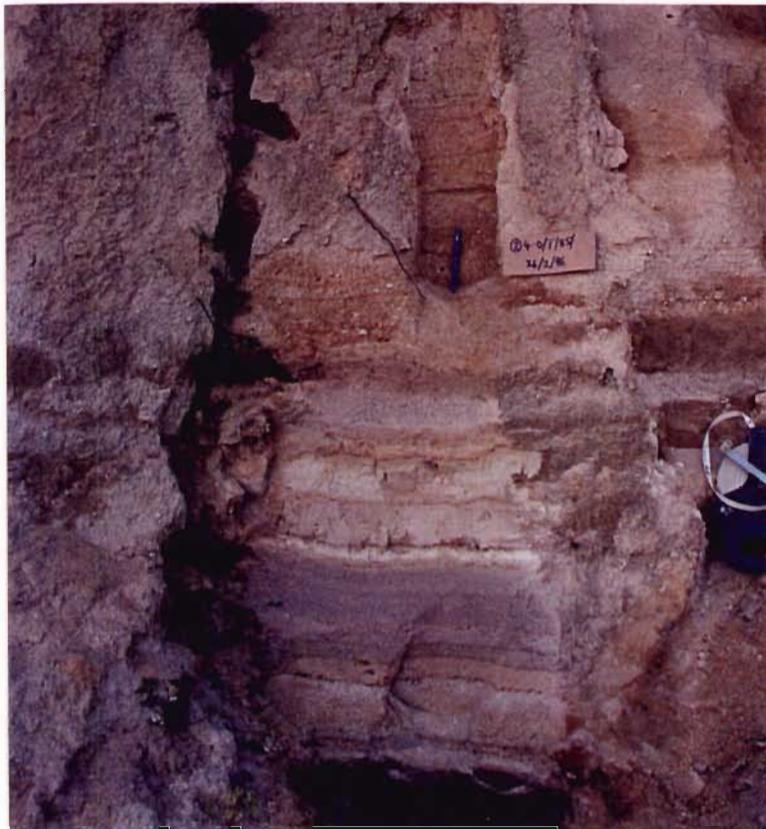
Figure 2.4 Photo showing the planar bedding of the Rotoehu Ash bounded by the Younger Ashes and the Palaeosol.

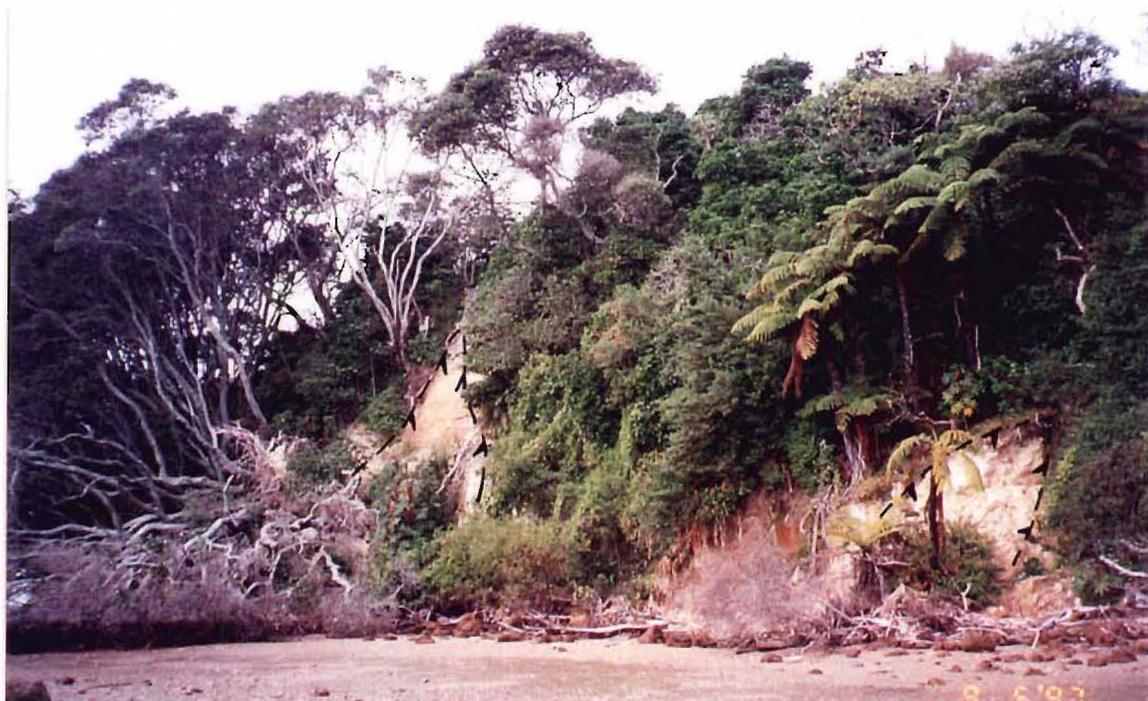
Figure 2.6 Two shallow failures where the vegetation has become too heavy for the Colluvium/Top soil to support. This can occur after a rainstorm event where the Colluvium/Top soil mass has become saturated. In addition to this the larger trees such as the Pohutukawa on the left hand side of the photograph impart a torque on the soil mass due to their large size and shallow root mass. This commonly produces these shallow failures seen around the Peninsula cliff sections. Photograph taken at grid reference 705650 275150 looking SE.

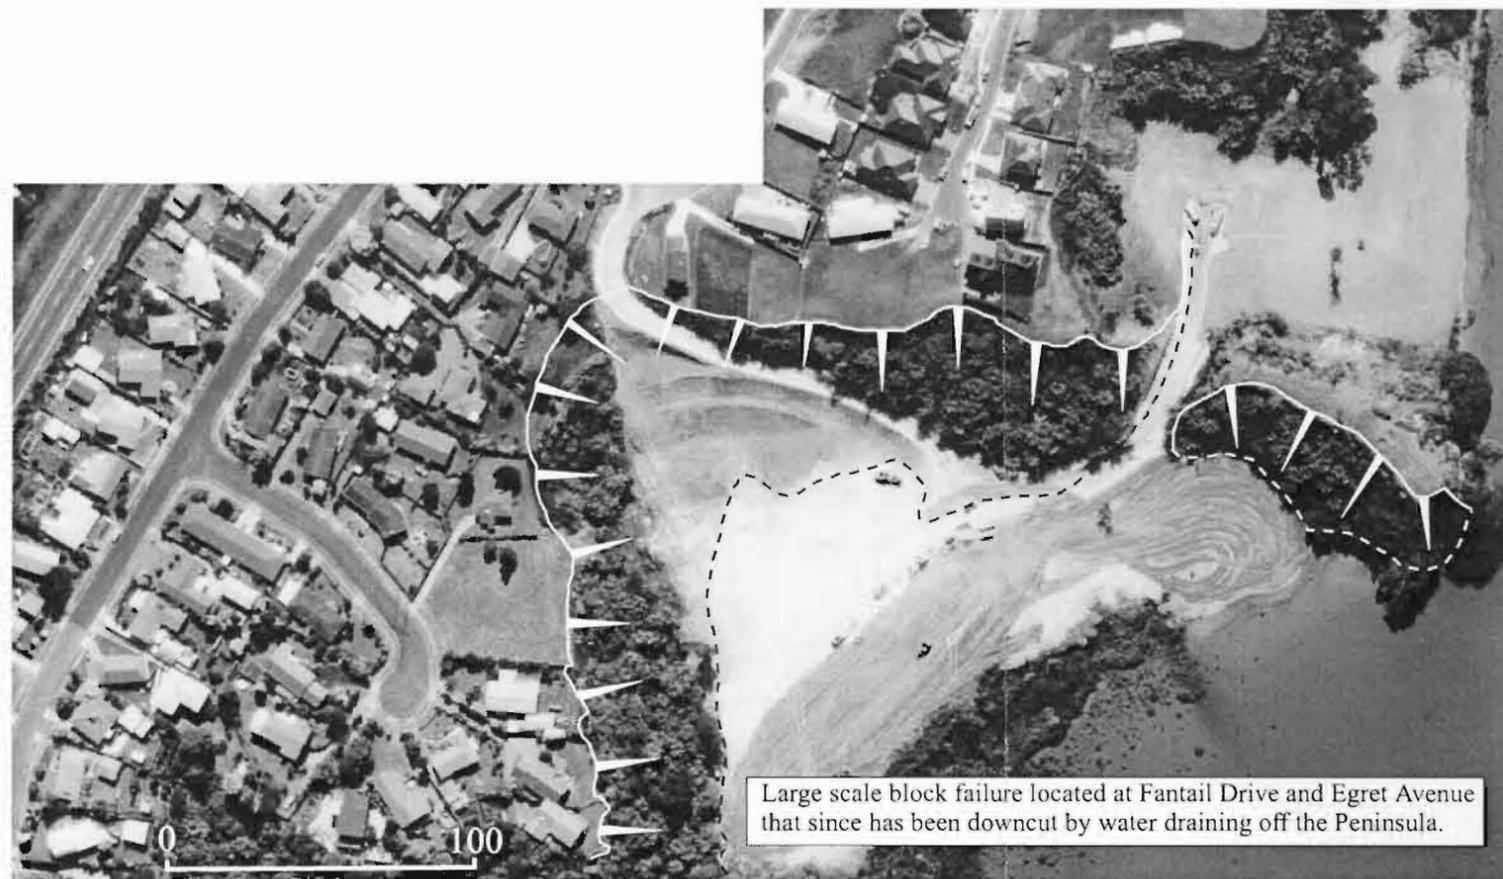
1.) Erosion of the toe of the cliff by the river results in a decrease in the stability of the cliff face.

Figure 2.9 Schematic representation for a wave erosion triggered block failure. Failure occurs where the toe of the cliff has been removed by erosion producing either a colluvium/top soil failure or a larger block failure. The later stages of failure can be dramatically influences by water content of the soil mass. From Cruden and Varnes (1996) terminology the failure can be defined as a "Retrogressive, complex; very slow-extremely slow, dry-moist, debris, fall; very rapid-extremely rapid, moist-very wet, debris, slide-flow".

Wave erosion-triggered block failures (Figure 2.9) do not appear to be as prominent as other failure types around the Peninsula. Areas most effected tend to be located at the NE end of the Peninsula where wave energy is the greatest. Initially they are started by a small colluvium/topsoil failure at the base of the cliff. Fretting along exfoliation is produced by large root mats related to the vegetation above propagation along defects (Figure 2.9). This fact in conjunction with wave erosion erosion at high tide and rainfall during storm events will produce small ($\sim <1\text{m}^3$) failures by falling. As the cavity grows the weight of the unsupported block above will shear along either the Colluvium/topsoil-stratigraphic unit boundary, or along an exfoliation defect (Figure 2.9). Difficulties arise in predicting the size of the failure. Potentially if the cavity becomes large enough a reasonable sized block failure could occur. However, in most cases it is surmised that a colluvium/topsoil or shallow block failure will form. A colluvium/topsoil failure is a term used for the failure of either a ($2\text{m}^3 - 200\text{m}^3$) section of the colluvium/topsoil (Figure 2.10), or a bigger failure ($\sim 400\text{m}^3$) that involves the colluvium/topsoil and the underlying stratic units (Figure 2.9).

Landslide type is influenced by a number of factors such as: water content, aquifer influence, vegetation mass, cliff geometry, size of cavity, and tide height. A suggested situation of moist water content, high vegetation density, reasonably sized cavity ($>50\text{m}^3$), and high tide, could by Cruden and Varnes (1996) terminology be termed a “enlarging, multiple, very slow-slow, dry-moist, earth, fall; complex, very rapid-extremely rapid, moist, debris, slide-flow”. Figure 2.9 presents a summary of the developmental stages of cliff failure.

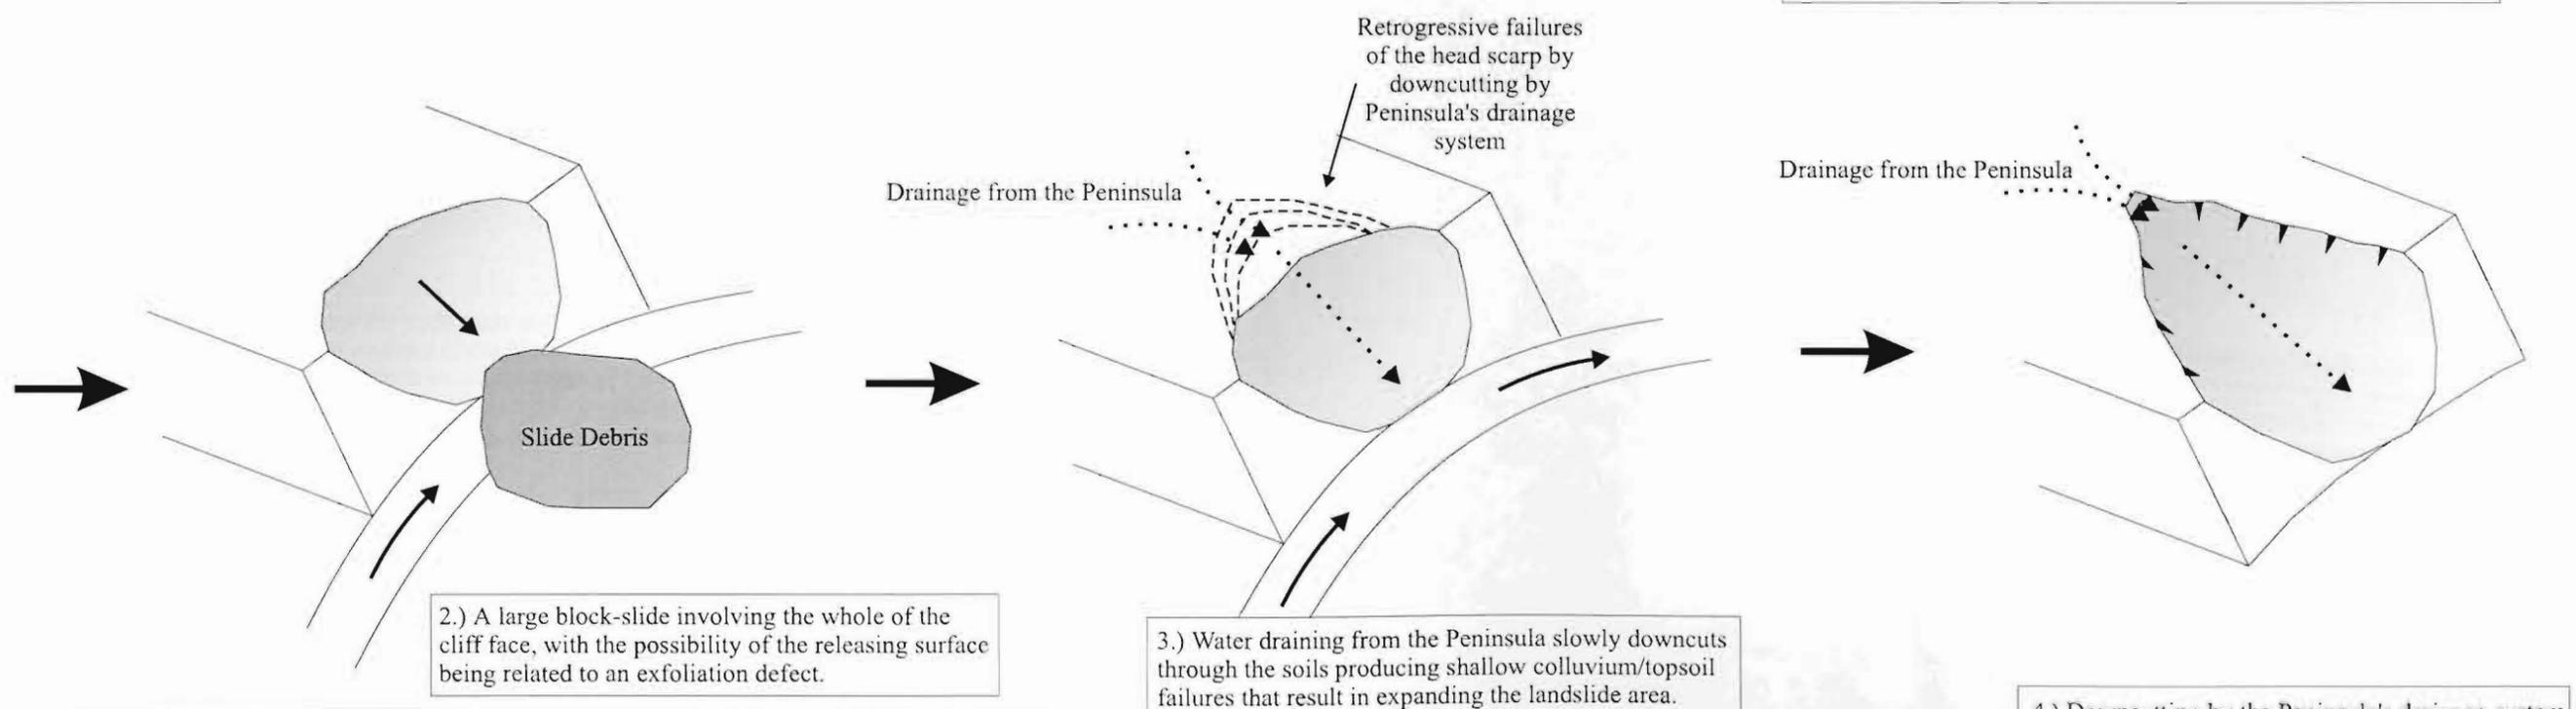
2.) A large block-slide involving the whole of the cliff face, with the possibility of the releasing surface being related to an exfoliation defect.

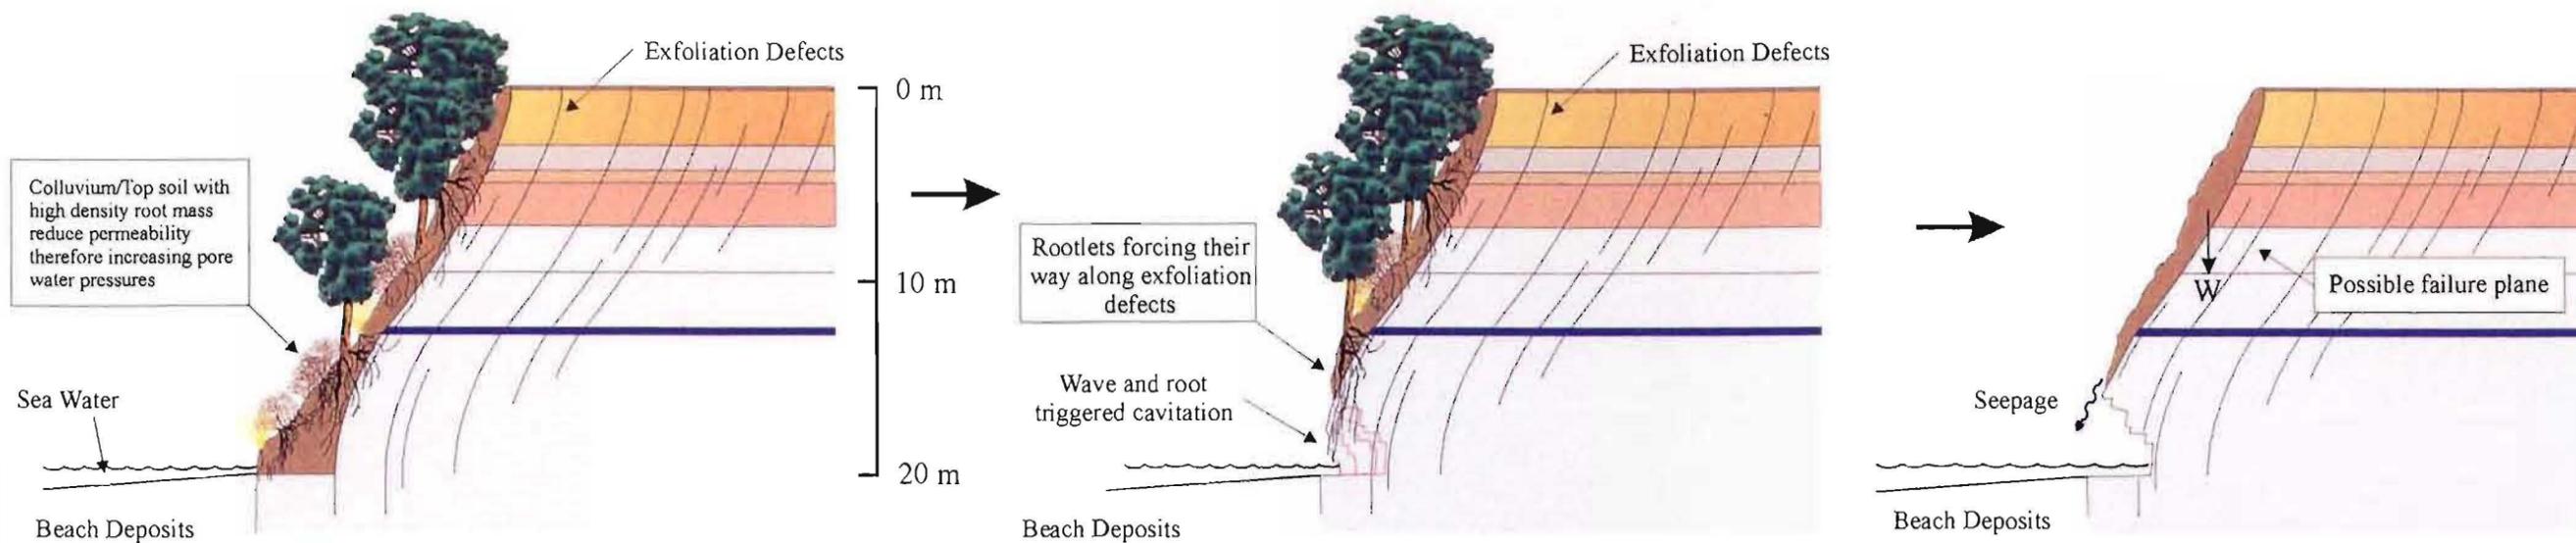
1.) A cliff section showing generalised geology, and vegetation with roots penetrating the colluvium/Top soil. Exfoliation defects which follow the cliff geometry provide possible releasing surfaces for block failure, and are picked up by rootlets near the cliff face.

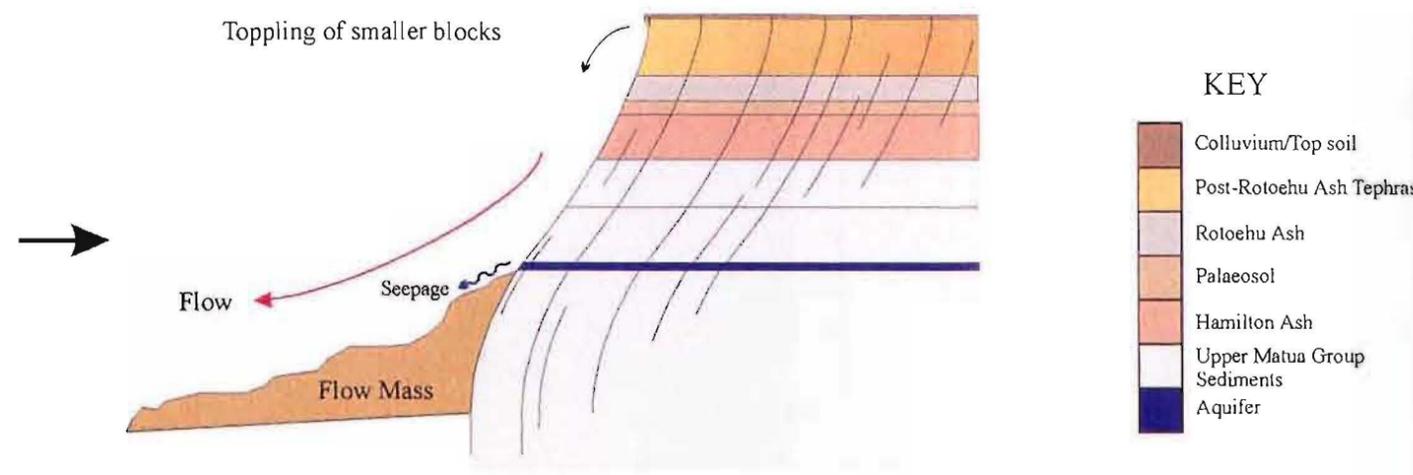
4.) As the block fails internal defects help to break it up as it hits the cliff bottom. With high water content as in aquifer triggered failures or on entering sea water will produce a flow instead of a slide as in the second phase of movement.

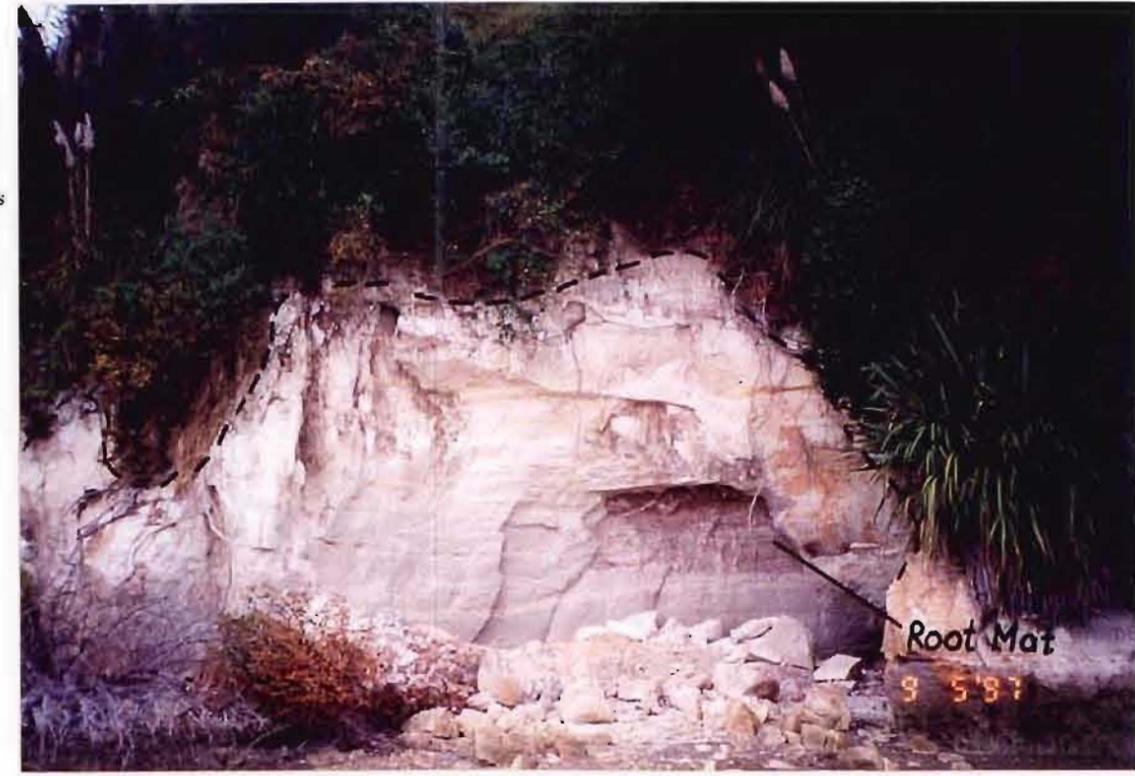
The Photograph depicts how the root mass from vegetation above pushes its way through the soil mass along exfoliation defects creating a root mat. This provides a surface on which the soil can fail after it has been undercut by wave action. Failure in this case tends to occur more as falls with debris easily seen accumulated at the bottom of the cliff.

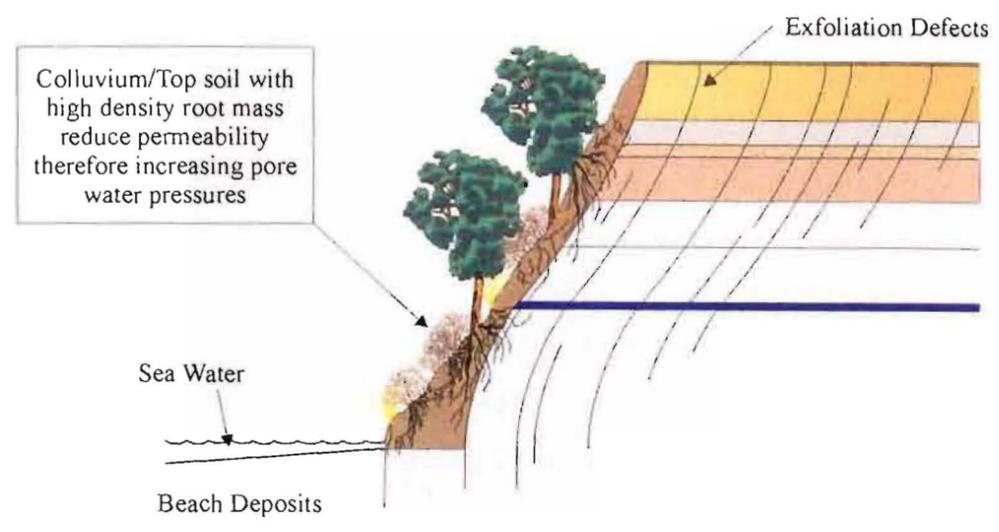
1.) A cliff section showing generalised geology, and vegetation with roots penetrating the Colluvium/Top soil. Exfoliation defects which follows the cliff geometry provide possible releasing surfaces for block failure, and are picked up by rootlets near the cliff face.

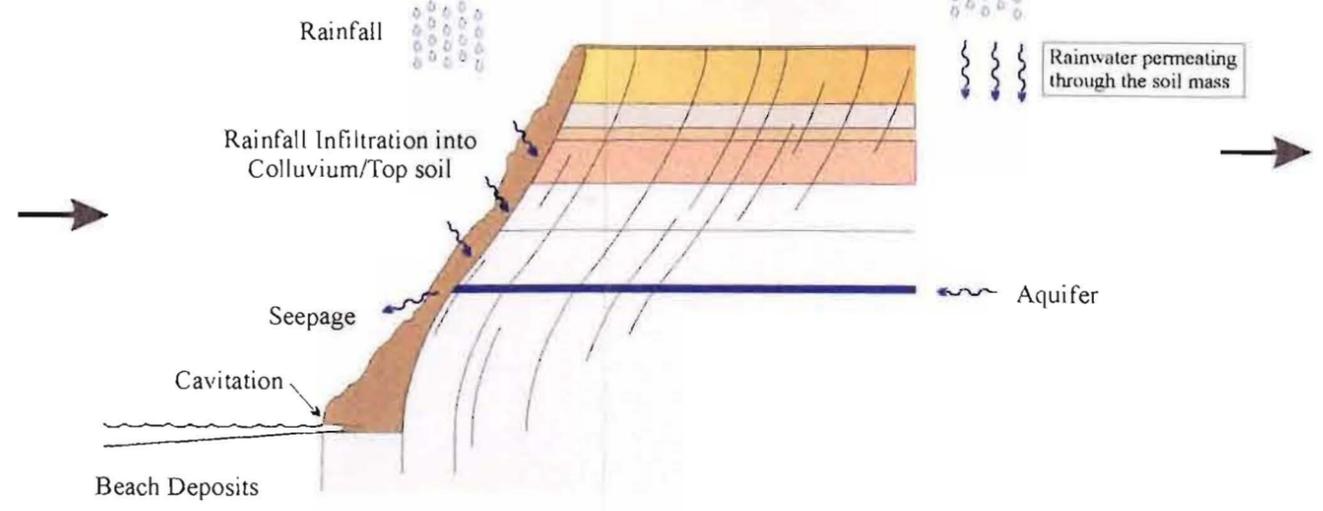
2.) Rainfall entering the soil mass from the surrounding hinterland and Peninsula is transferred to the aquifer which exits at the cliff face. In Addition, rainfall can help to saturate the Colluvium/Top soil mass adding extra weight and increasing pore water pressures. Also erosion by wave action at the base of the cliff can increase the possibility that failure will occur.

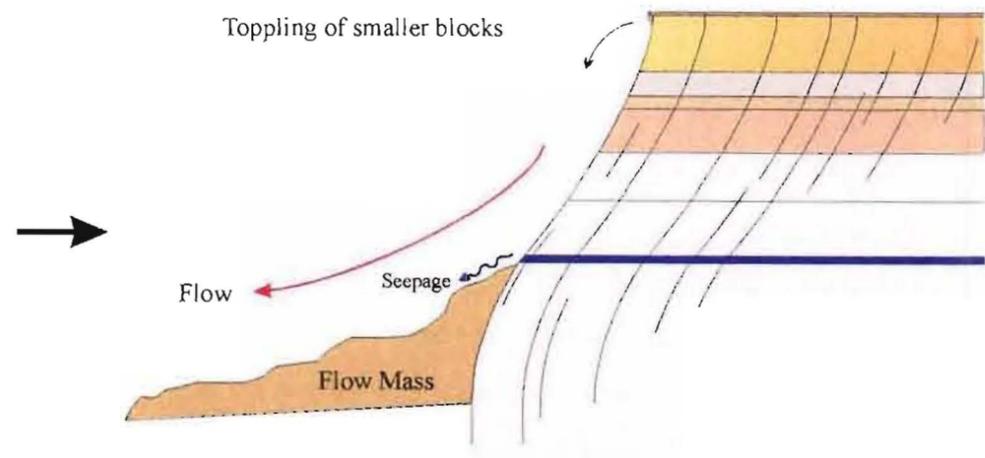
3.) The boundary between the Colluvium/Top soil and underlying geologic units can provide a surface on which a top soil failure may occur. As the top soil slides internal mixing of the soil mass due to the high water content produces a flow. If the flow enters sea water this will increase the effects of the internal mixing and how far the flow will travel. Most of the vegetation tends to survive the failure remaining in a semi-vertical position as on the cliff face.

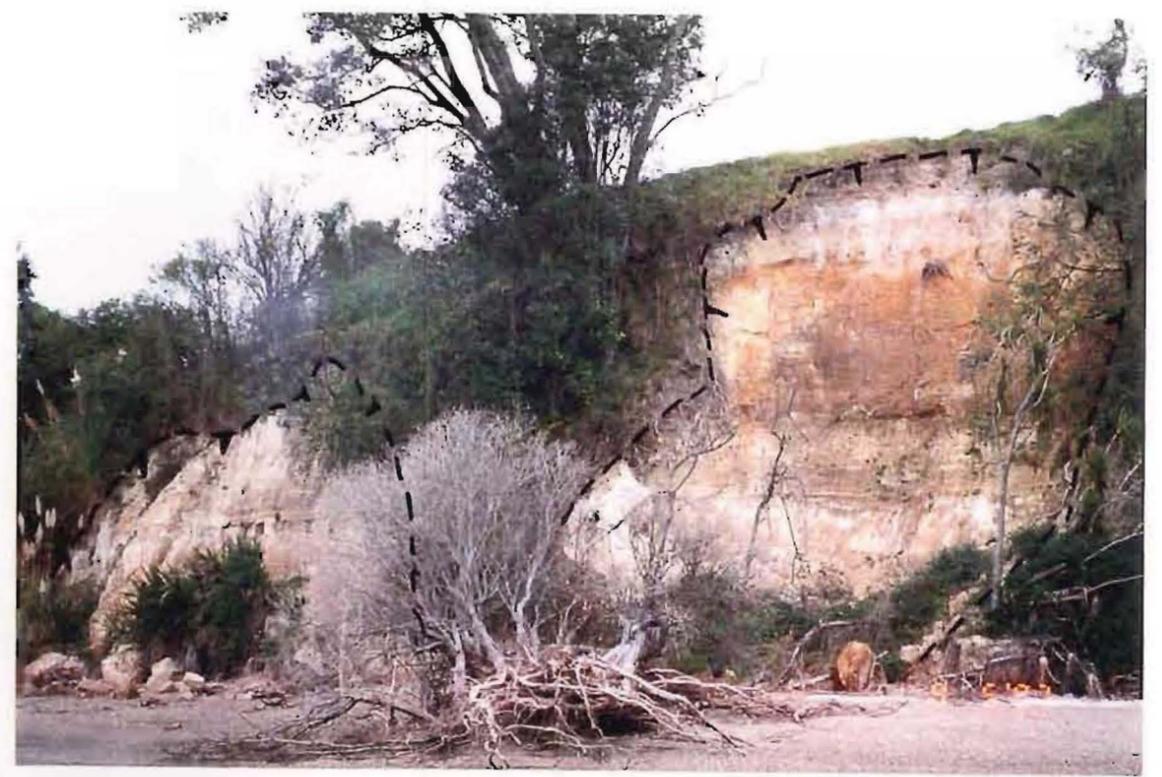
The Photograph show vegetation root mass in conjunction with Colluvium/Top soil produces a surface on which failure may occur. Vegetation weight especially larger trees results in a torque placed on the soil mass aiding in production of instability. Sliding has occurred along the interface between the vegetation root mass-Colluvium/Top soil and a shallow exfoliation defect. The debris has subsequently been eroded away by wave action.
