**A GEOTECHNICAL
CHARACTERISATION OF VOLCANIC
SOILS IN RELATION TO COASTAL
LANDSLIDING ON THE MAUNGATAPU
PENINSULA, TAURANGA, NEW
ZEALAND**

A Thesis
submitted in partial fulfillment
of the requirements for the Degree
of
Master of Science in Engineering Geology
at the
University of Canterbury
by
Robert Craig Oliver

**University of Canterbury
1997**

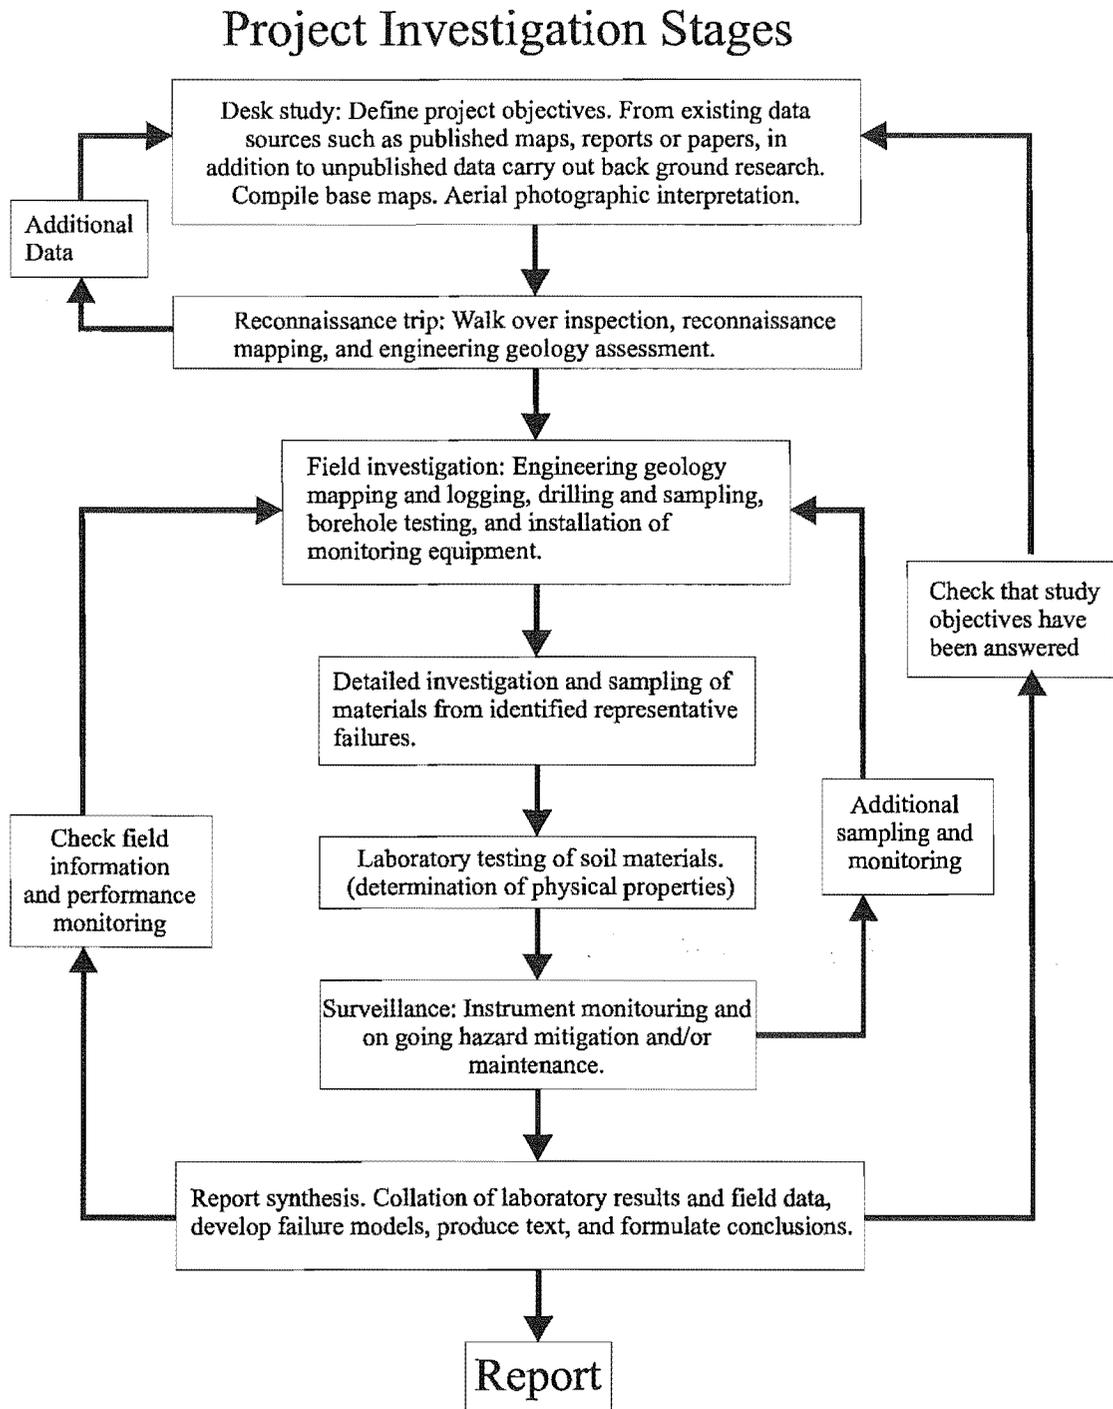
Figure 3.1 Flow chart illustrating the methodology used during this study. The conceptual stages were adopted from Clayton et al. (1982) and Bell (1990).

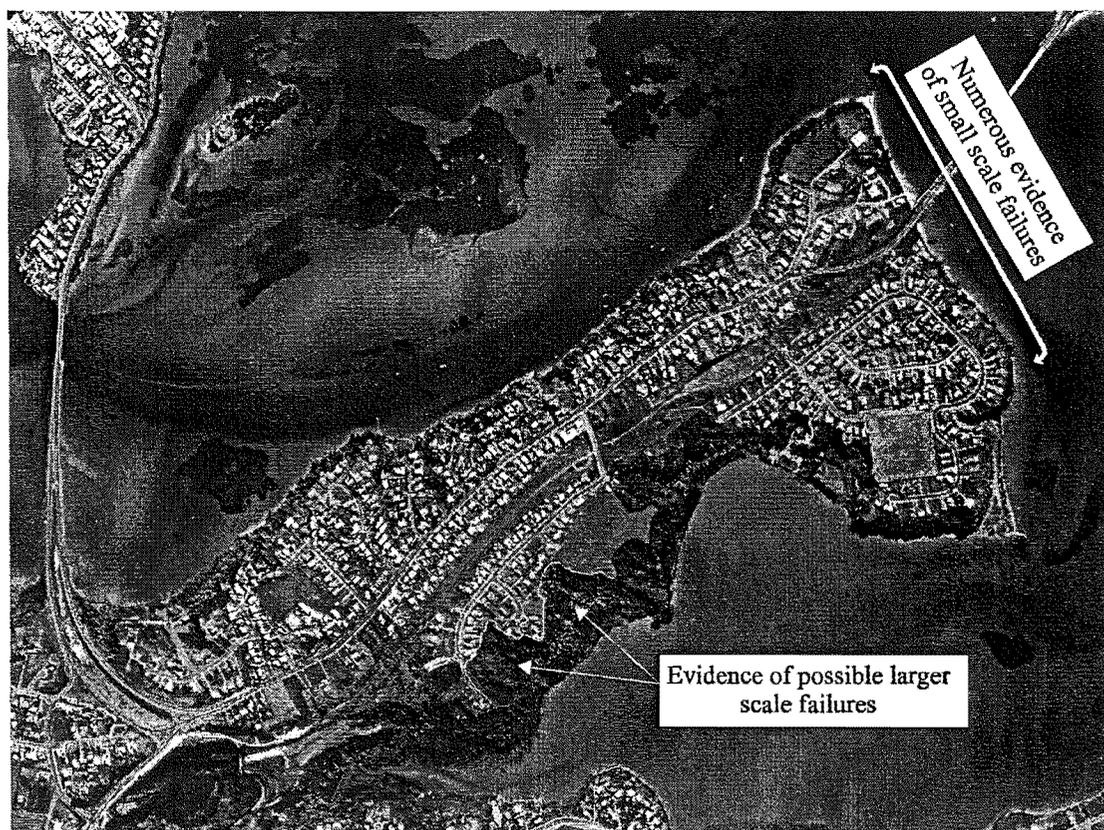
Figure 3.2 Aerial Photograph identifying some of these possible large landslide features as well as a zone where there is numerous evidence of smaller scale failures such as those seen at 85 Te Hono Street.

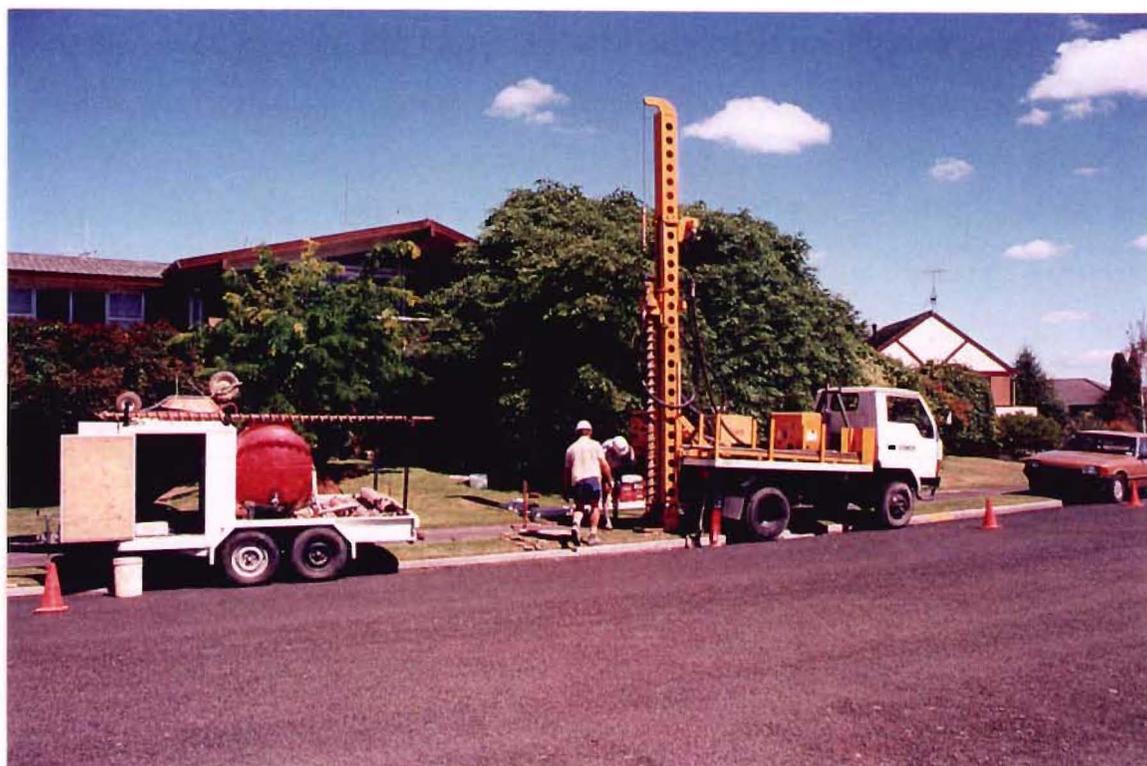
Figure 3.3 Hydraulic open hole drill rig set up. Hollow augers with an internal diameter of approximately 80 mm were used to drill a bore hole to a depth where core recovery was inadequate. A 75 mm internal diameter by 750 mm long split tube was used to recover the core using water to create a vacuum. When core recovery became poor a 50 mm internal diameter by 1500 mm long push tube was used.

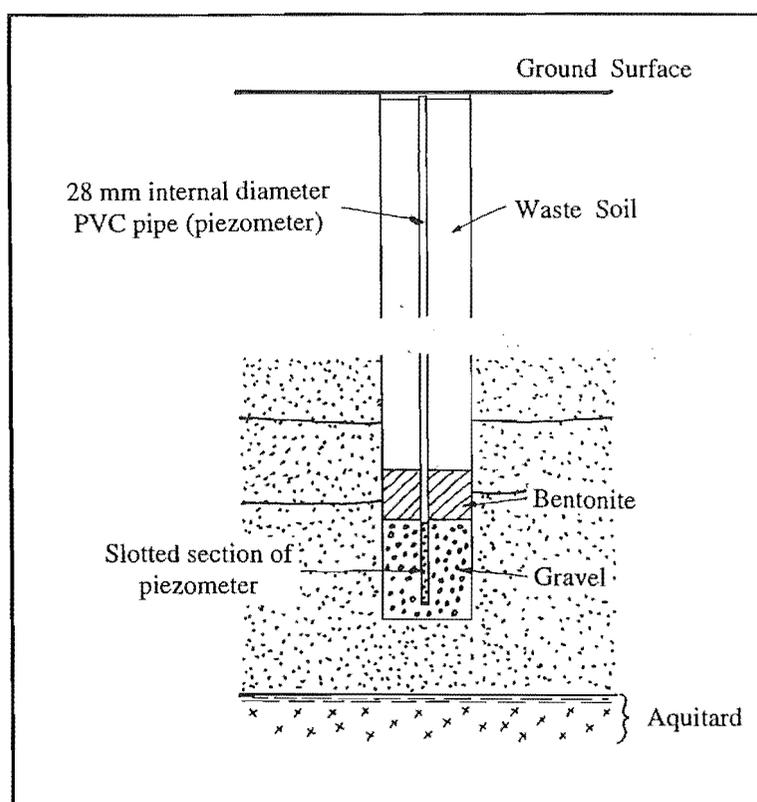
Figure 3.4 shows the typical set up of a piezometer used to measure water level responses from rainfall.

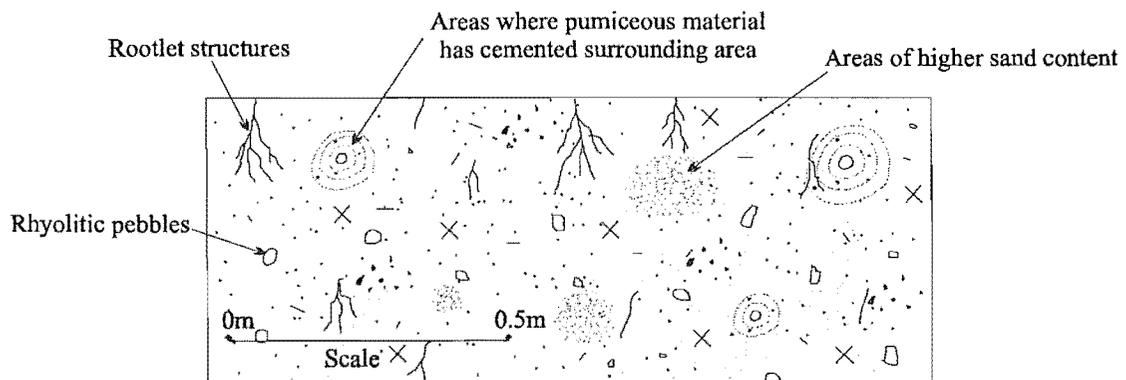
Figure 3.5 Section through a portion of a tephra bed associated with the Pahoia Tephra indicating the wide range of grainsizes, areas of higher sand content, and areas where pumice has cemented grain together.

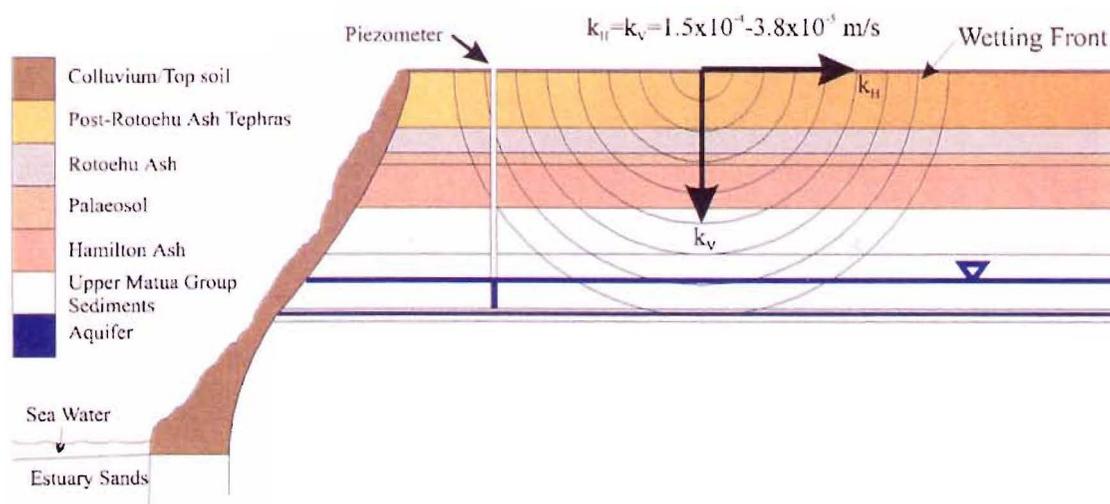
Figure 3.10 Hypothetical soil profile where the vertical permeability is equal to the horizontal permeability through the stratigraphic units.

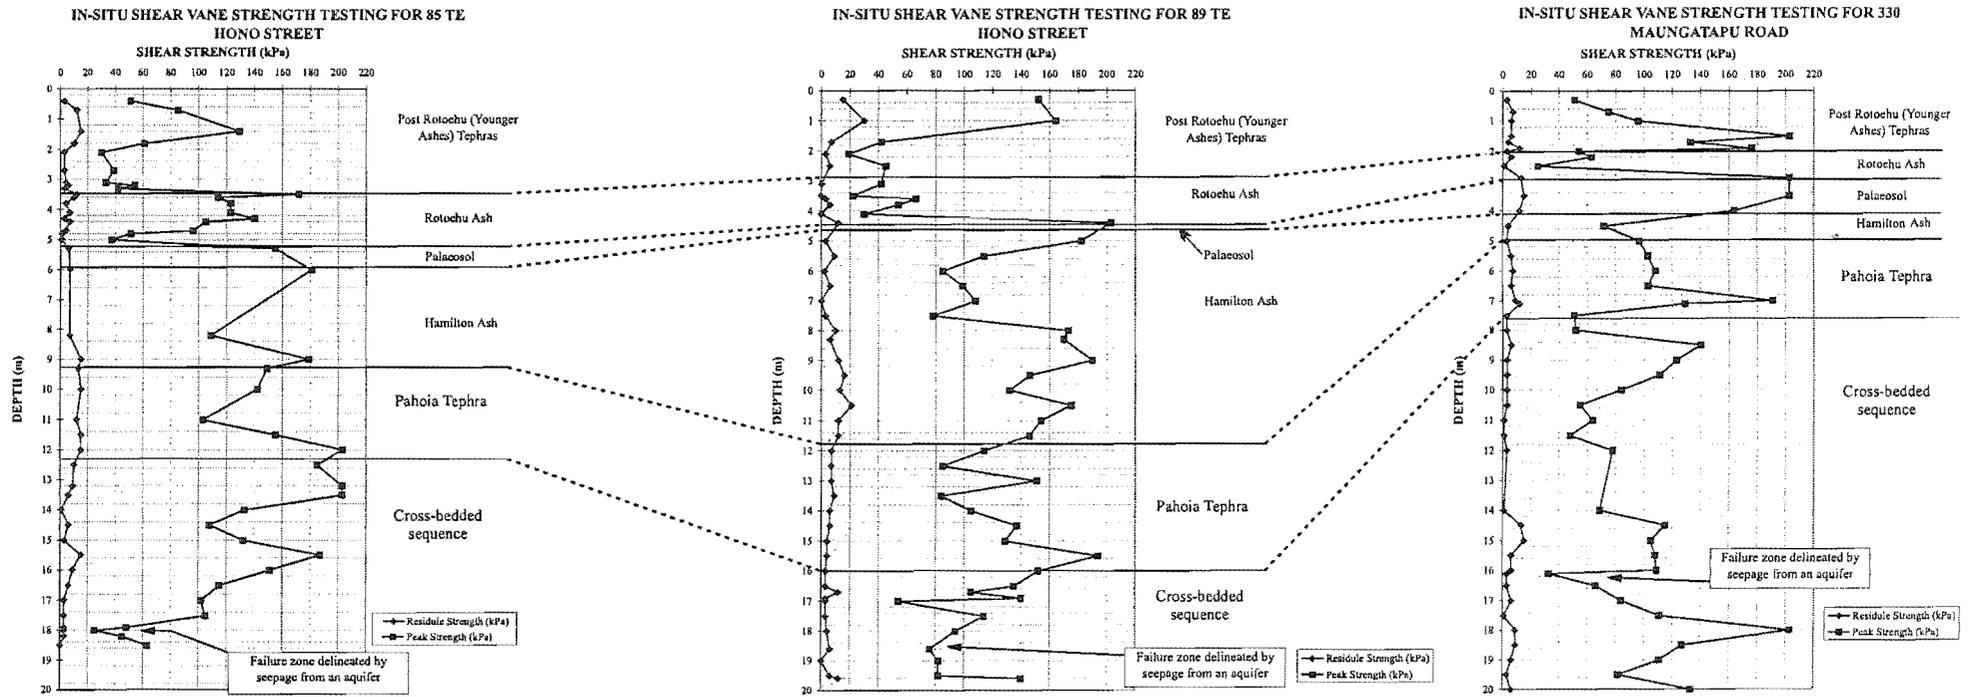
Figure 3.11 Plots presenting in-situ shear strengths for 330 Maungatapu Road, 85 and 89 Te Hono Street tested using a Pilcon Shear Vane during cliff face logging.

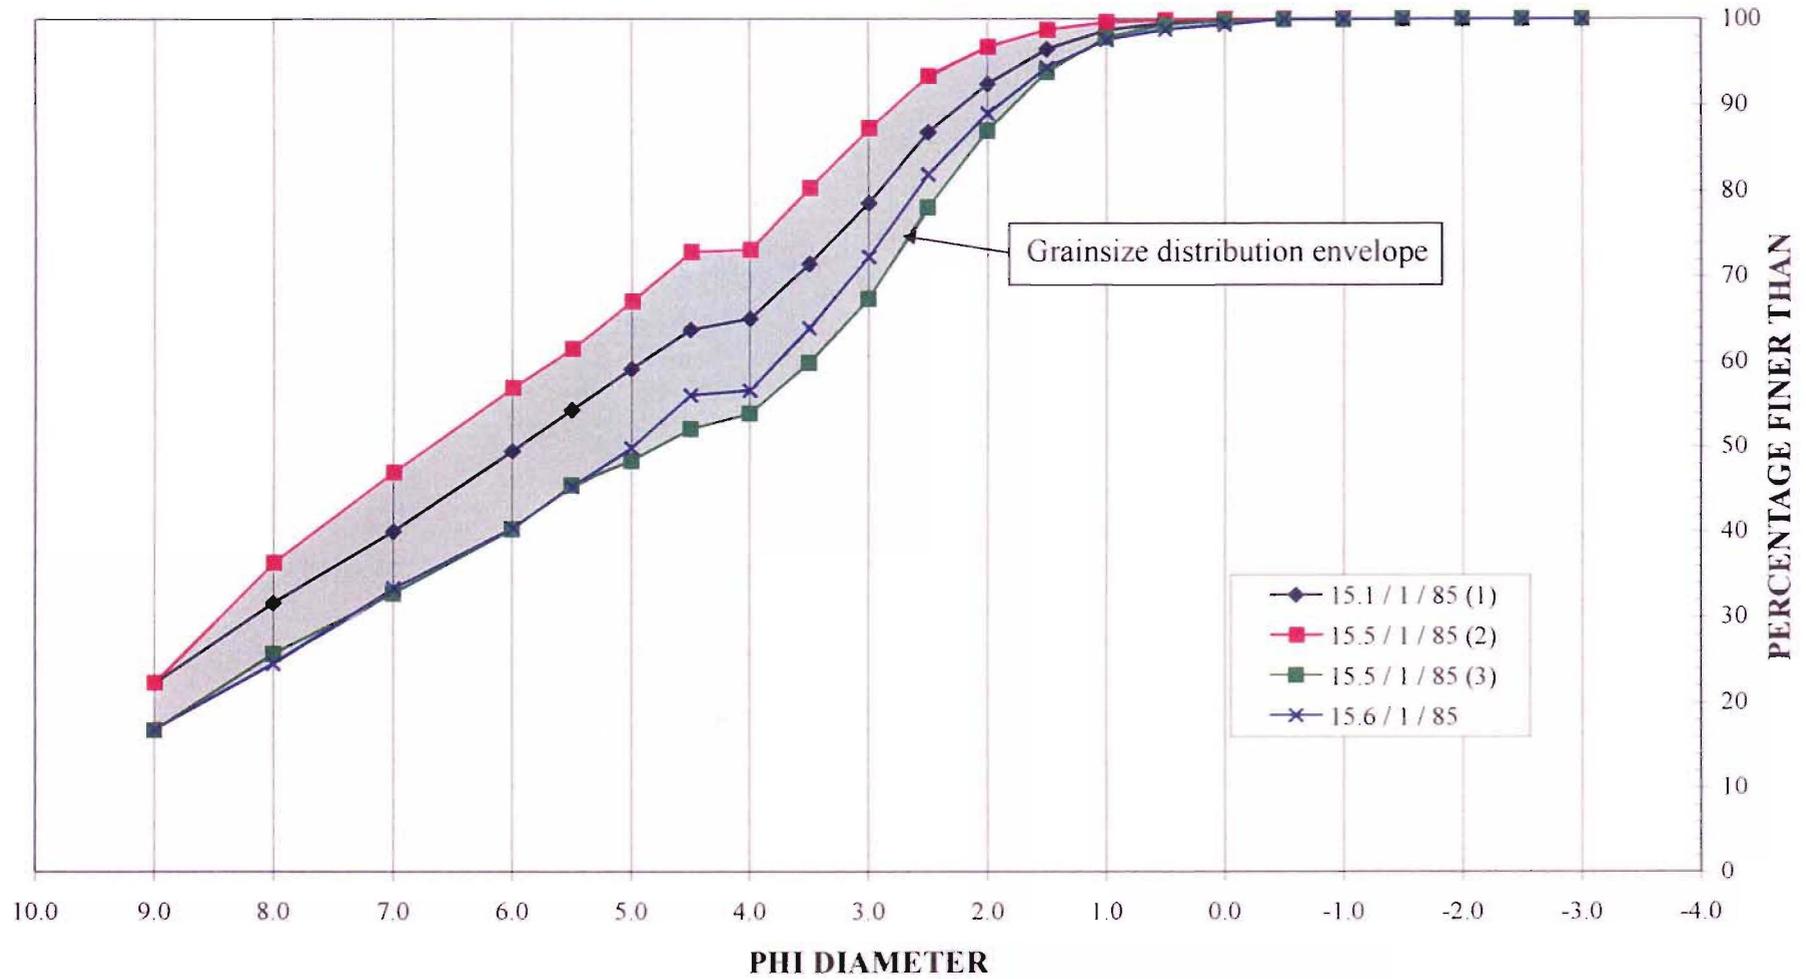
Figure 4.2 Grainsize distribution envelope for Cross-bedded section of the Upper Matua Subgroup

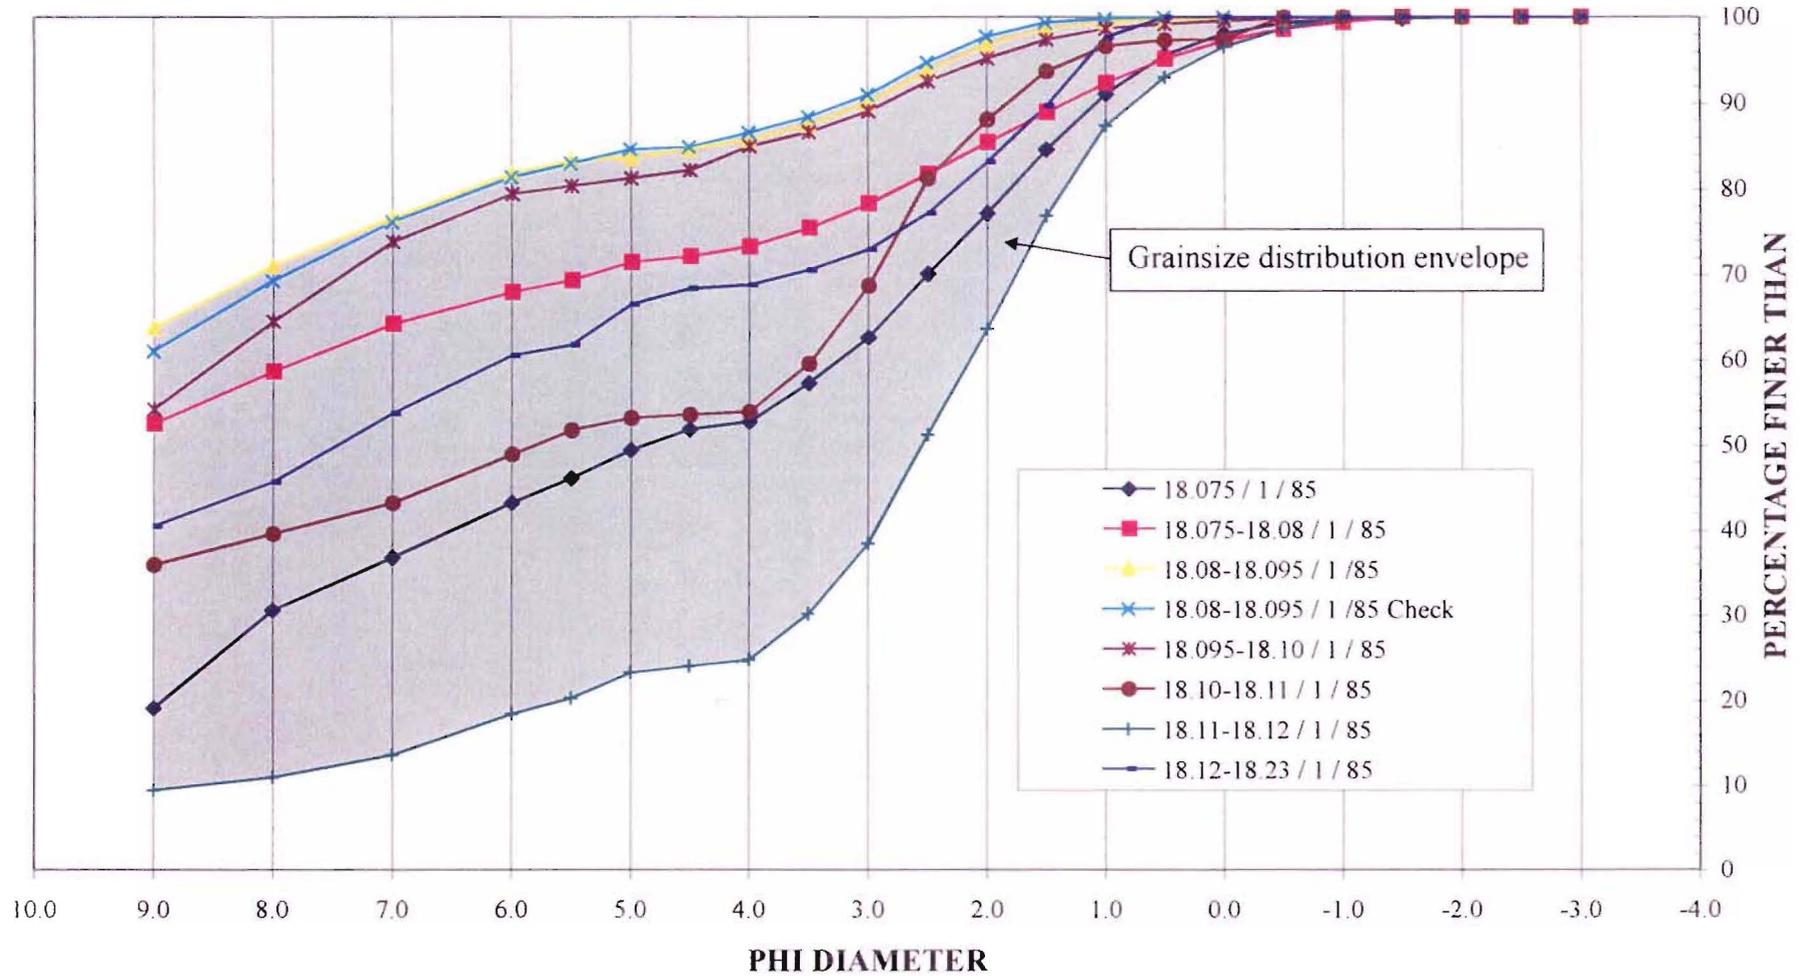
Figure 4.3 Grainsize distribution envelope for the lower aquitard located within the Upper Matua Subgroup

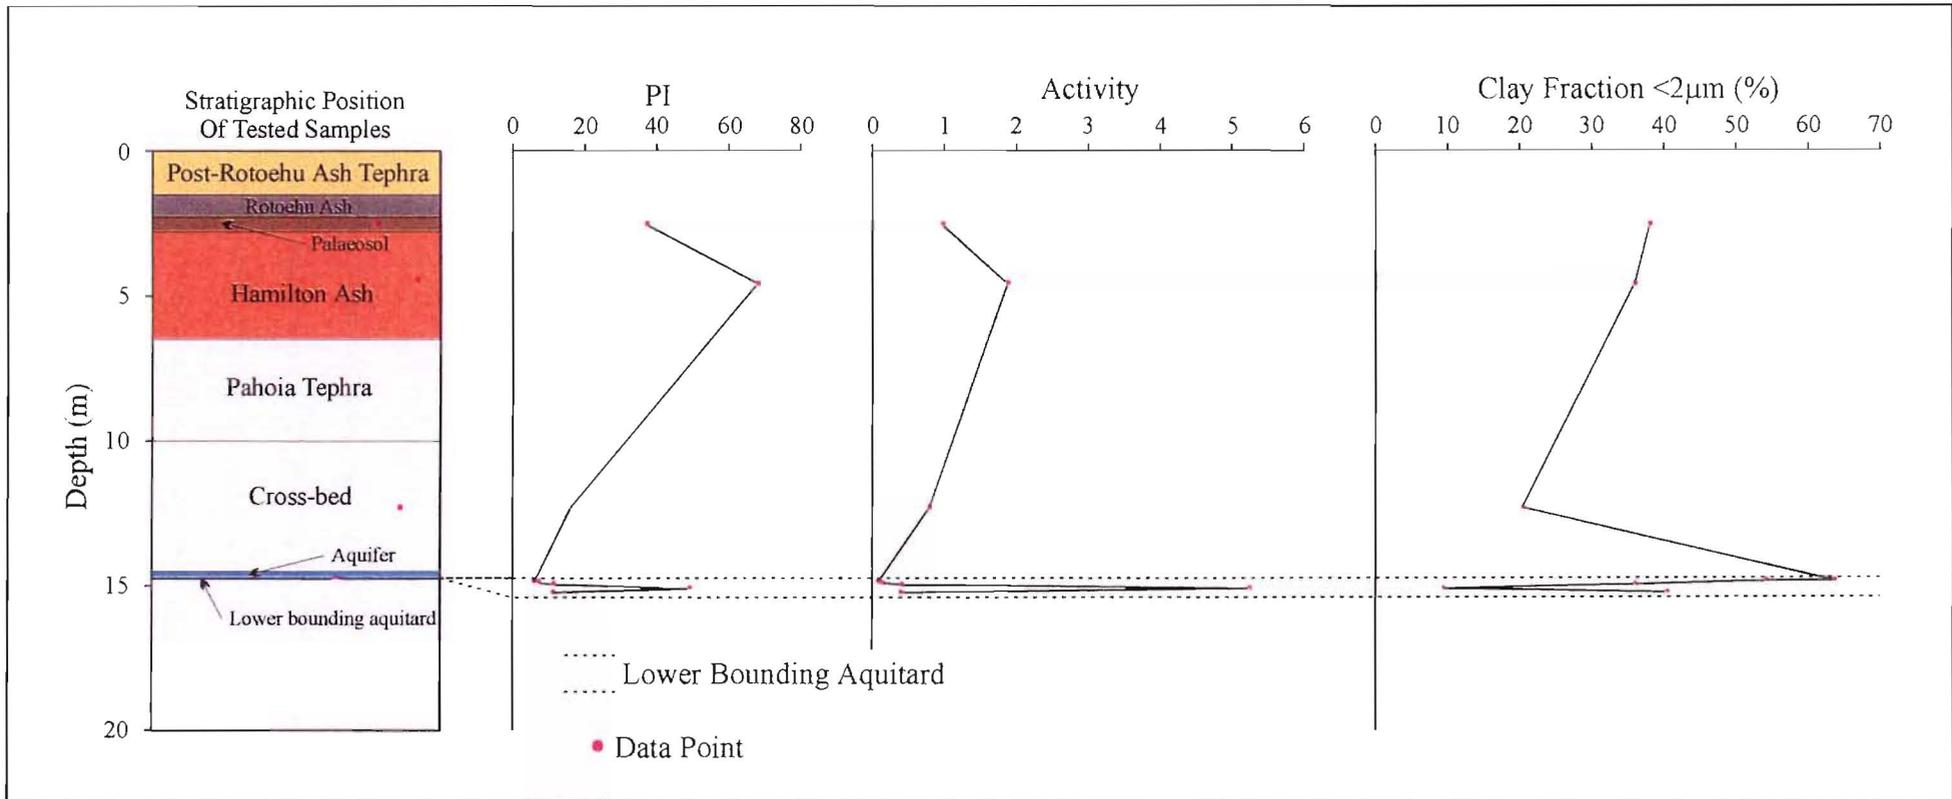
Figure 4.5 Plasticity and activity compared to stratigraphic position and clay fraction. Note Aquifer not tested.

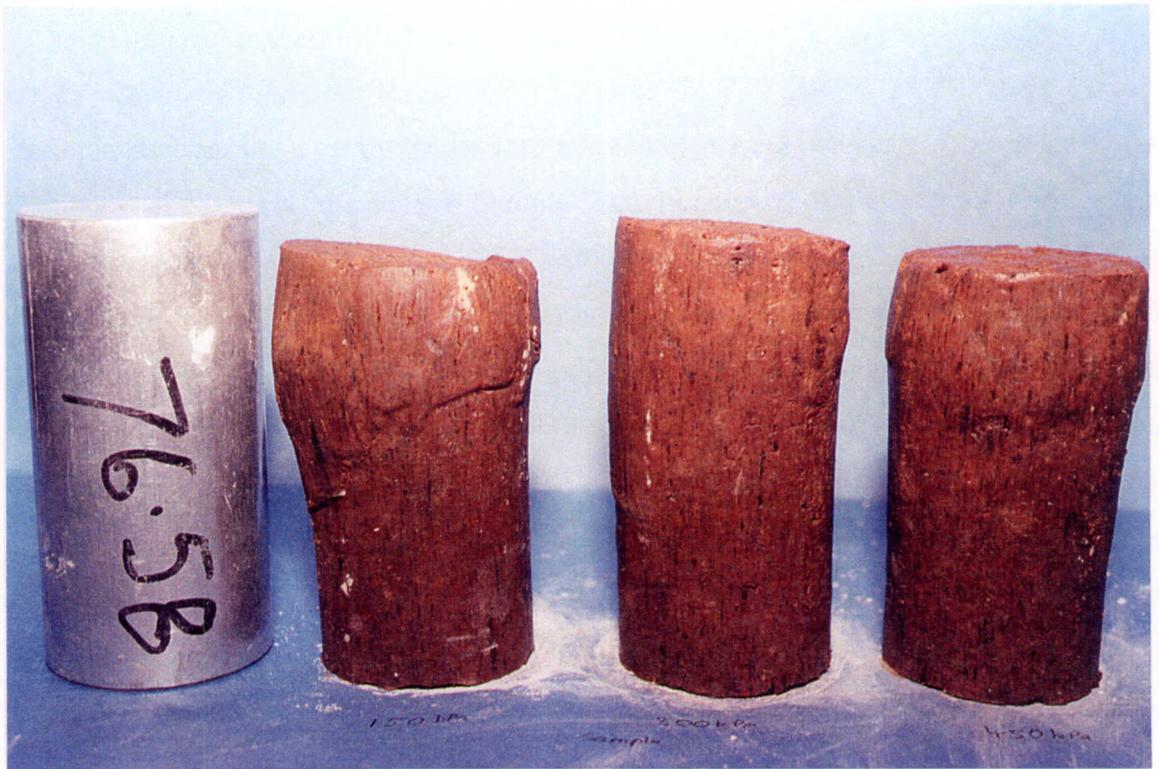
Figure 4.8 Photograph of conjugate shears which were produced during triaxial testing within the Palaeosol.

The Palaeosol (sample 3.1/1/330) produced the highest shear strength (80kPa), reflecting the compact nature of the in-situ material (Table 4.8). The failed test samples showed clear conjugate shear planes which developed during testing (Figure 4.8). The shear strengths obtained in the field by the use of the Pilcon shear vane were predominantly higher than those seen during laboratory testing, and ranged between 150-200 kPa for the in-situ Palaeosol (Chapter 3). From particle size analysis the Palaeosol was determined to have a clay content of 40%, and as such would be expected to exhibit cohesive properties. Because of this the shear strengths can be classified according to Table 4.9, laboratory determined shear strengths would equate to a soft to firm cohesive soil strength classification. However, shear vane values would equate to a stiff to very stiff cohesive soil strength (Table 4.9). Overall the Palaeosol is suggested to represent the strongest unit within the logged cliff faces.

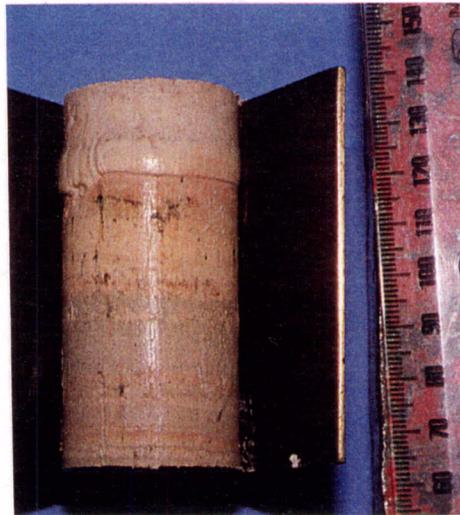
Figure 4.9 Photograph of the numerous layering present within sample 1. Also notable is the weak bulging bed towards the top of the sample.

Sample 1 is situated within the upper bounding aquitard and consists of numerous small beds 2 to 10 mm in thickness (Figure 4.9). One of these beds can be seen to bulge outwards slightly, indicating a weak zone within the sample. This zone is also present in the lower bounding aquitard. During testing the weak zone was easily compressed, producing a localised failure in the test specimen. The unconfined undrained (UU) plots showed evidence of this by a minor peak around 20 and 40 kPa for the 150 and 300 kPa

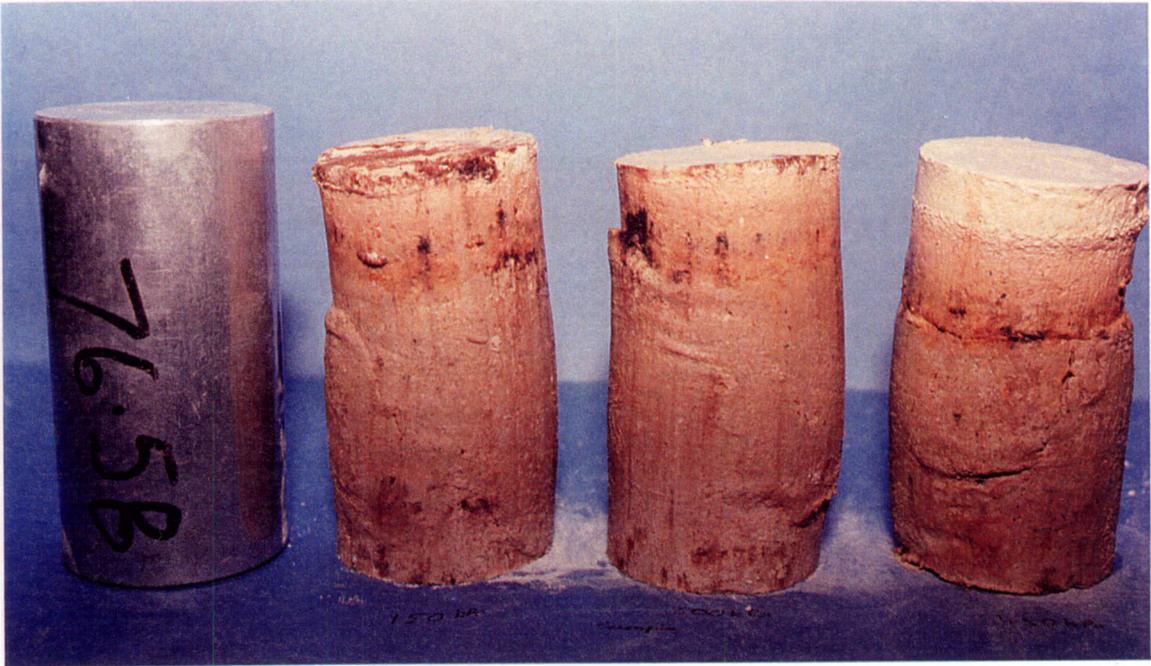
Figure 4.10 Photograph of 2bottom showing a planar failure at about 60-70° from the horizontal.

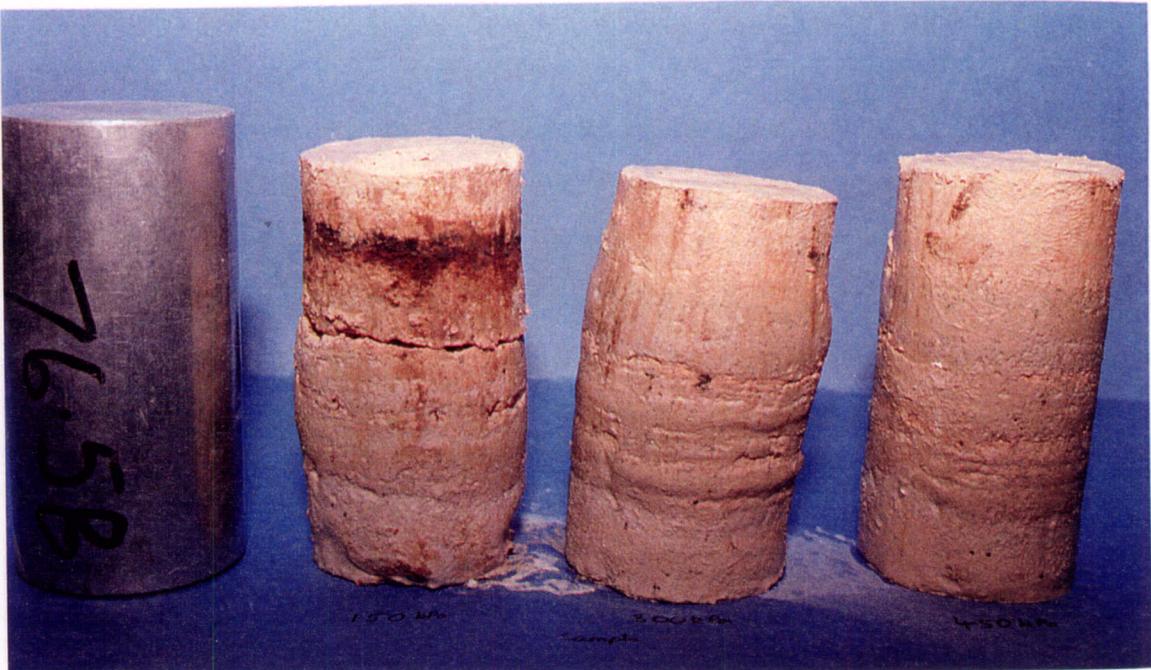
Figure 4.11 Photograph of 3bottom showing horizontal failures occurring between boundaries of two beds. Also notable are individual beds of weaker silty-clay material which bulge outwards compared to the more sandy beds.

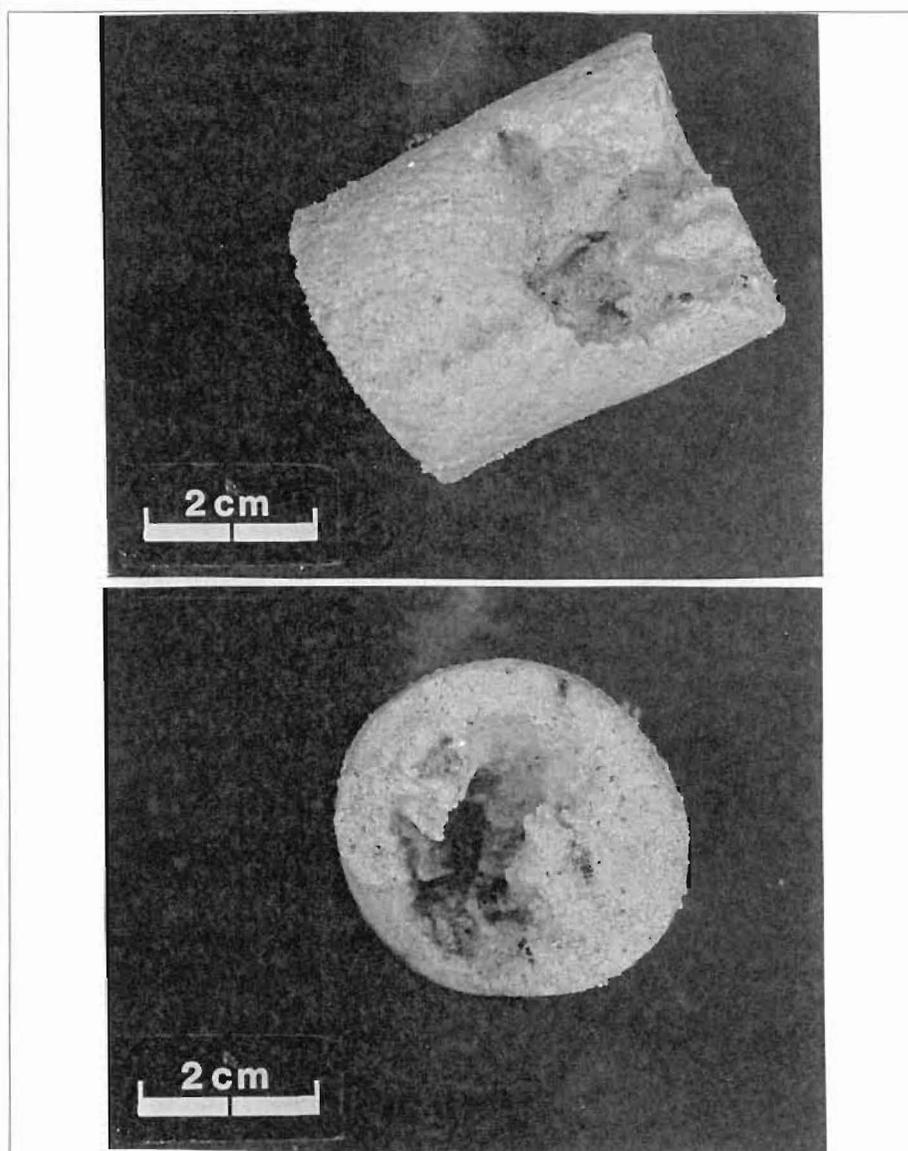
Figure 4.12 Photograph taken of a blowout in sample 14.2/1/330 leaving a large chamber at the end of the sample.

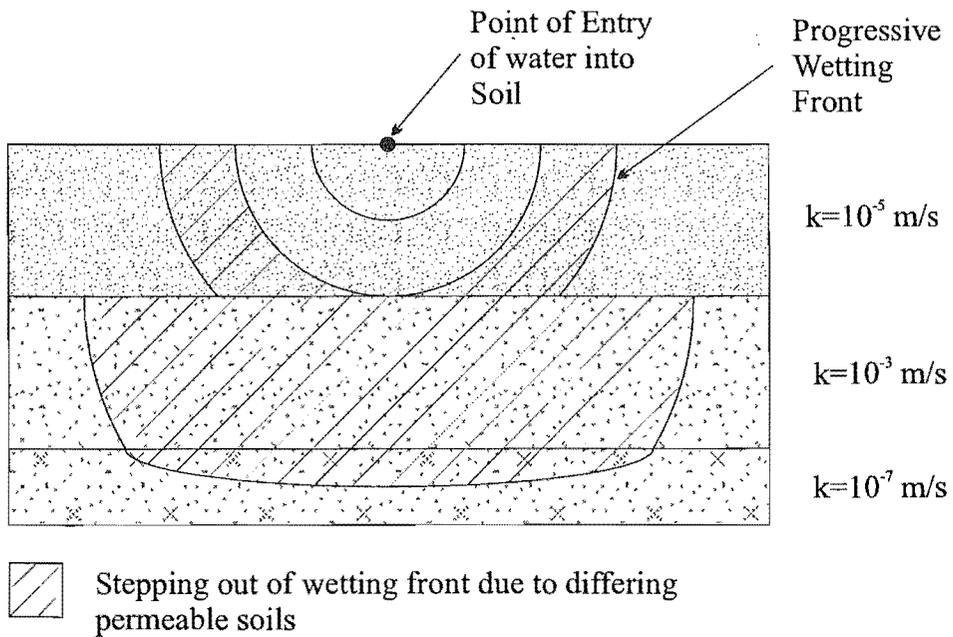
Figure 5.3 Theoretical progression of a wetting front through a number of soils with varying permeabilities. This is a two dimensional schematic in the vertical plane.

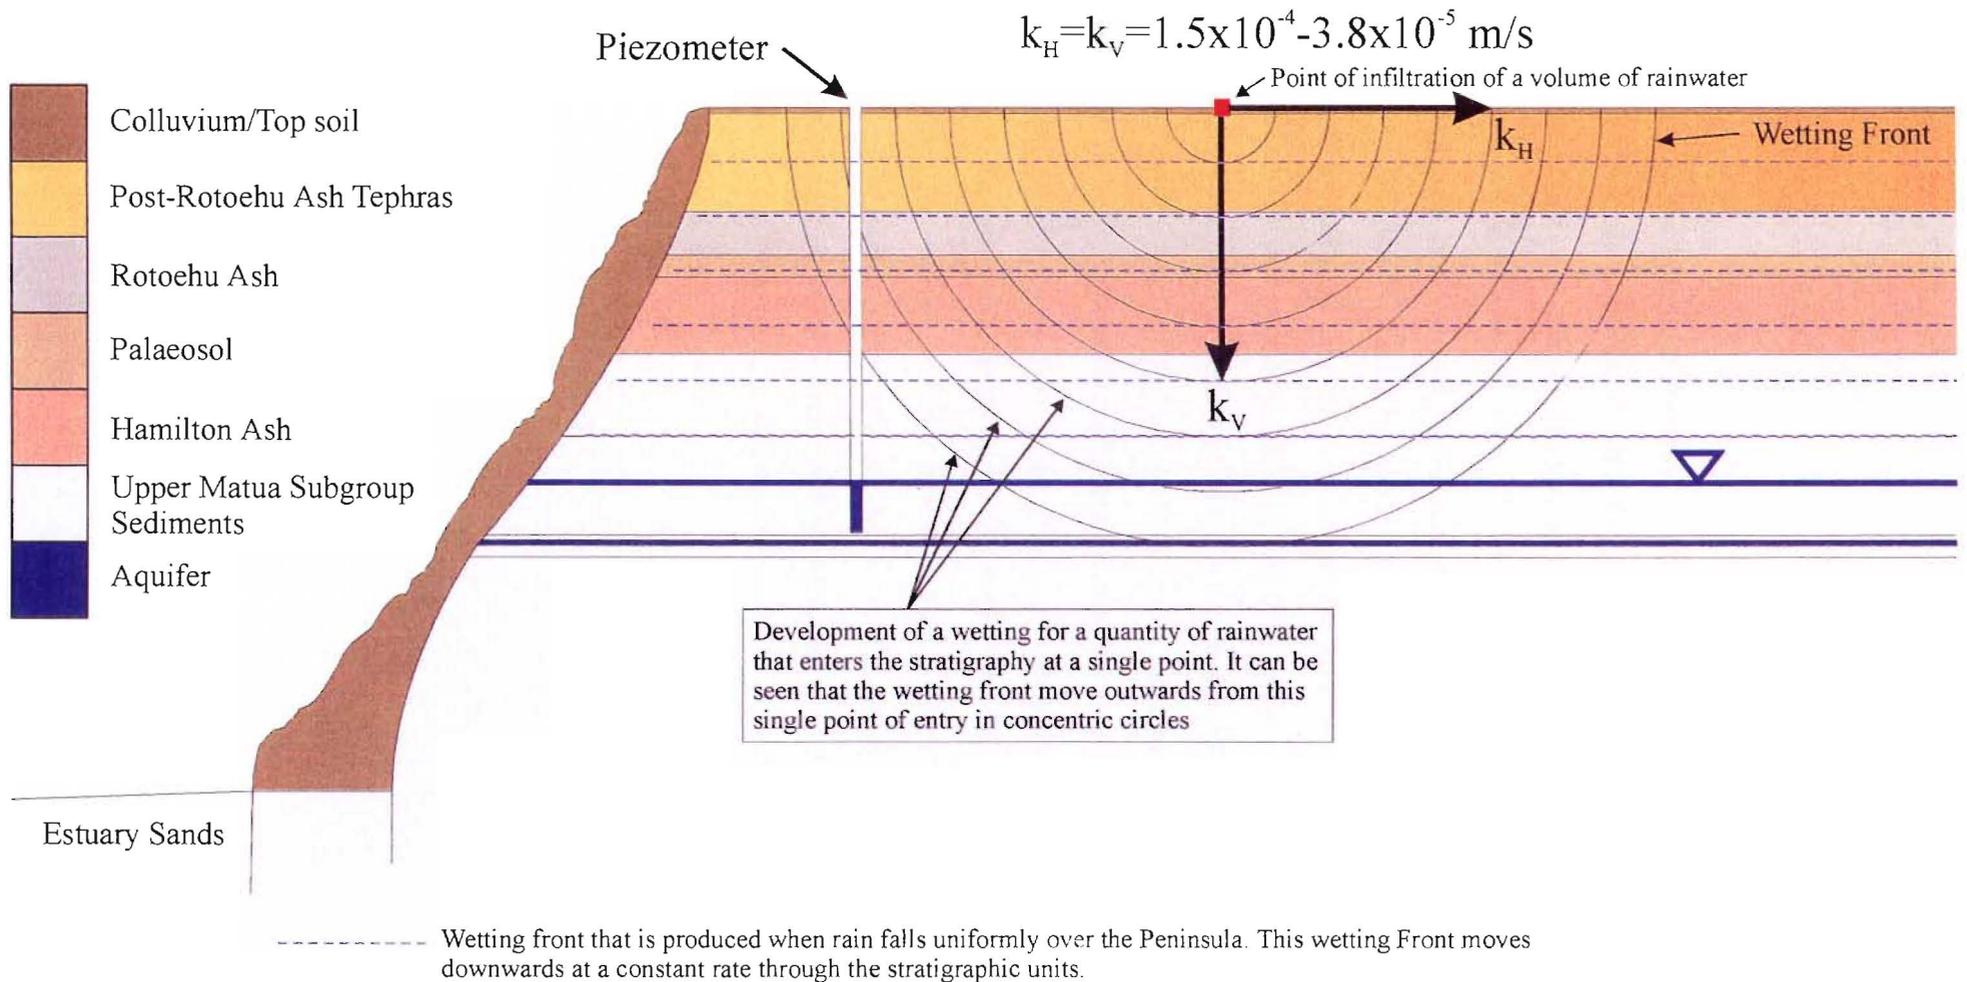
Figure 5.4 Construction of a wetting front from lag time response data in which the vertical permeability of the soil mass is equal to the horizontal.

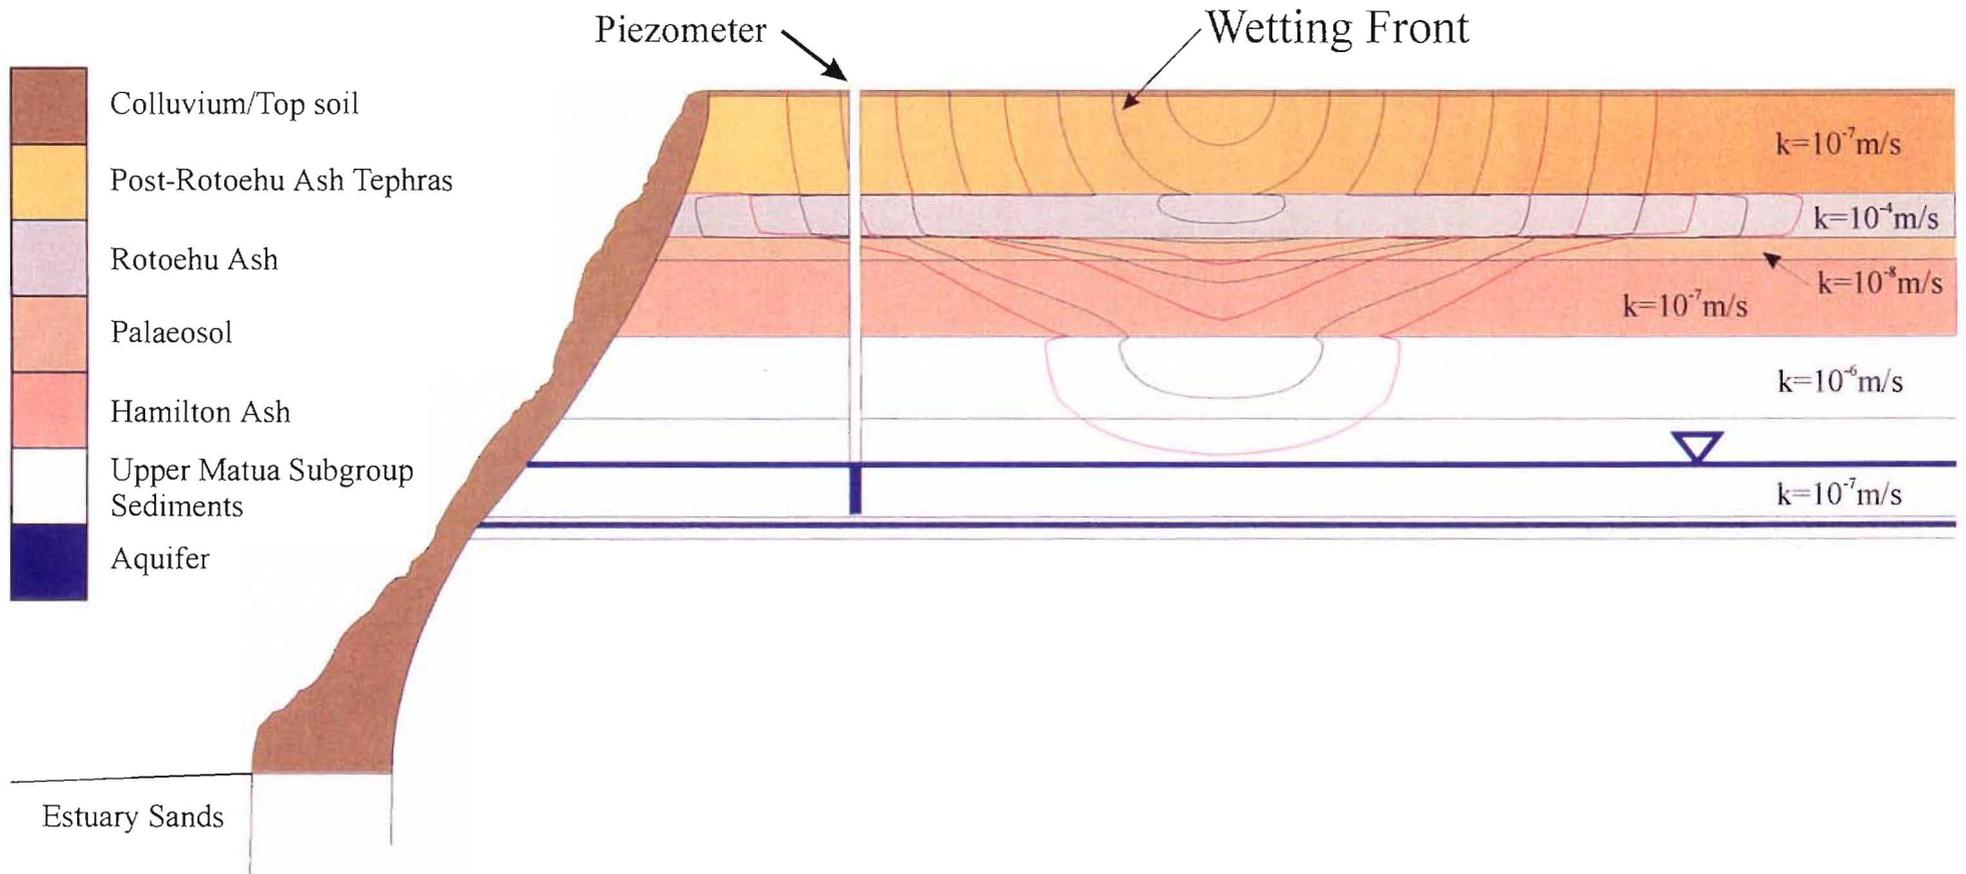
Figure 5.5 Construction of a wetting front related to differing permeabilities for the geologic units of the soil profile. It can be seen that the wetting front moves faster in more permeable units than less permeable. This has the overall affect that lateral movement of soakage water will be greater than the vertical infiltration.

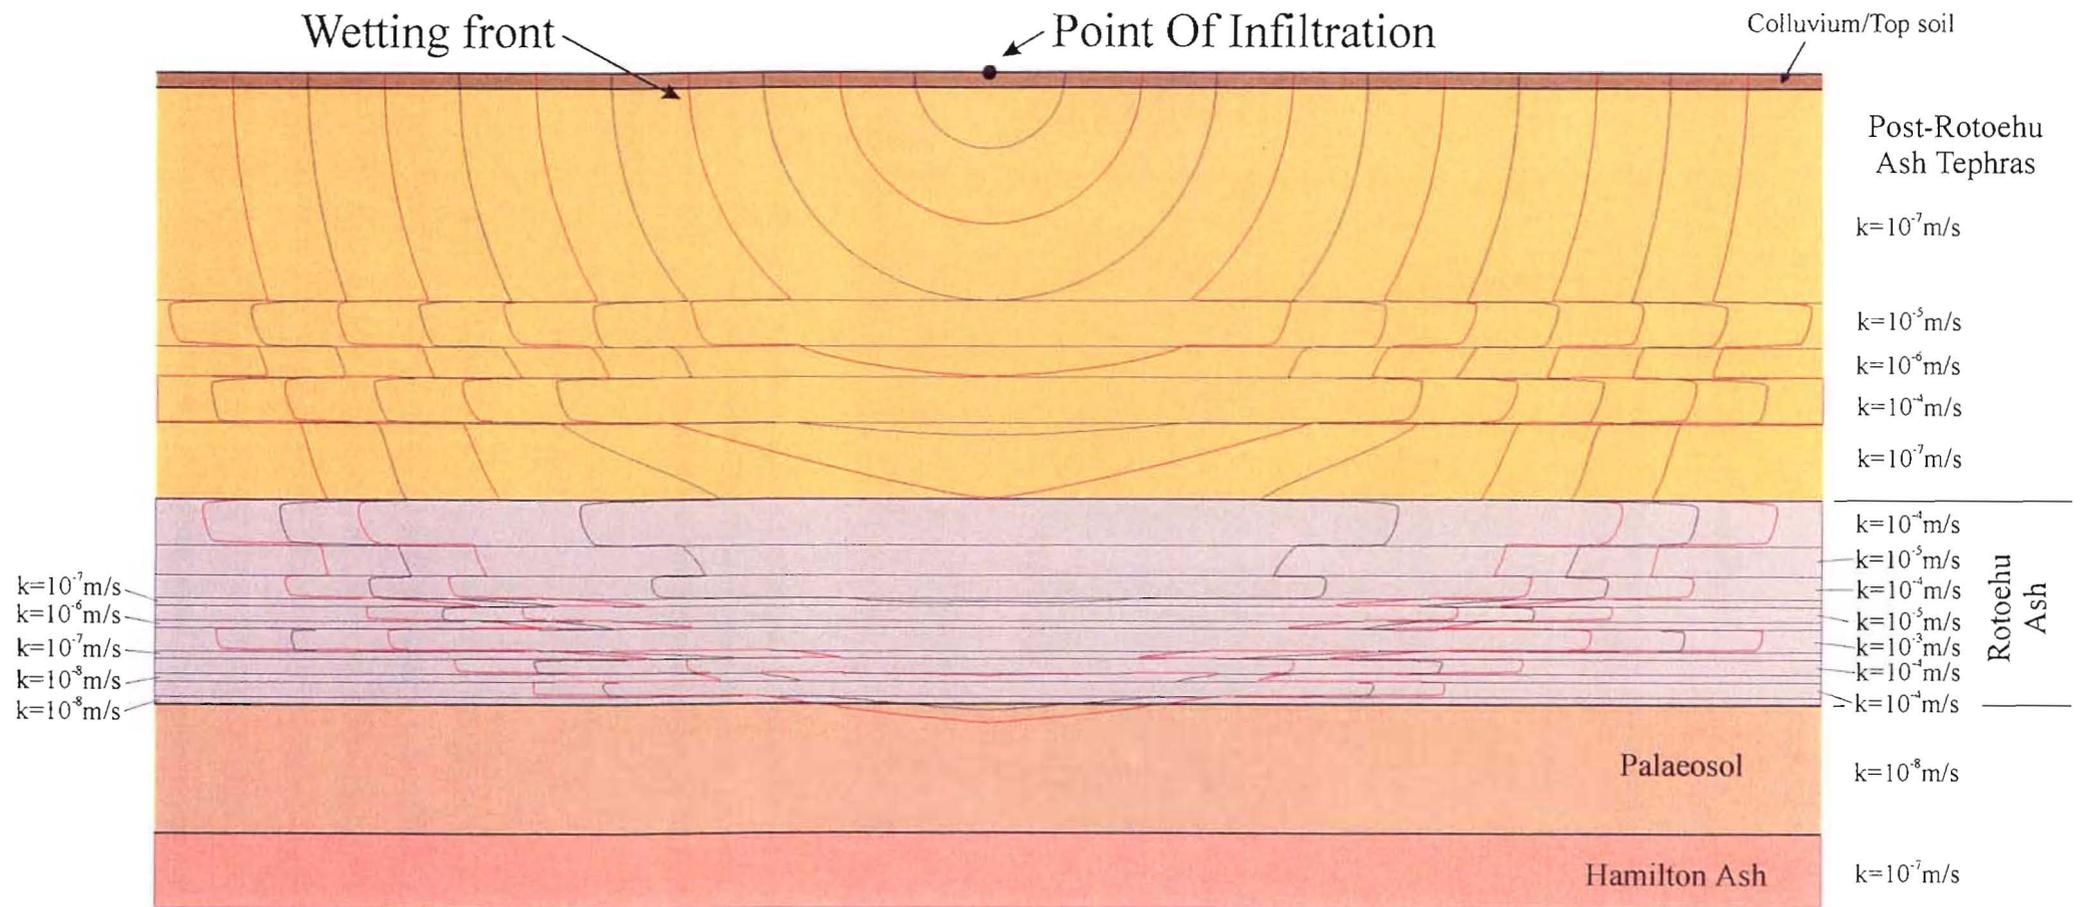
Figure 5.6 A schematic representation of permeabilities associated with the beds of the Post-Rotoehu Ash Tephra, Rotoehu Ash, Palaeosol, and Hamilton Ash. The diagram represents the behavioural characteristics of a volume of water as it infiltrates the soil mass by the use of a wetting front model. The wetting front can be seen to be stepping out in beds with a higher permeability compared to those with a lower permeability. The result of this means that there will be greater lateral flow within the more sandy-higher permeability beds.
