**A GEOTECHNICAL
CHARACTERISATION OF VOLCANIC
SOILS IN RELATION TO COASTAL
LANDSLIDING ON THE MAUNGATAPU
PENINSULA, TAURANGA, NEW
ZEALAND**

A Thesis
submitted in partial fulfillment
of the requirements for the Degree
of
Master of Science in Engineering Geology
at the
University of Canterbury
by
Robert Craig Oliver

**University of Canterbury
1997**

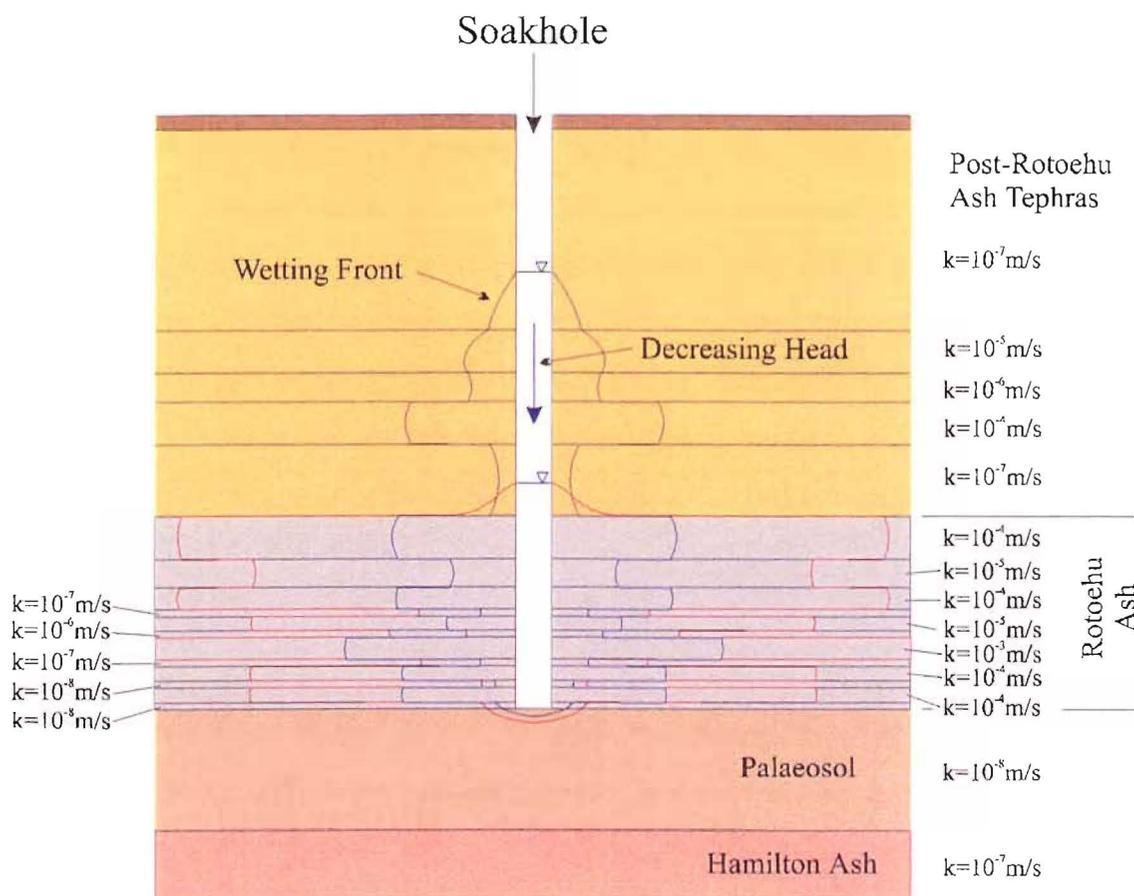
Figure 5.7 Demonstrated how the soakholes provides direct access for the soakage water to enter the various beds of the Post-Rotoehu Ash Tephra and Rotoehu Ash. This means the soakage water will tend to flow laterally along the higher permeability beds which is represented in the construction of a wetting front.

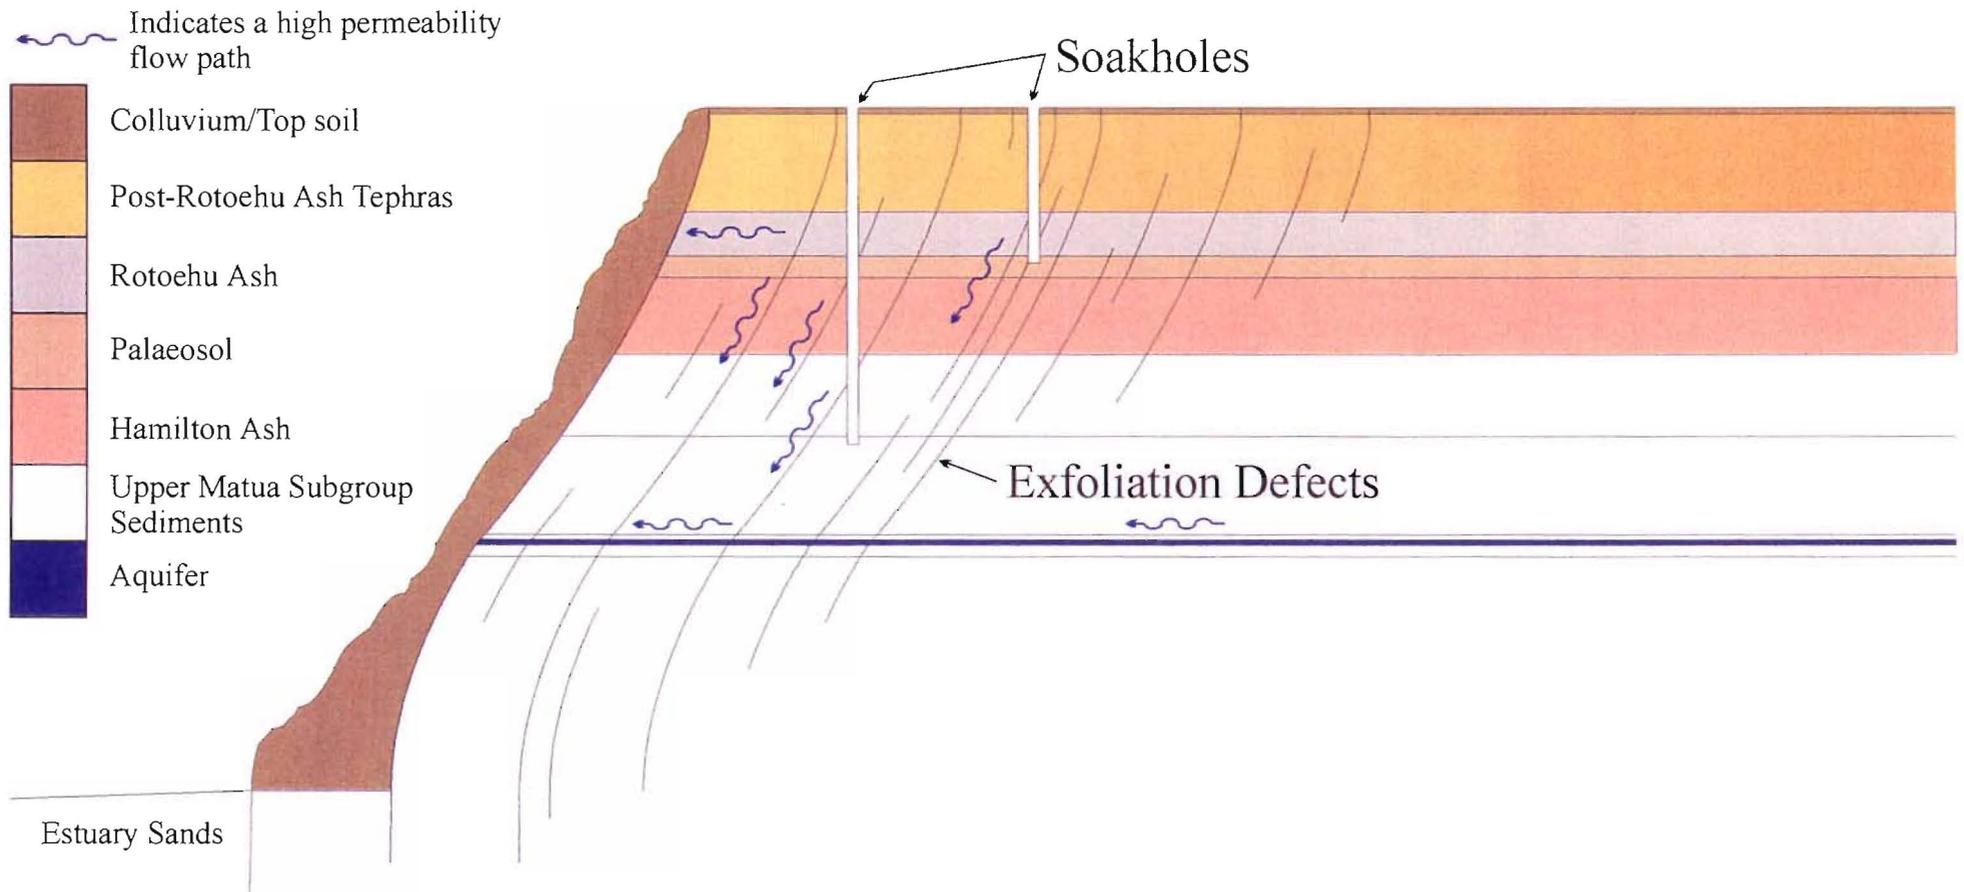
Figure 5.8 Exfoliation defects provide high permeability flow paths where soakage water infiltration time will be dramatically reduced close to the cliff edges (i.e. within ~50m). In addition soakholes will allow direct injection of this soakage water into exfoliation defects and fractures within the soil mass. The deeper the soakholes the greater number of structures that they will intercept, therefore further reducing the infiltration time.

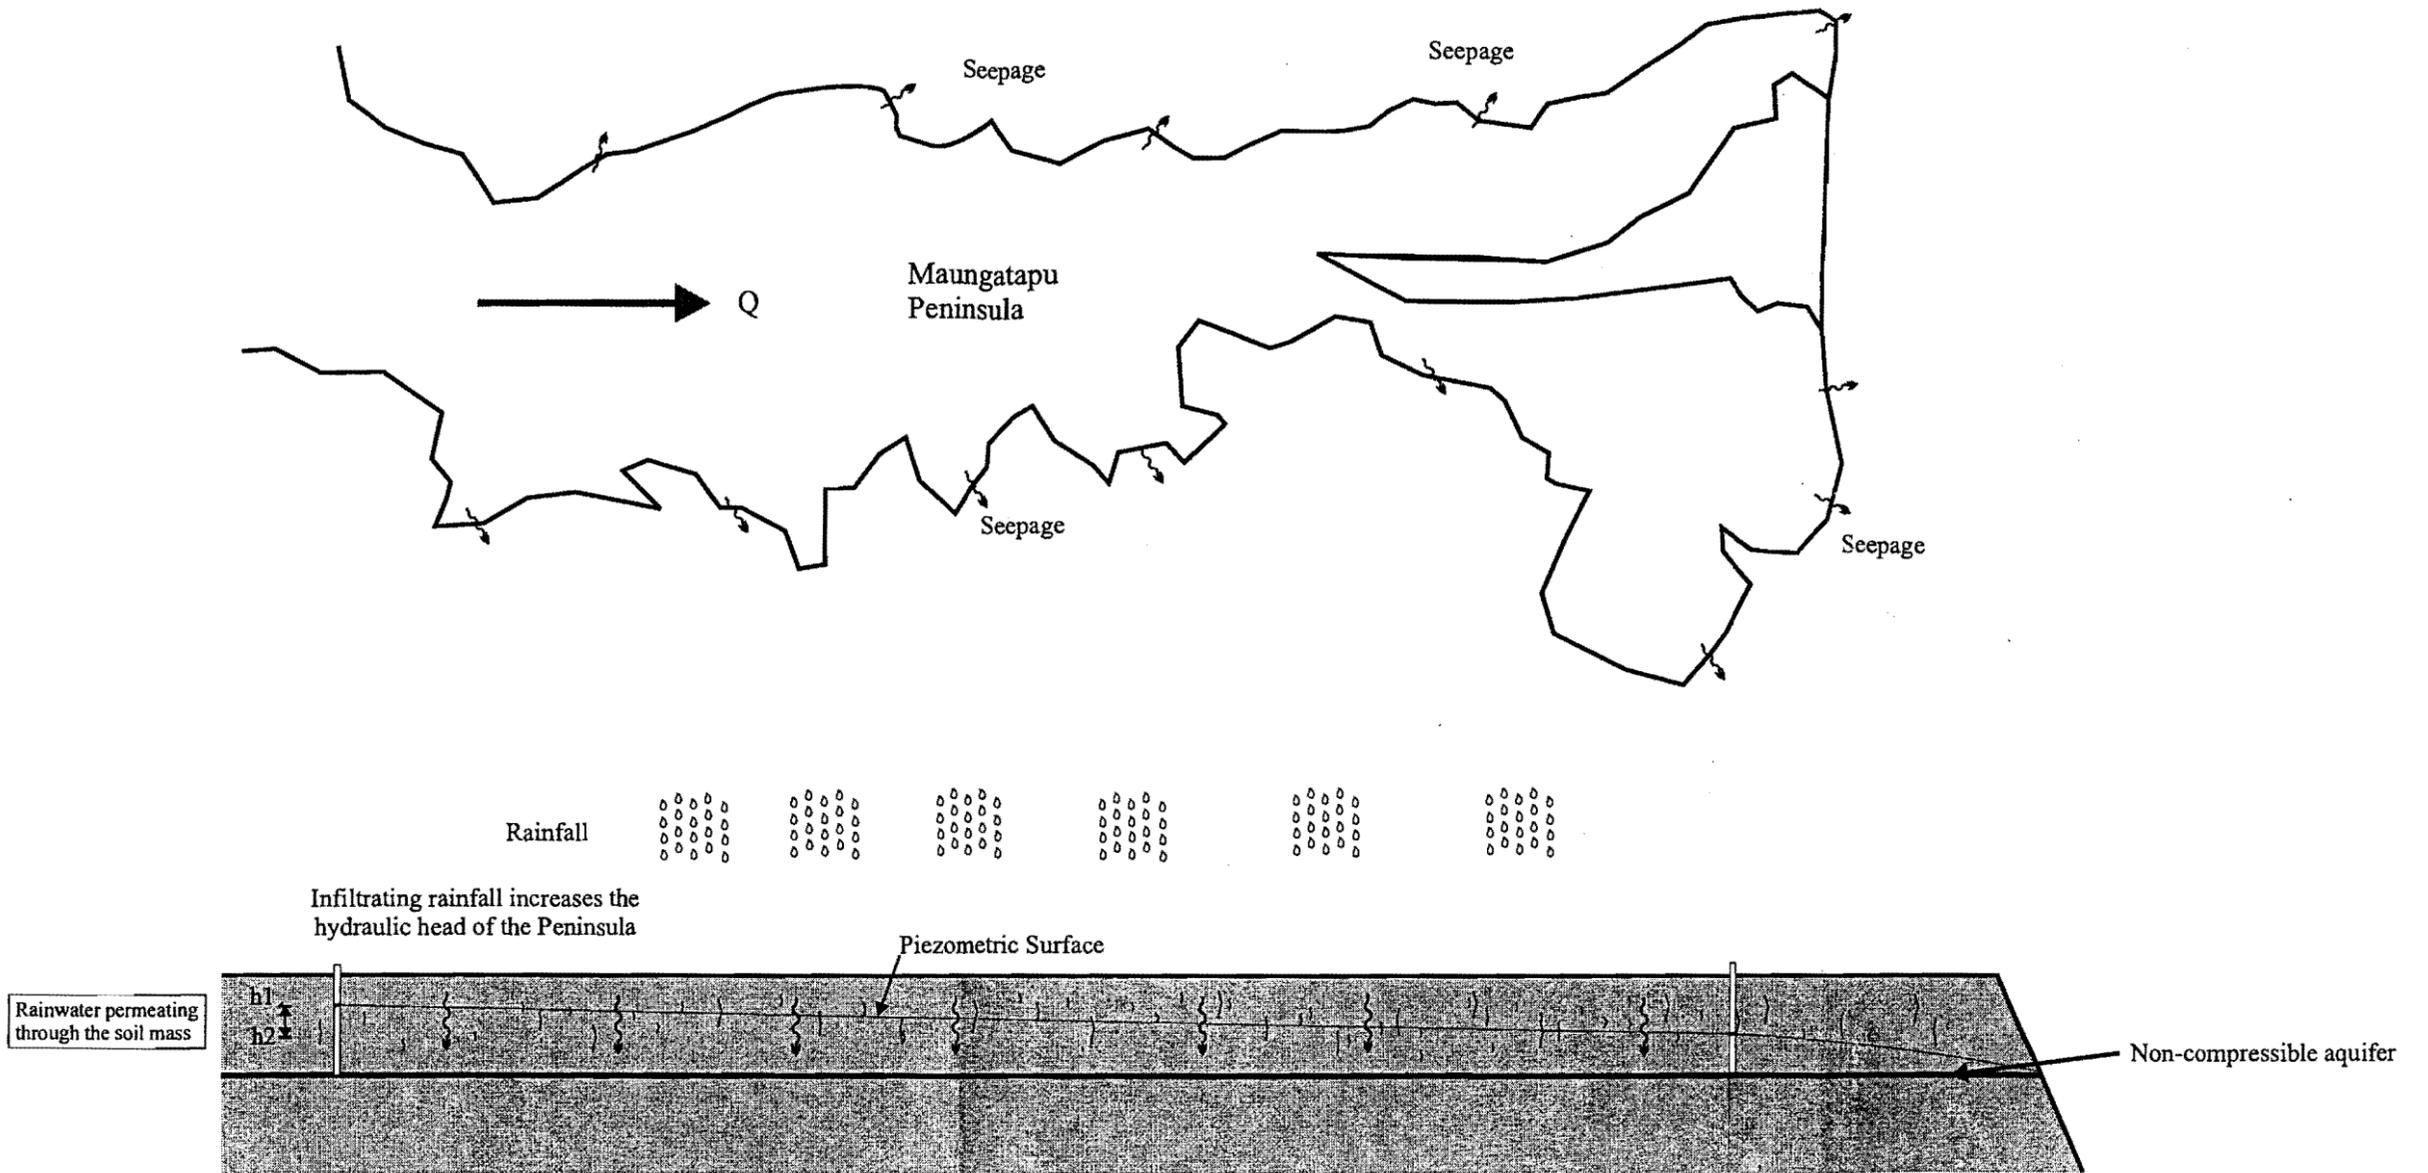
Figure 5.9 Schematical representation of a head recharge model where water permeating through the soil mass induces a pressure wave. This pressure wave can travel rapidly through the aquifer and lower section of the Cross-bedded sequence, resulting in an increase in pore water pressures at the cliff edge.

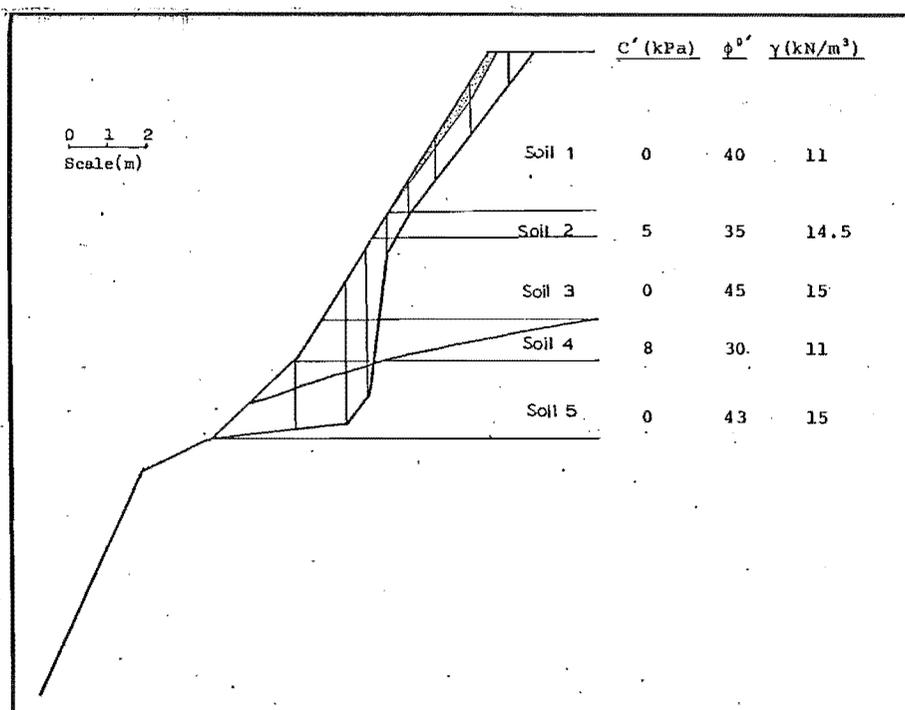
Figure 5.11 Soil profile for stability analysis from Bird (1981).

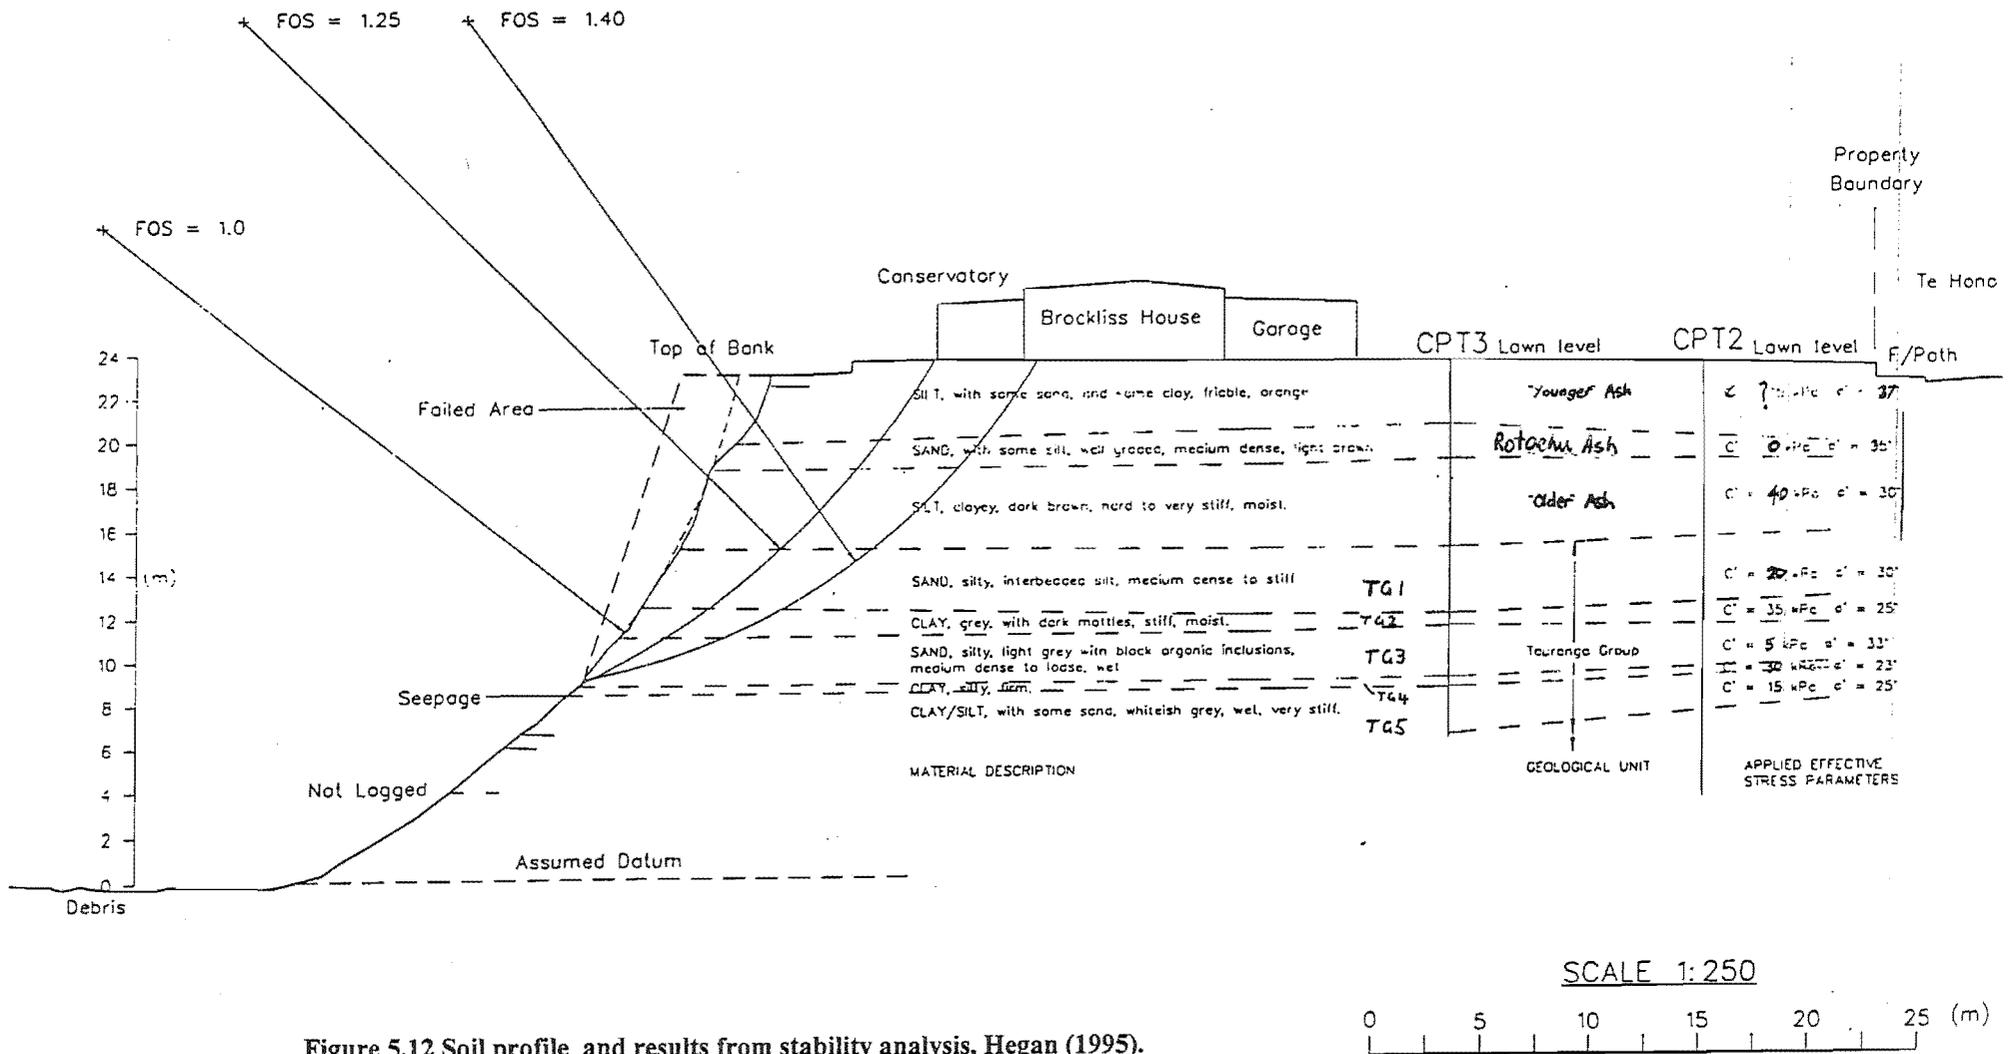
Figure 5.12 Soil profile and results from stability analysis, Hegan (1995).

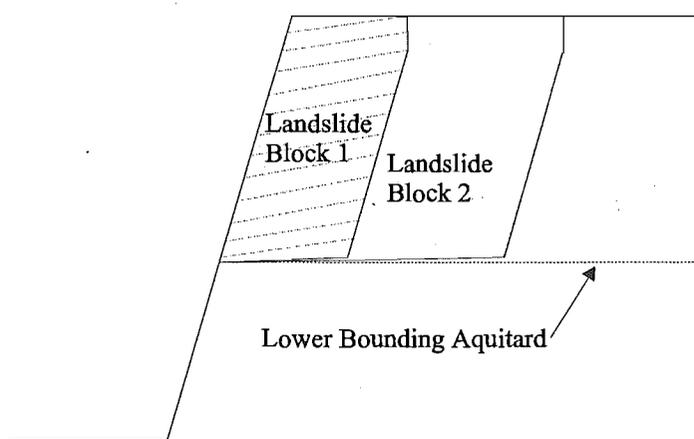
Figure 5.14 Schematical representation of differing sized landslide blocks used to determine how much the factor of safety increases with increasing block size.

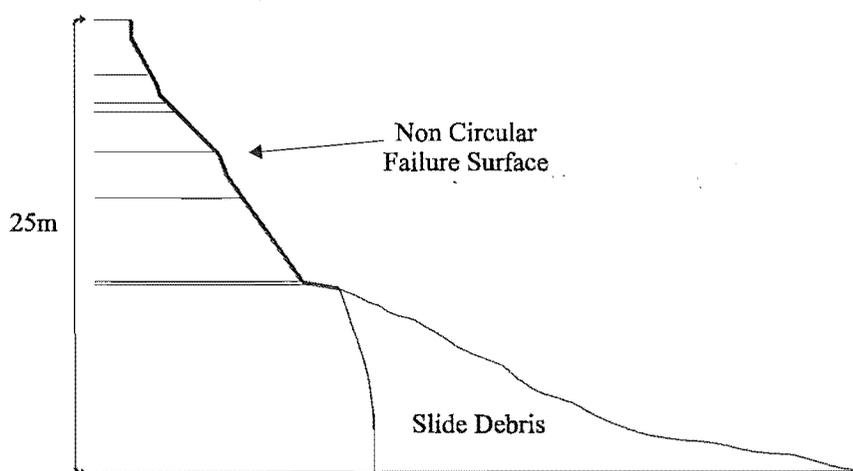
Figure 5.15 Schematic representation of a non-circular failure surface from 85 Te Hono Street.

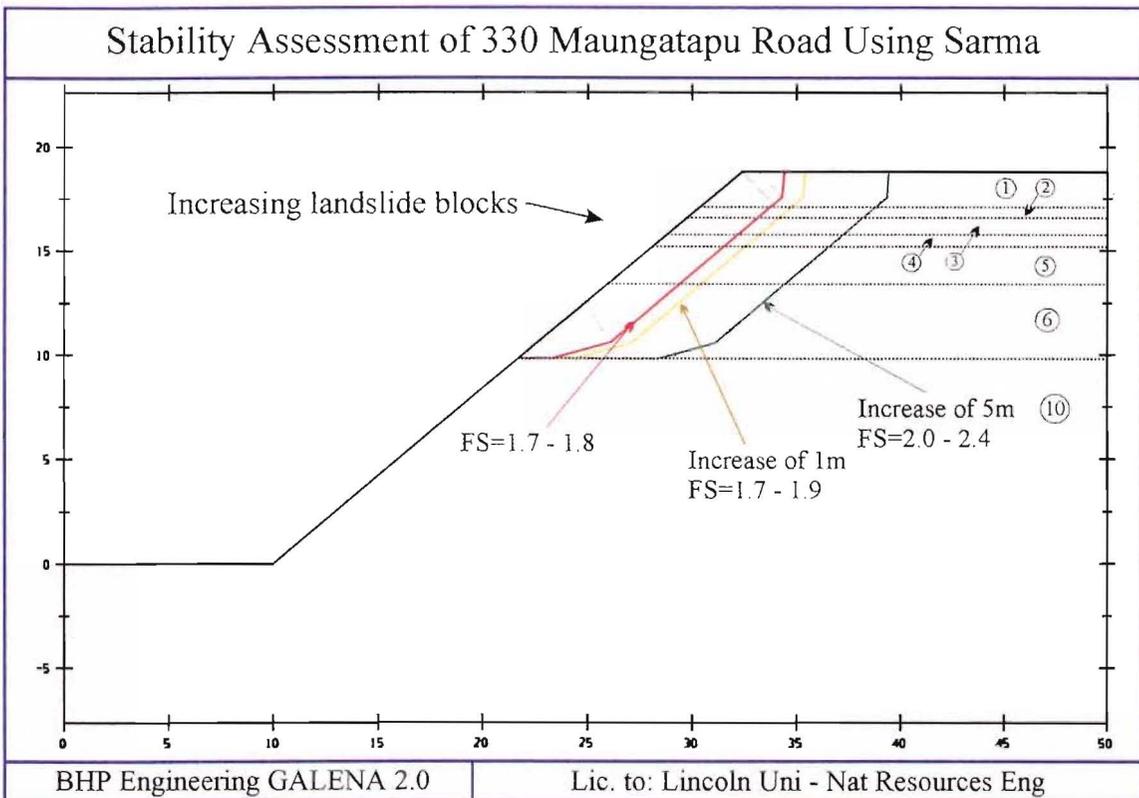
Figure 5.21 Determination of the effect an increasing landslide block size has on the factor of safety for 330 Maungatapu Road.

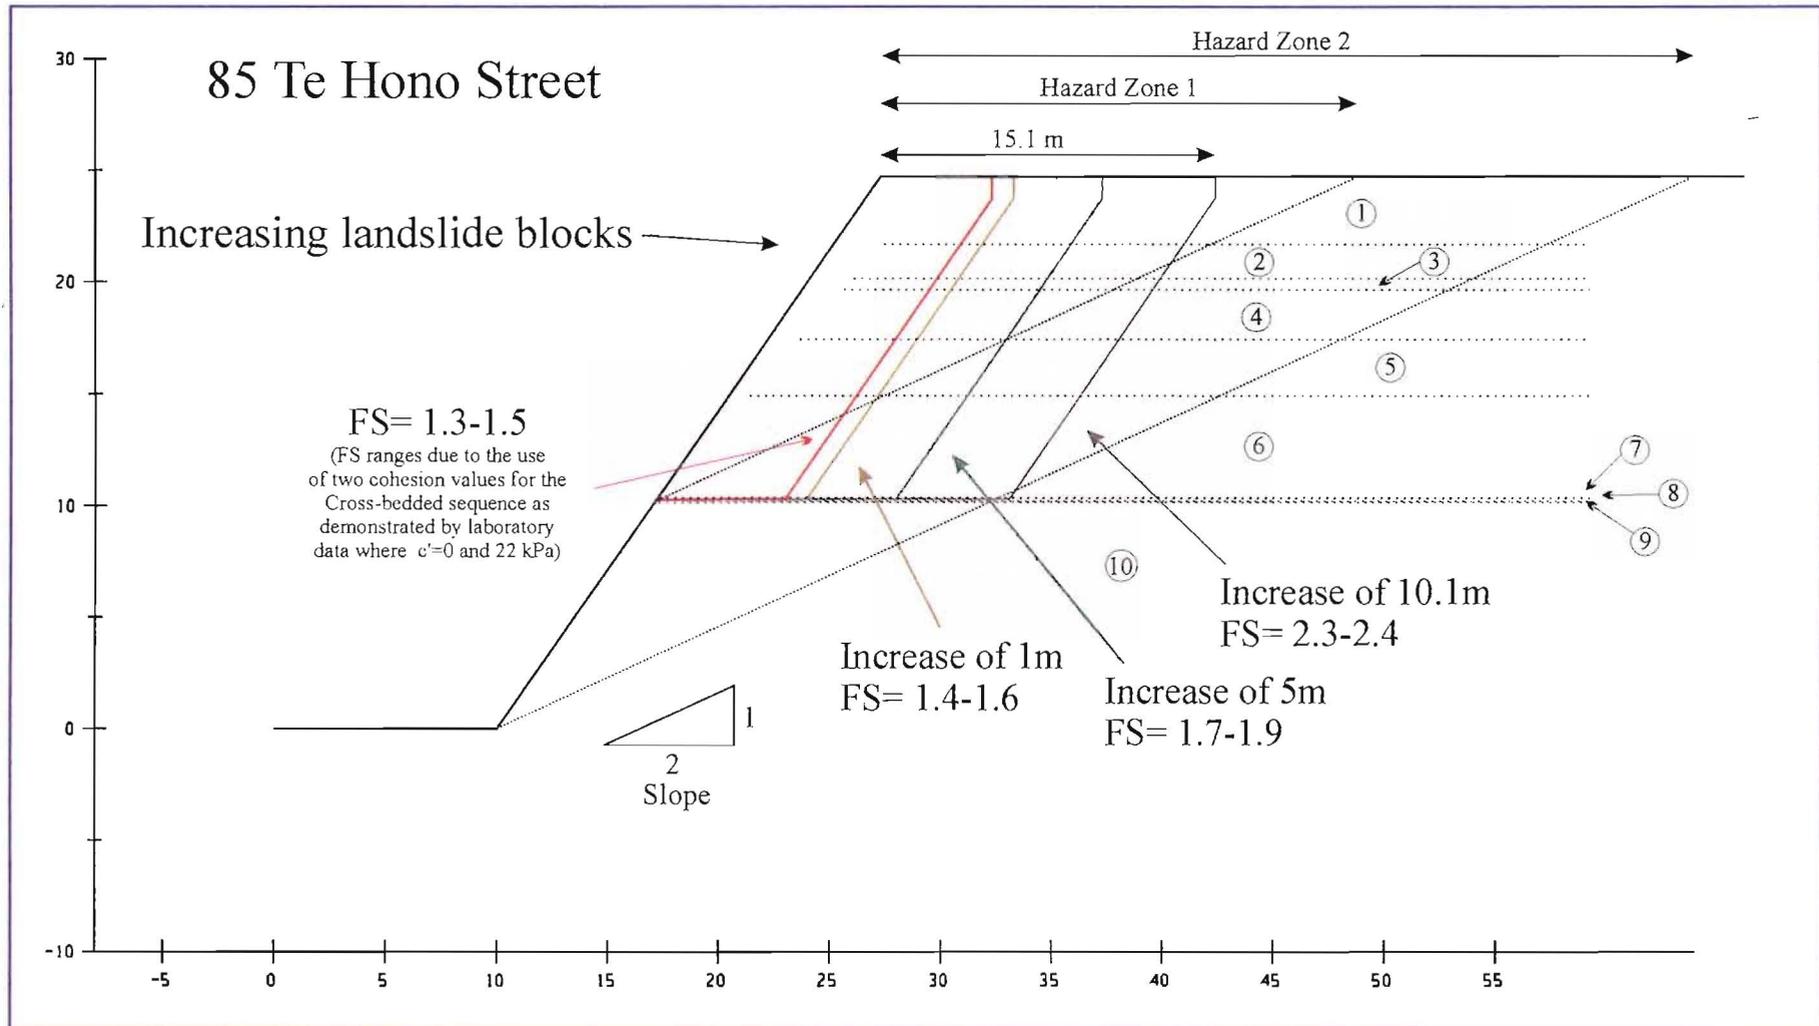
Figure 5.22 Assessment of the validity of the set back distance considering a slope angle of 2H:1V. It can be seen that the 2H:1V slope projected up from the base of the cliff lies approximately 24m inland from the largest proposed landslide block size (15.1m back from the cliff edge). This landslide block yields a FS=2.3-2.4 indicating that the 2H:1V slope is far too conservative a guideline to be used for assessment proposes.

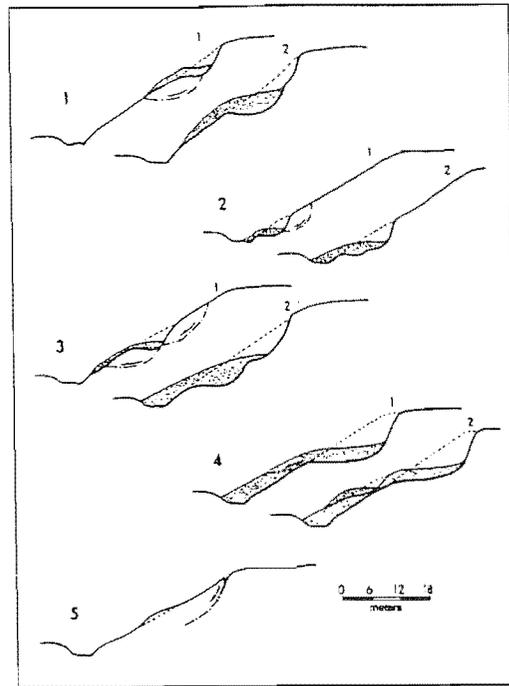
Figure A2.1 Section through landslides showing different distributions of activity:

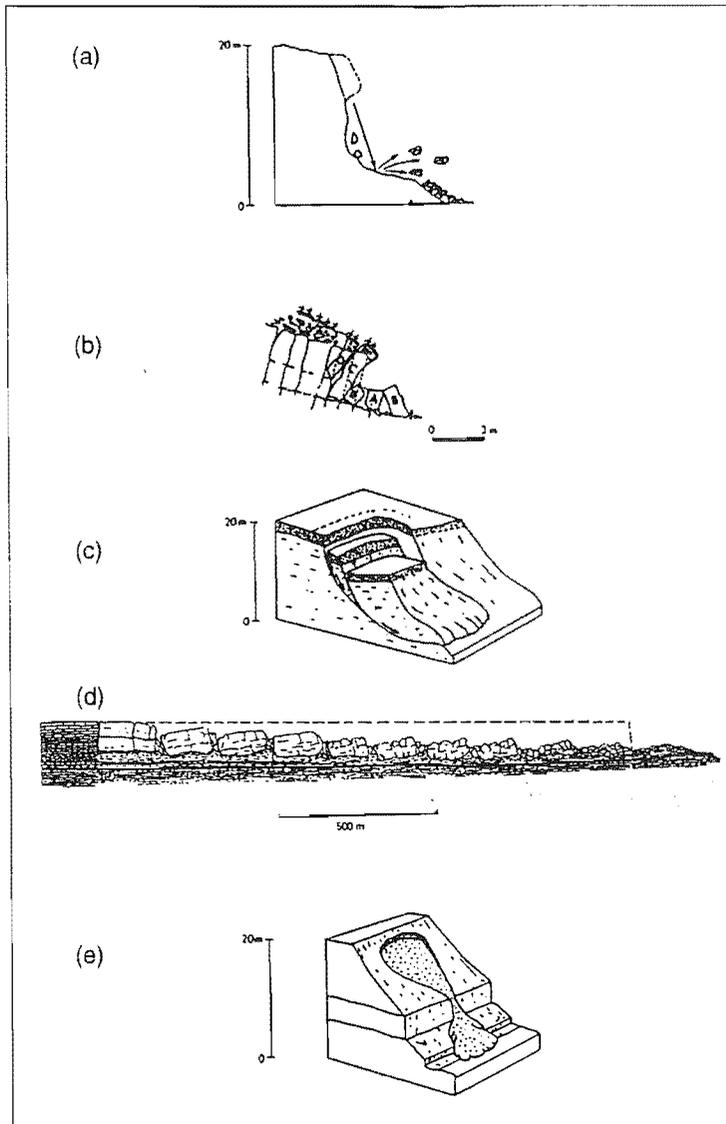
Figure A2.2 Types of landslides: (a) fall, (b) topple, (c) slide, (d) spread, (e) flow. Broken lines indicate original ground surfaces; arrows show portions of trajectories of individual particles of displaced mass (modified from Varnes 1978)

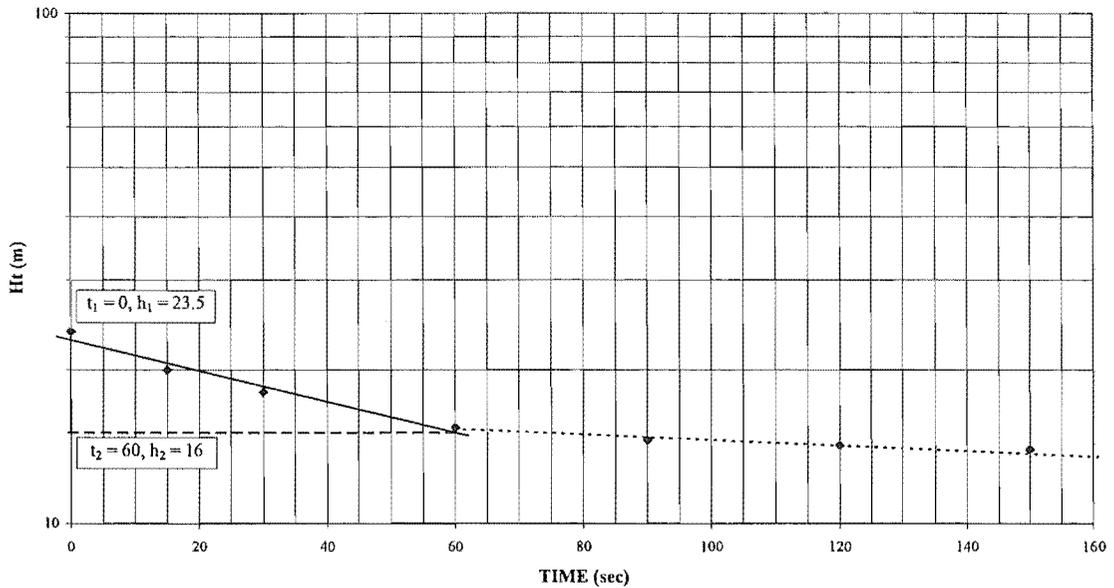
Figure A3.40 Plot to determine the relationship $(1/t) \ln(H_0/H_t)$.

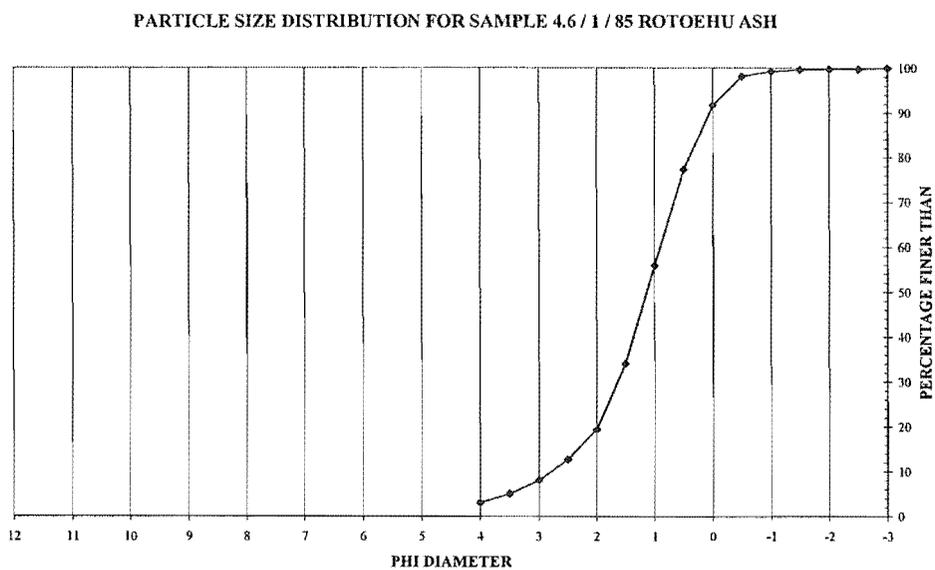
Figure A4.1 Grainsize distribution curve for 4.6 / 1 / 85 which is situated within the Rotoehu Ash.

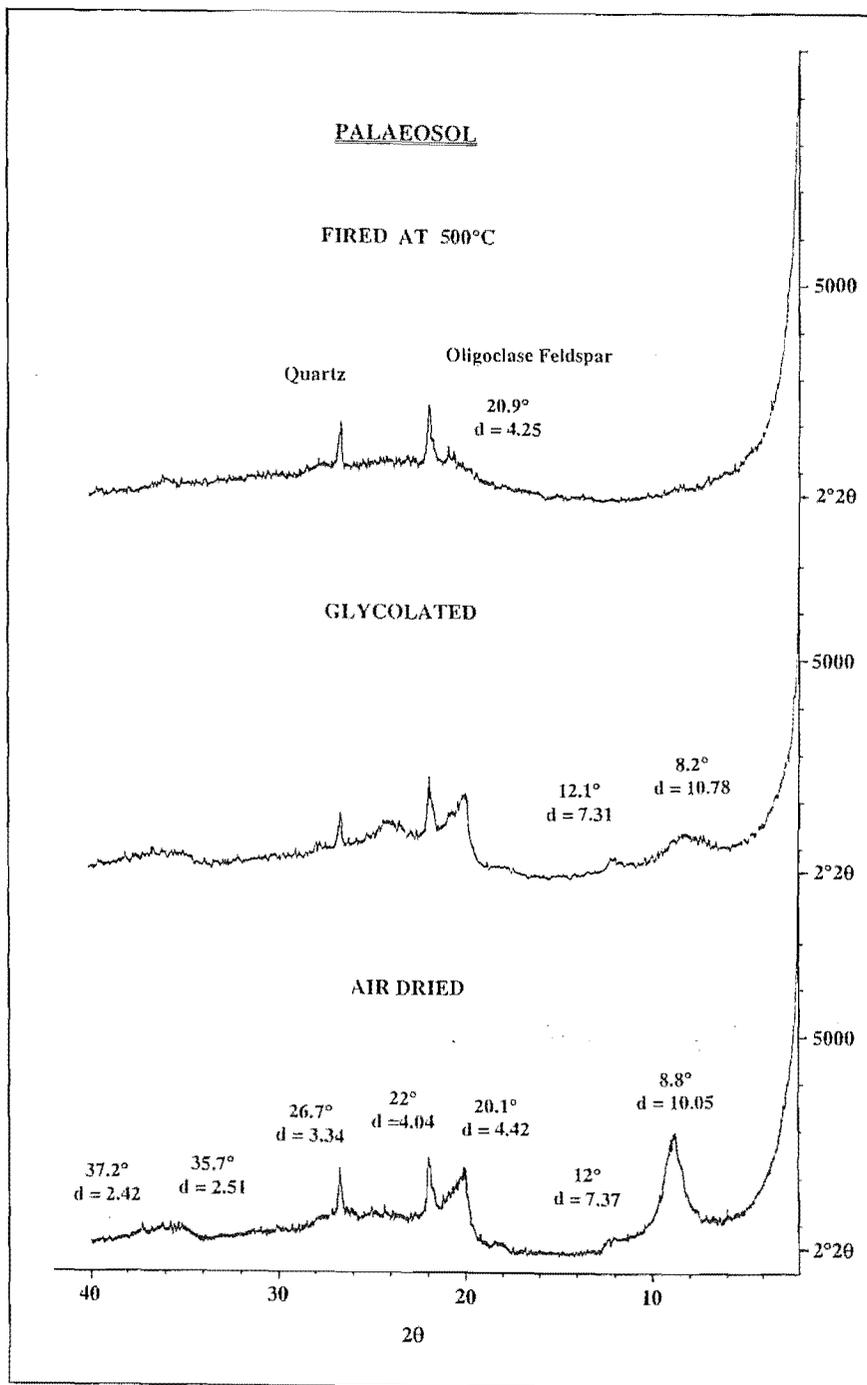
Figure A4.17 XRD profiles for the 9φ fraction of the Palaeosol

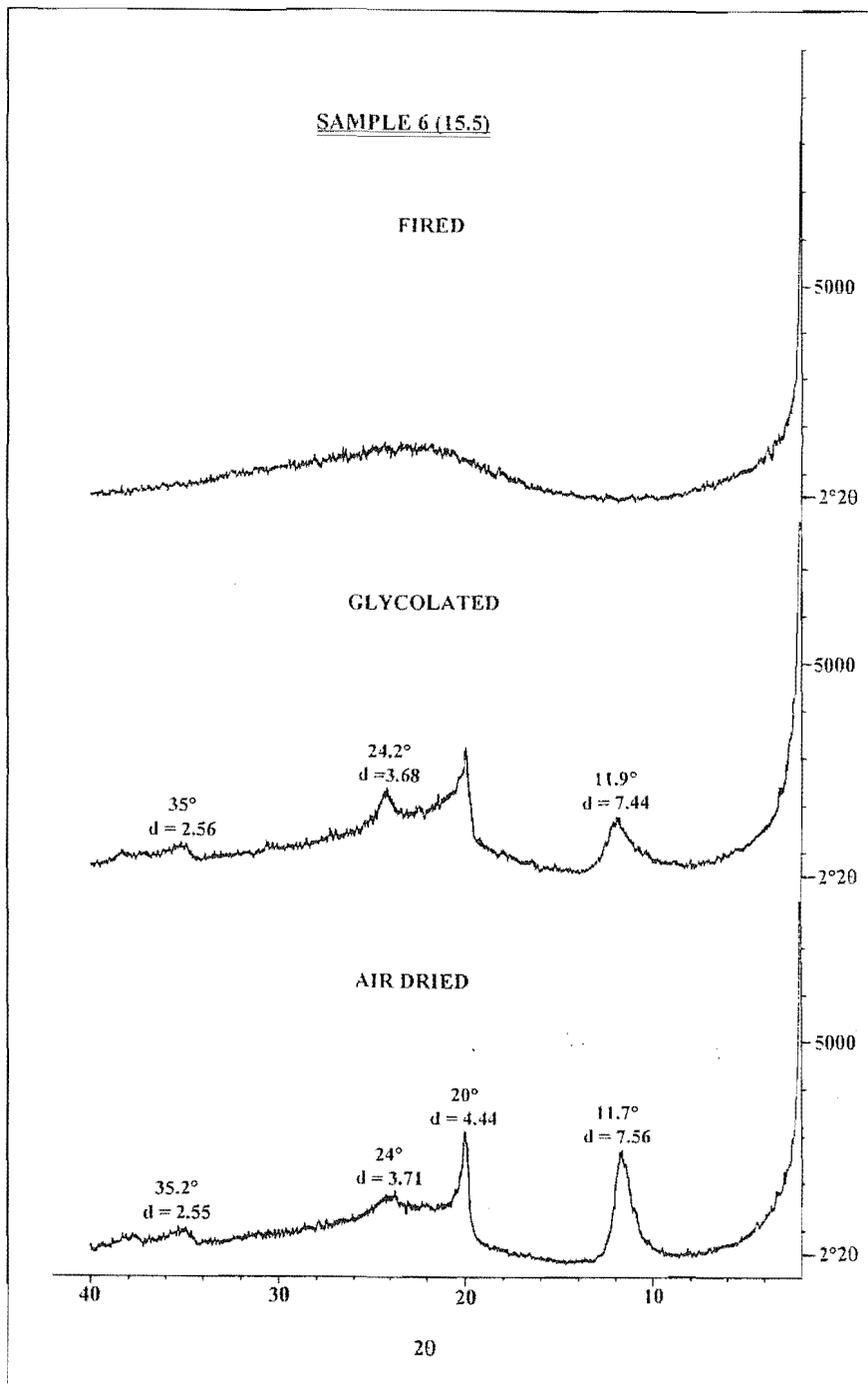
Figure A4.19 XRD profiles for sample 15.5 / 1 / 85 Cross-bedded section of the Upper Matua Subgroup

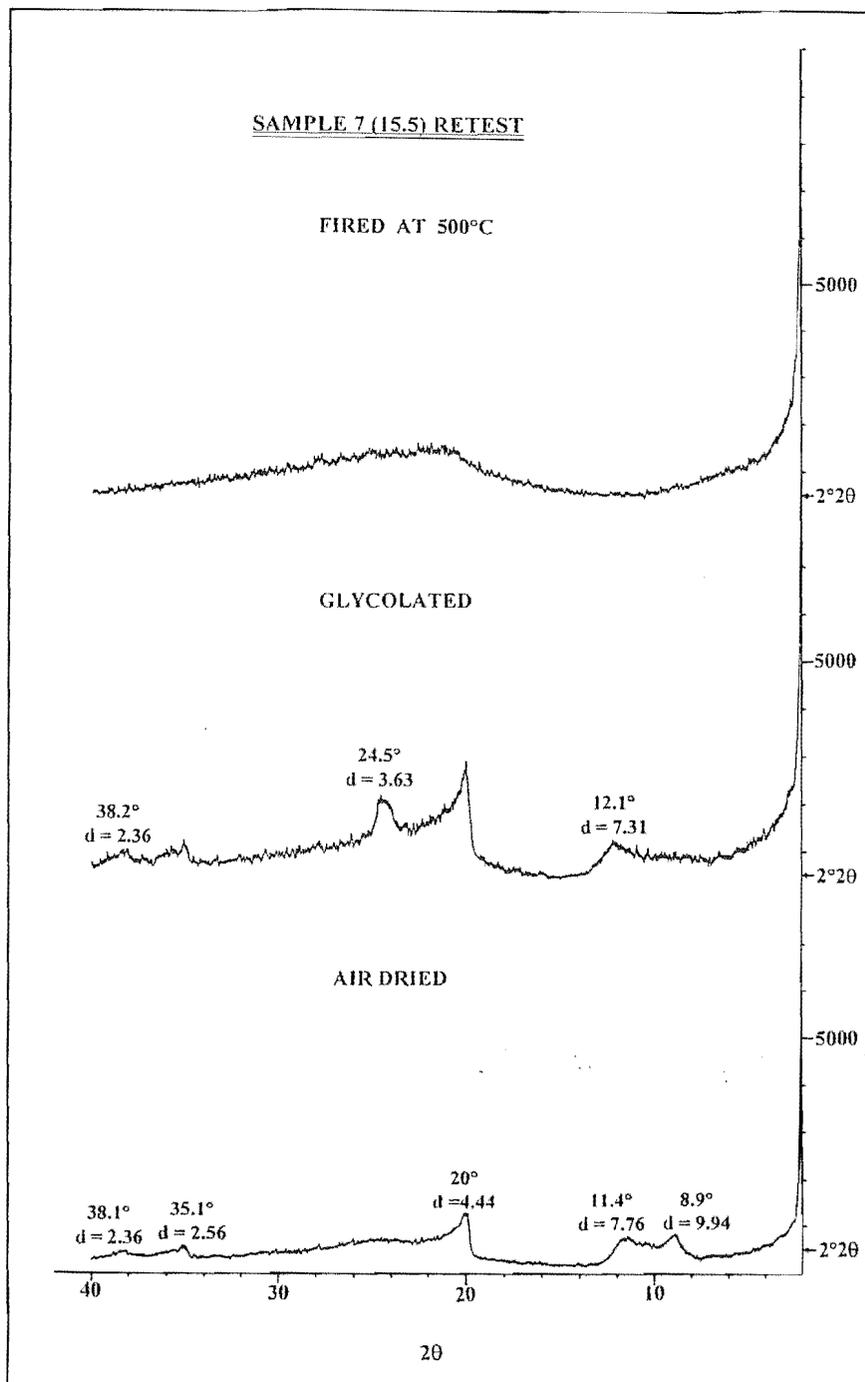
Figure A4.20 XRD retest profiles for the sample fired at 500°C, sample 15.5 / 1 / 85 Cross-bedded section of the Upper Matua Subgroup

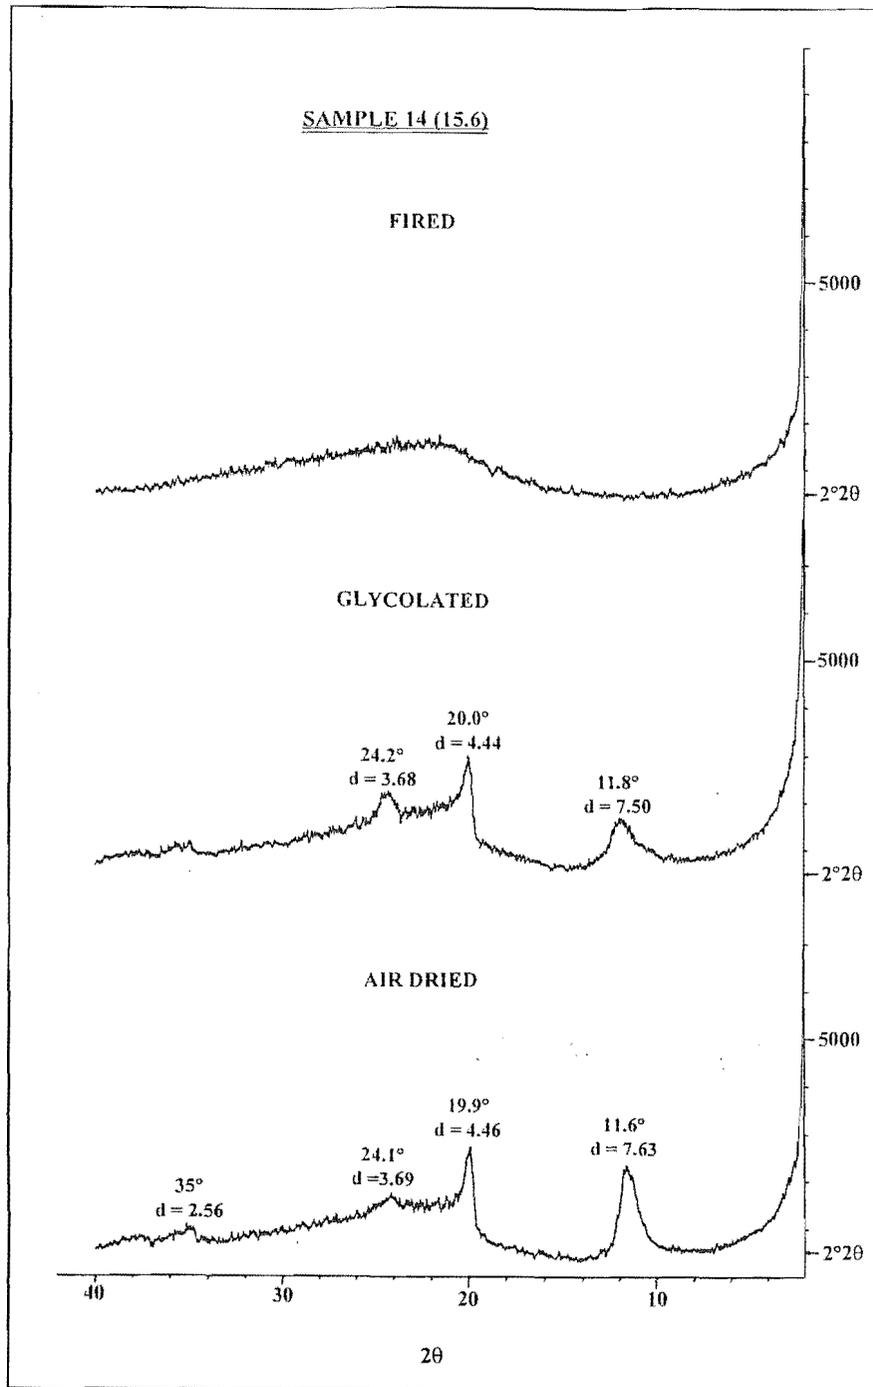
Figure A4.21 XRD profiles for sample 15.6 / 1 / 85 Cross-bedded section of the Upper Matua Subgroup

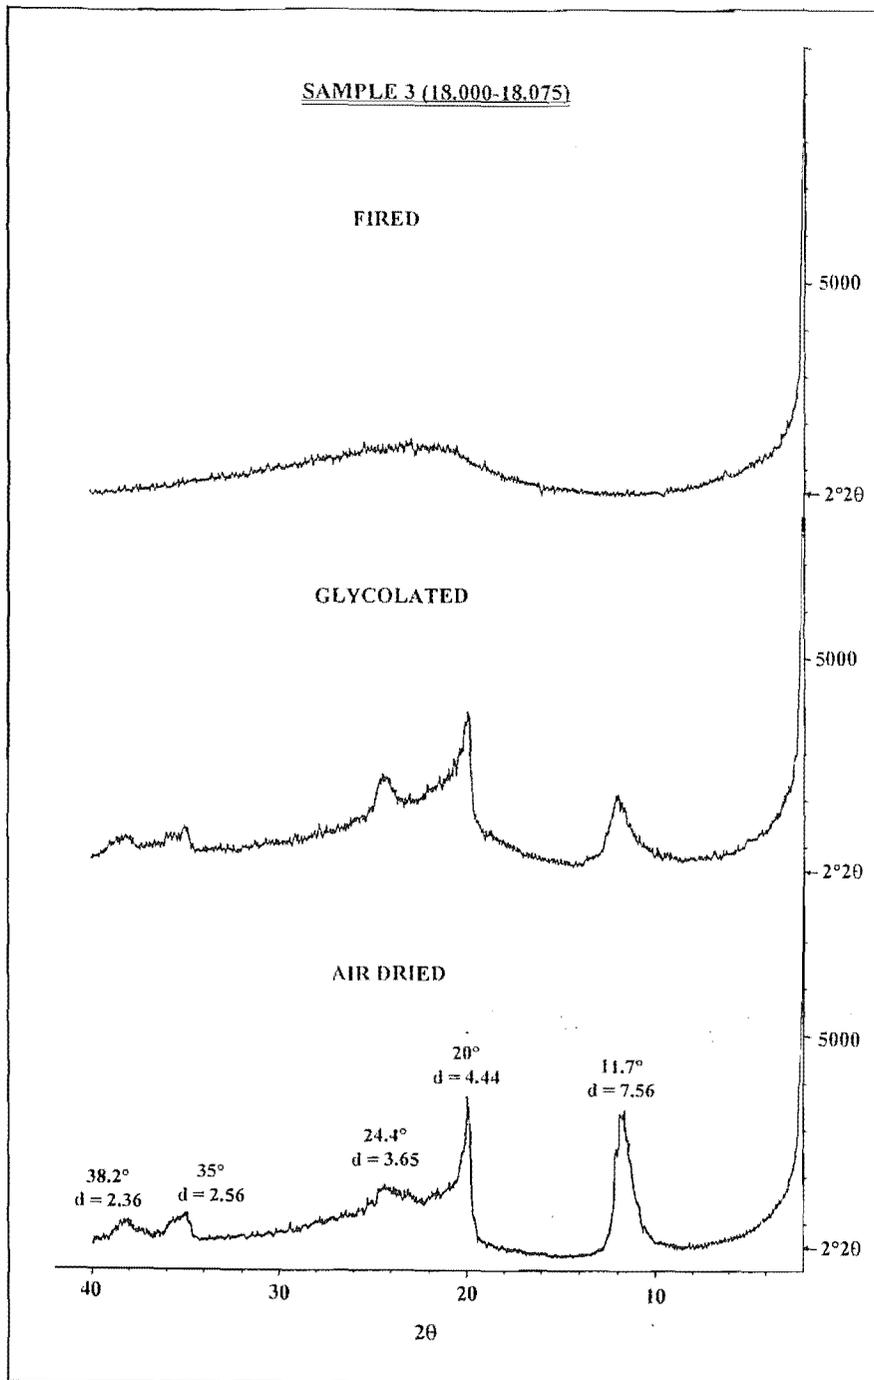
Figure A4.23 XRD profiles for the 9 ϕ fraction, sample 18.0-18.075 / 1 / 85 located within the lower bounding aquitard of the Upper Matua Subgroup

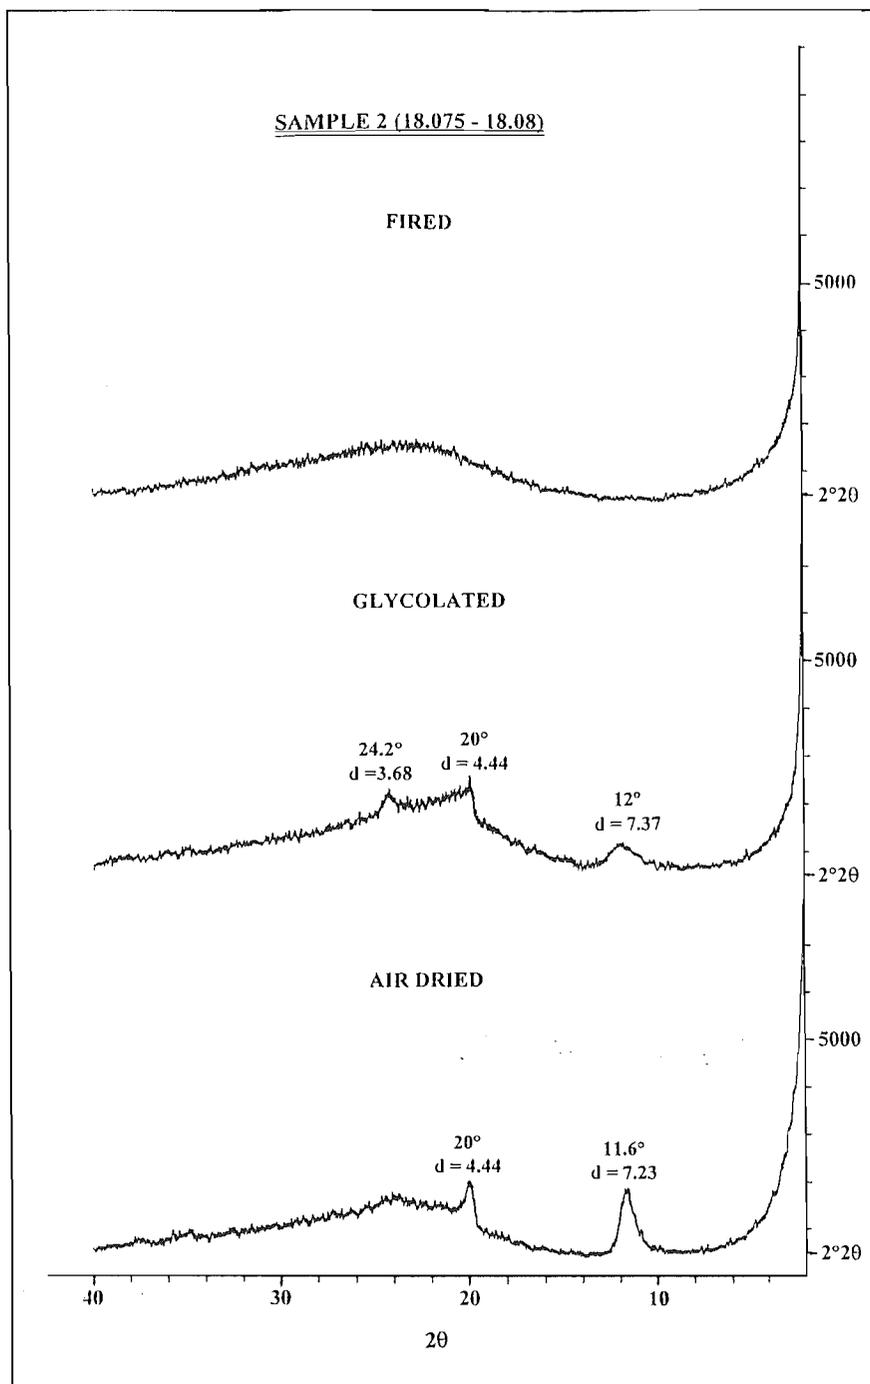
Figure A4.24 XRD profiles for sample 18.075-18.08 / 1 / 85 located within the lower bounding aquitard of the Upper Matua Subgroup
