**A GEOTECHNICAL
CHARACTERISATION OF VOLCANIC
SOILS IN RELATION TO COASTAL
LANDSLIDING ON THE MAUNGATAPU
PENINSULA, TAURANGA, NEW
ZEALAND**

A Thesis
submitted in partial fulfillment
of the requirements for the Degree
of
Master of Science in Engineering Geology
at the
University of Canterbury
by
Robert Craig Oliver

**University of Canterbury
1997**

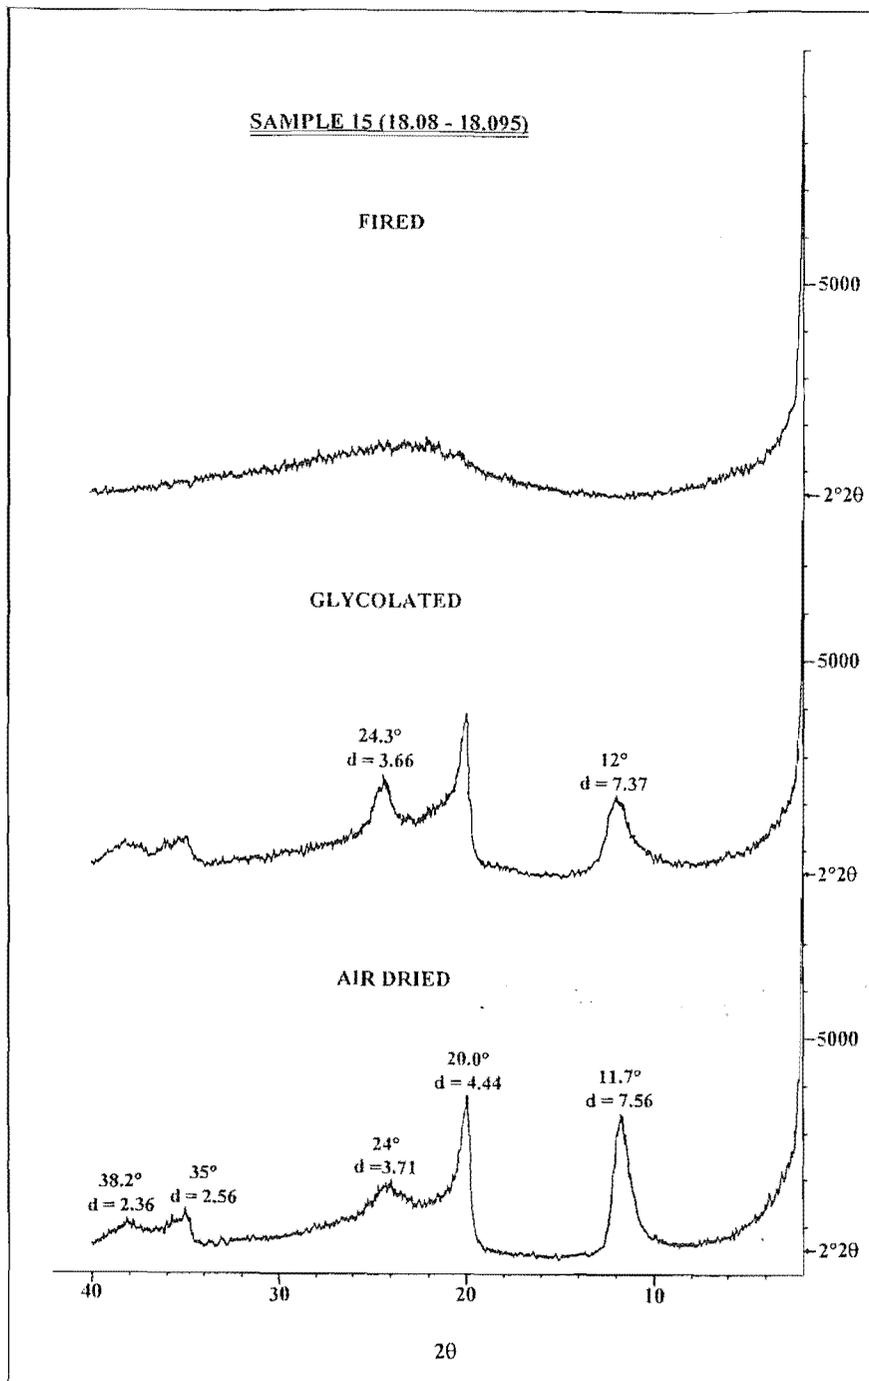
Figure A4.24 XRD profiles for the 8ϕ fraction, sample 18.08-18.095 / 1 / 85 located within the lower bounding aquitard of the Upper Matua Subgroup

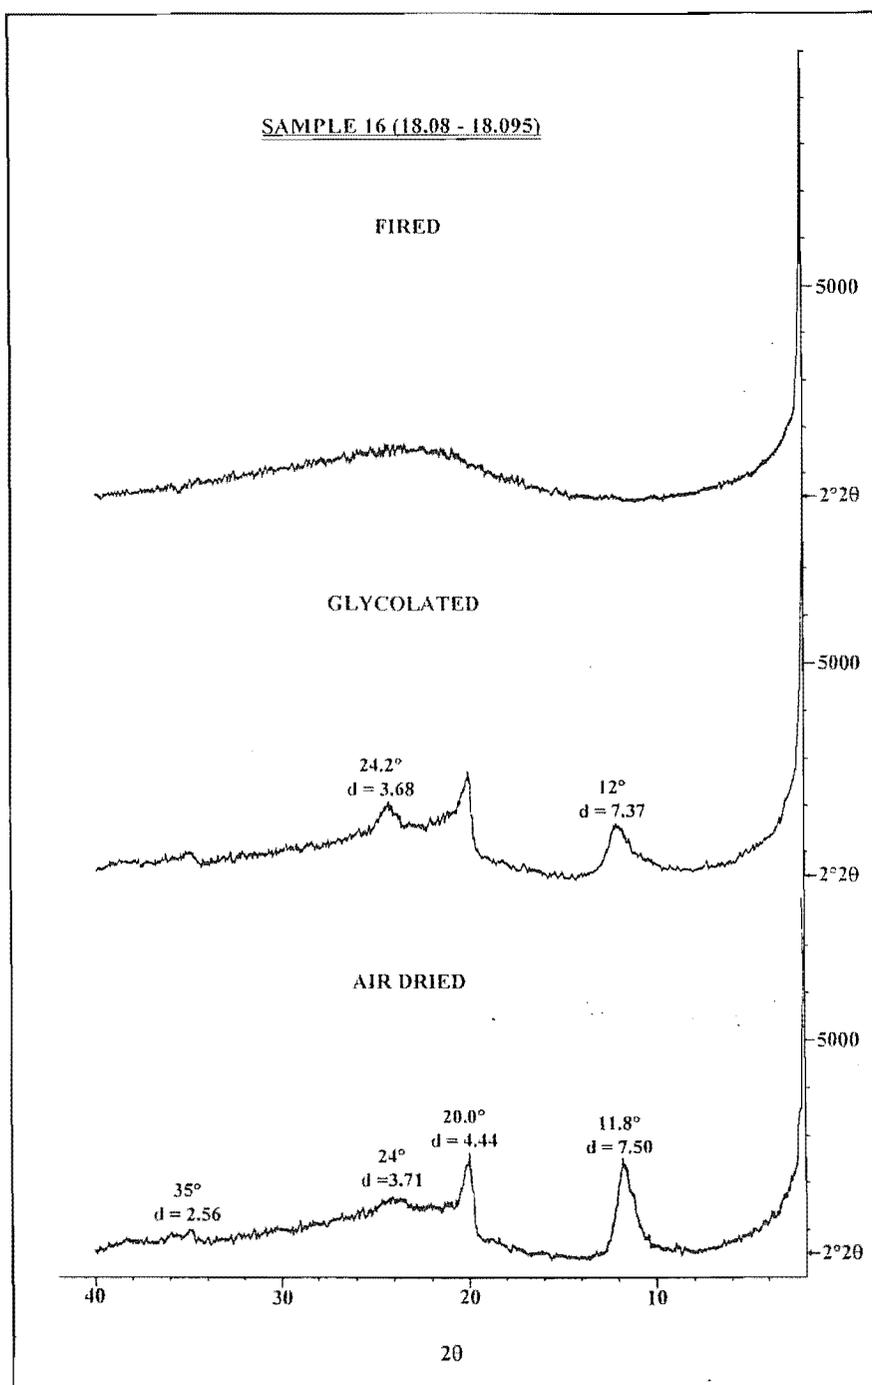
Figure A4.25 XRD profiles for the 9 ϕ fraction, sample 18.08-18.095 / 1 / 85 located within the lower bounding aquitard of the Upper Matua Subgroup

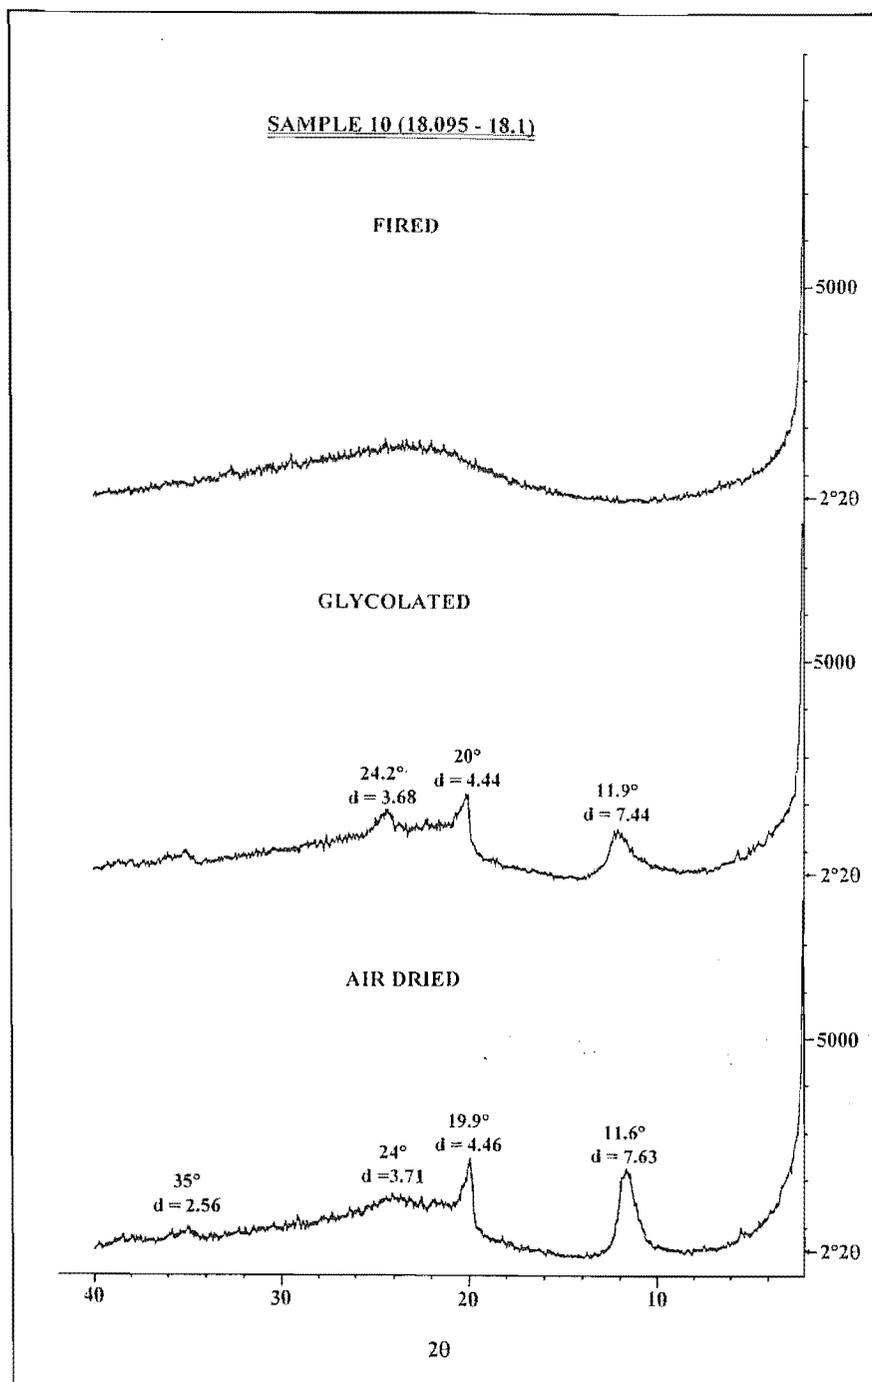
Figure A4.26 XRD profiles for sample 18.095-18.1 / 1 / 85 located within the lower bounding aquitard of the Upper Matua Subgroup

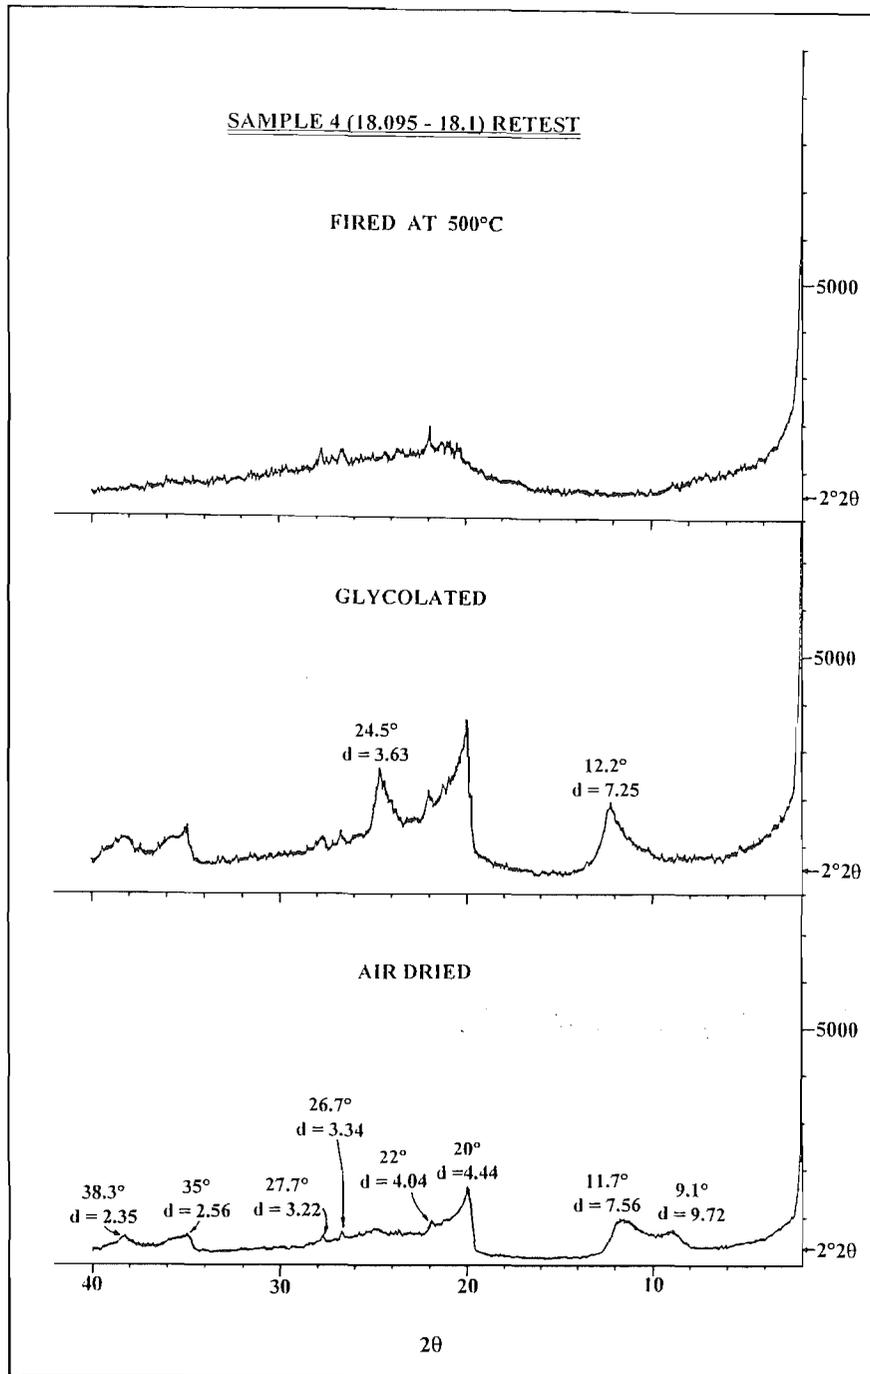
Figure A4.27 XRD retest profiles for the sample fired at 500°C, 18.095-18.1 / 1 / 85 located within the lower bounding aquitard of the Upper Matua Subgroup

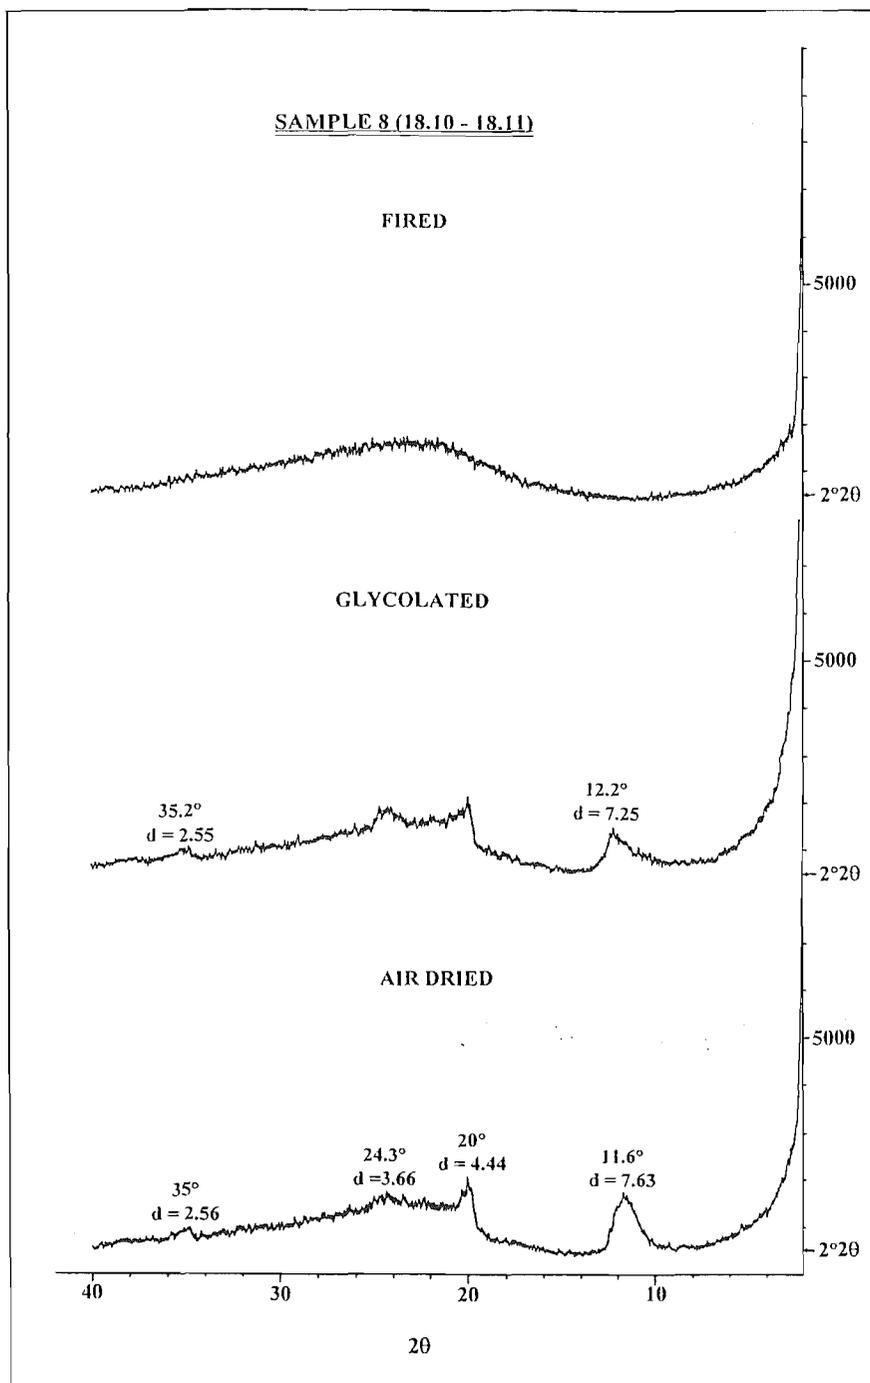
Figure A4.28 XRD for sample 18.10-18.11 / 1 / 85 located within the lower bounding aquitard of the Upper Matua Subgroup

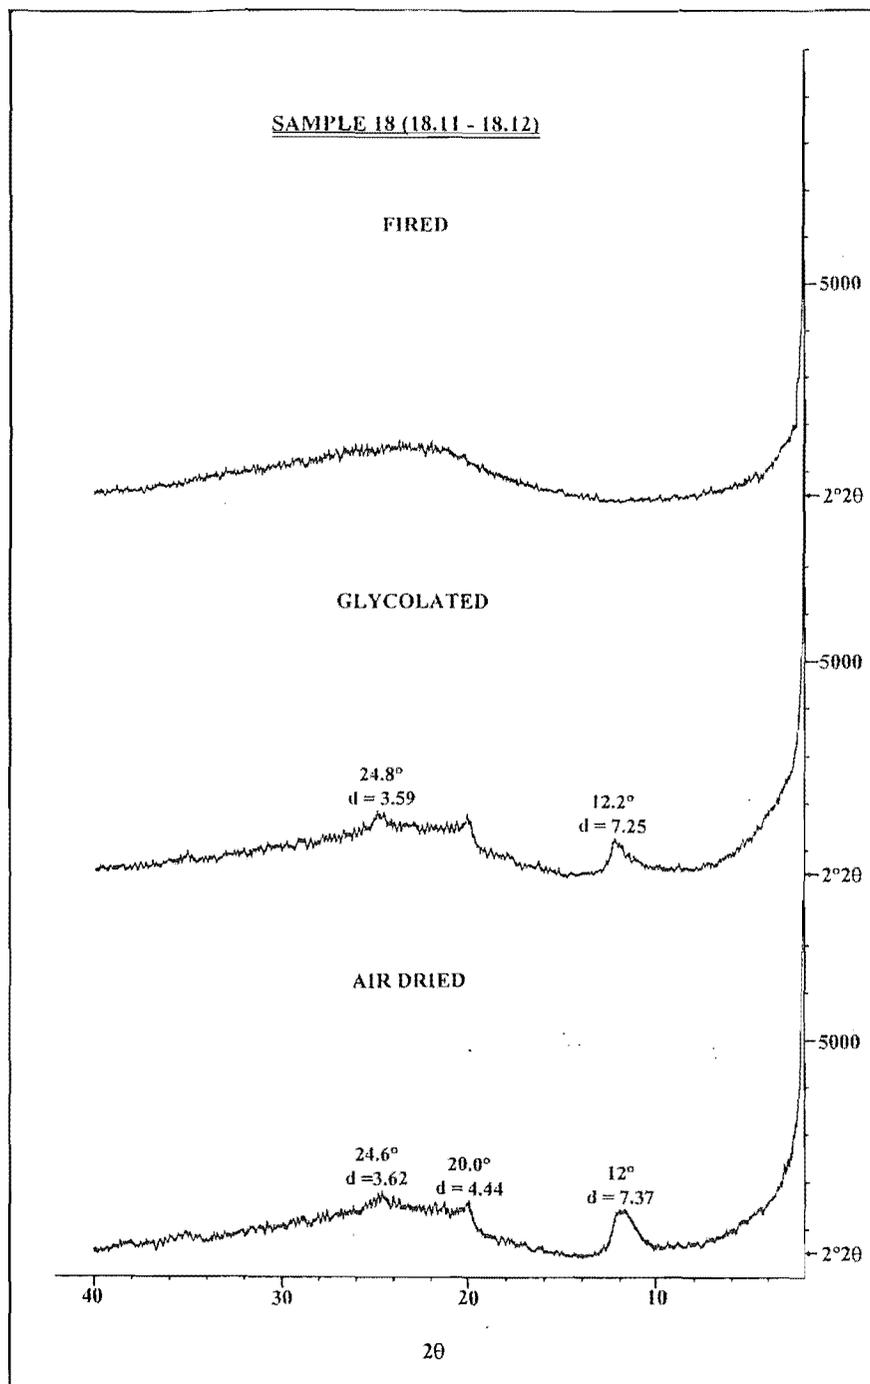
Figure A4.29 XRD profiles for sample 18.11-18.12 / 1 / 85 located within the lower bounding aquitard of the Upper Matua Subgroup

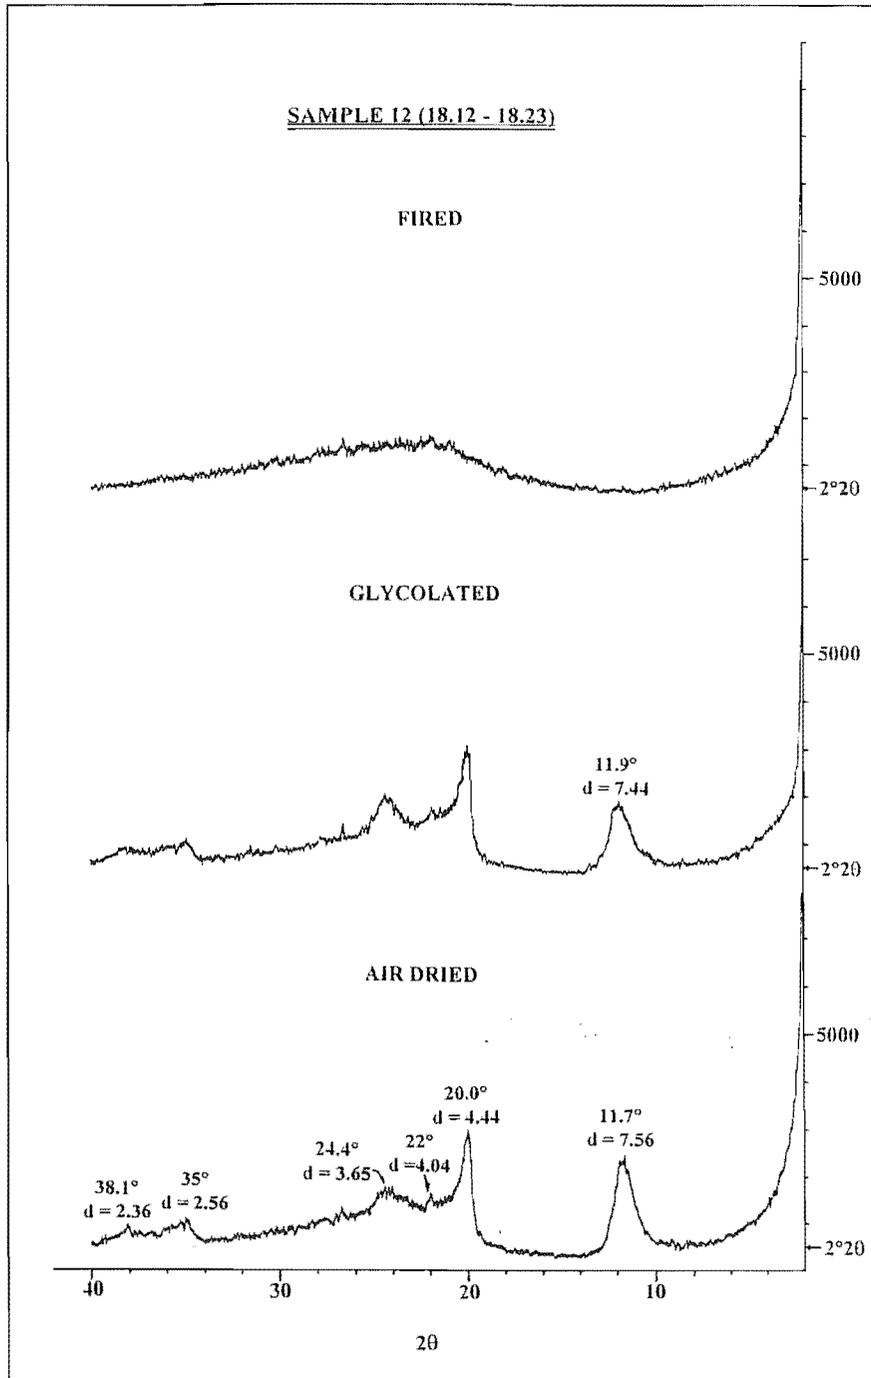
Figure A4.30 XRD profiles for sample 18.12-18.23 / 1 / 85 located within the lower bounding aquitard of the Upper Matua Subgroup

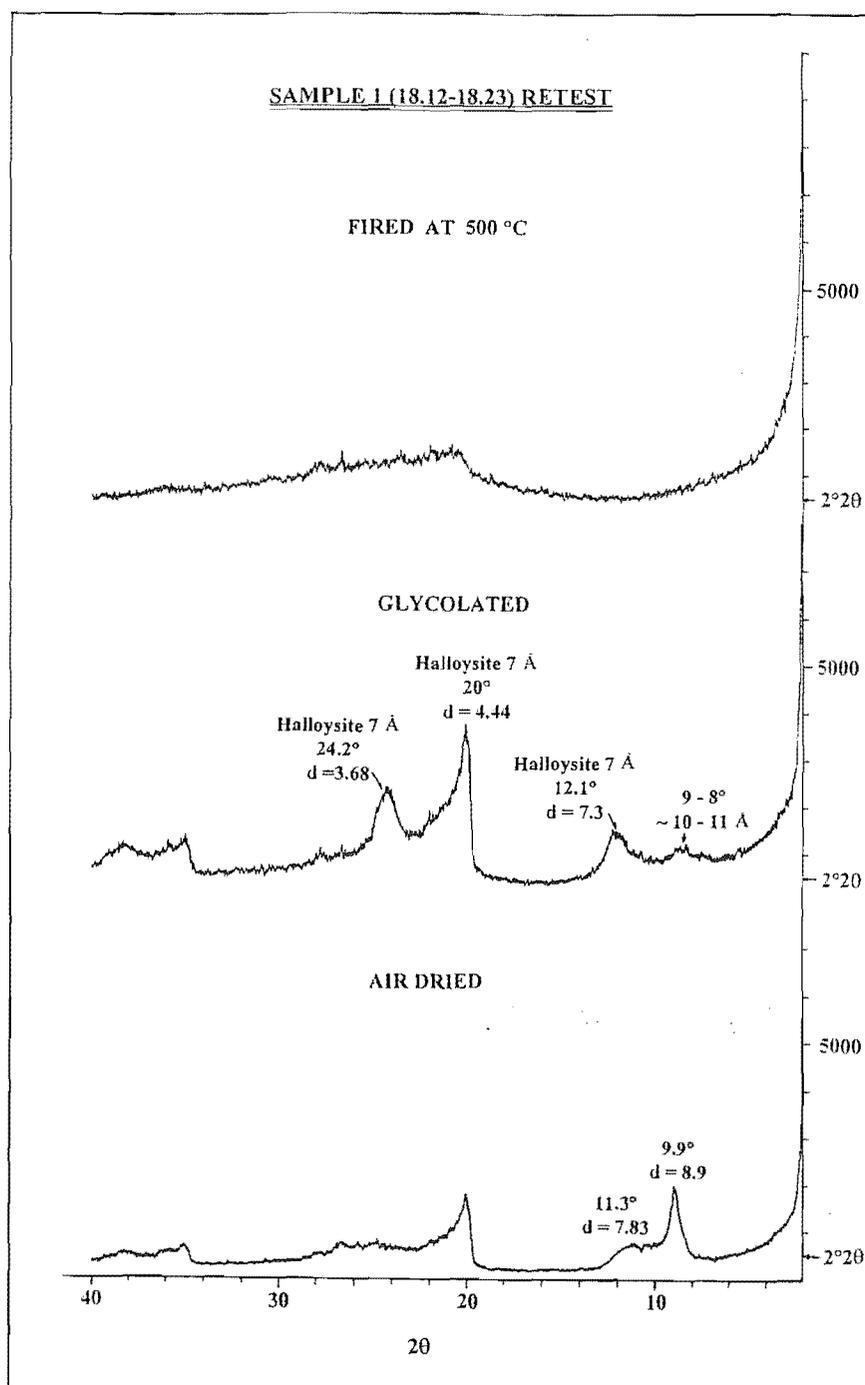
Figure A4.31 XRD retest profiles for the sample fired at 500°C, 18.12-18.23 / 1 / 85 located within the lower bounding aquitard of the Upper Matua Subgroup

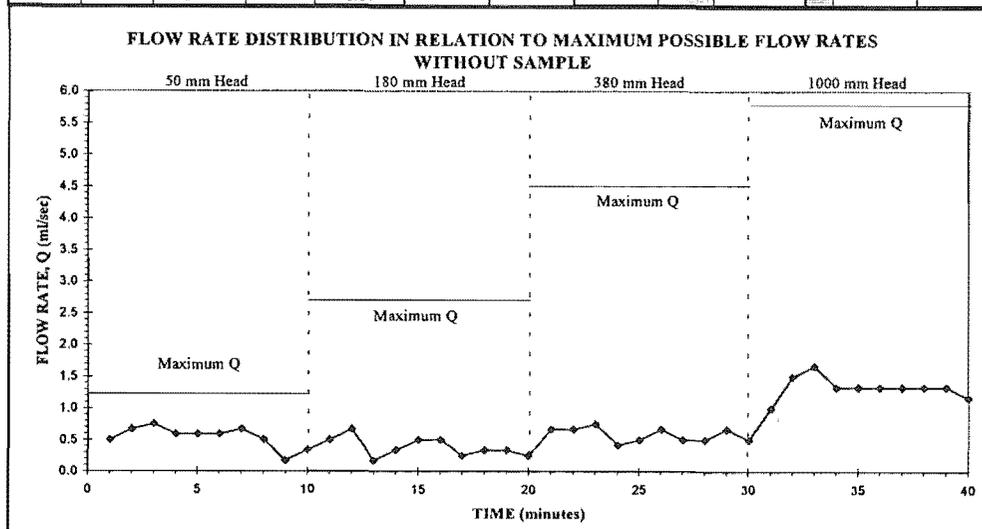
Table A4.8 Pinhole data sheet for sample 3.1 /1/330 indicating colour, particles falling, flow rate, and flow rate distribution plot.

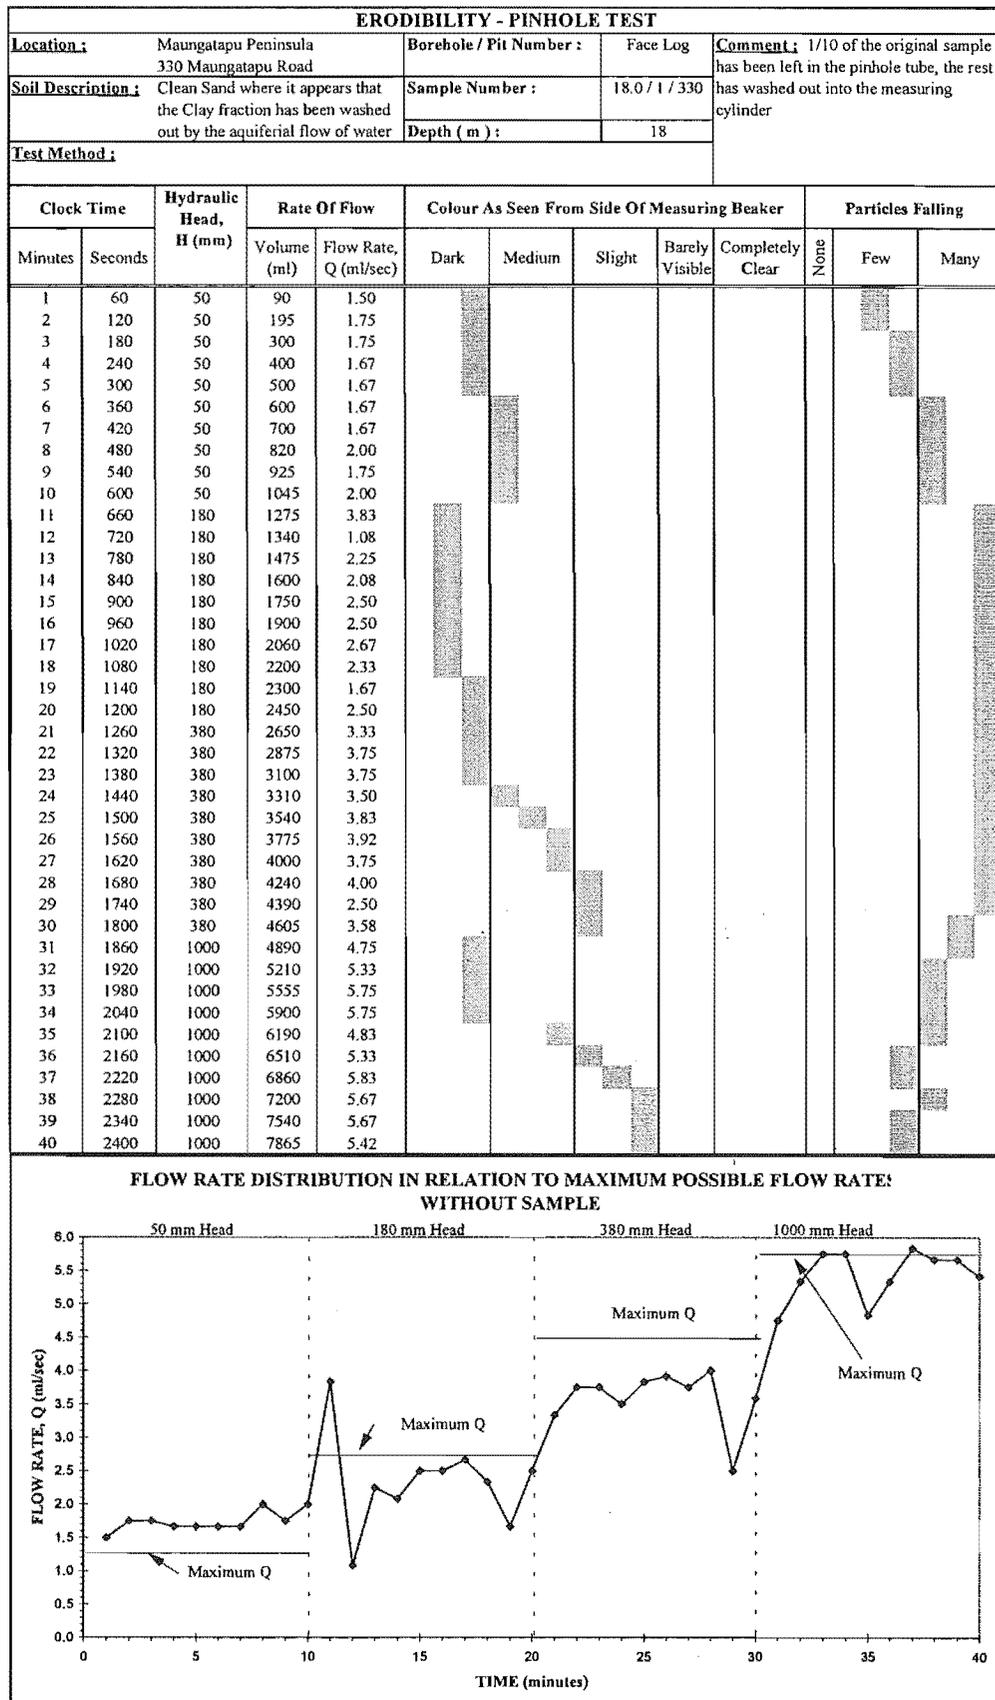
Table A4.14 Pinhole data sheet for sample 18.8/1/330 indicating colour, particles falling, flow rate, and flow rate distribution plot.
