## **South British House – A collaborative approach for the seismic upgrade of a building**

K L de Graaf  
Beca, Tauranga, NZ  
[kim.degraaf@beca.com](mailto:kim.degraaf@beca.com) (Corresponding author)

### **ABSTRACT**

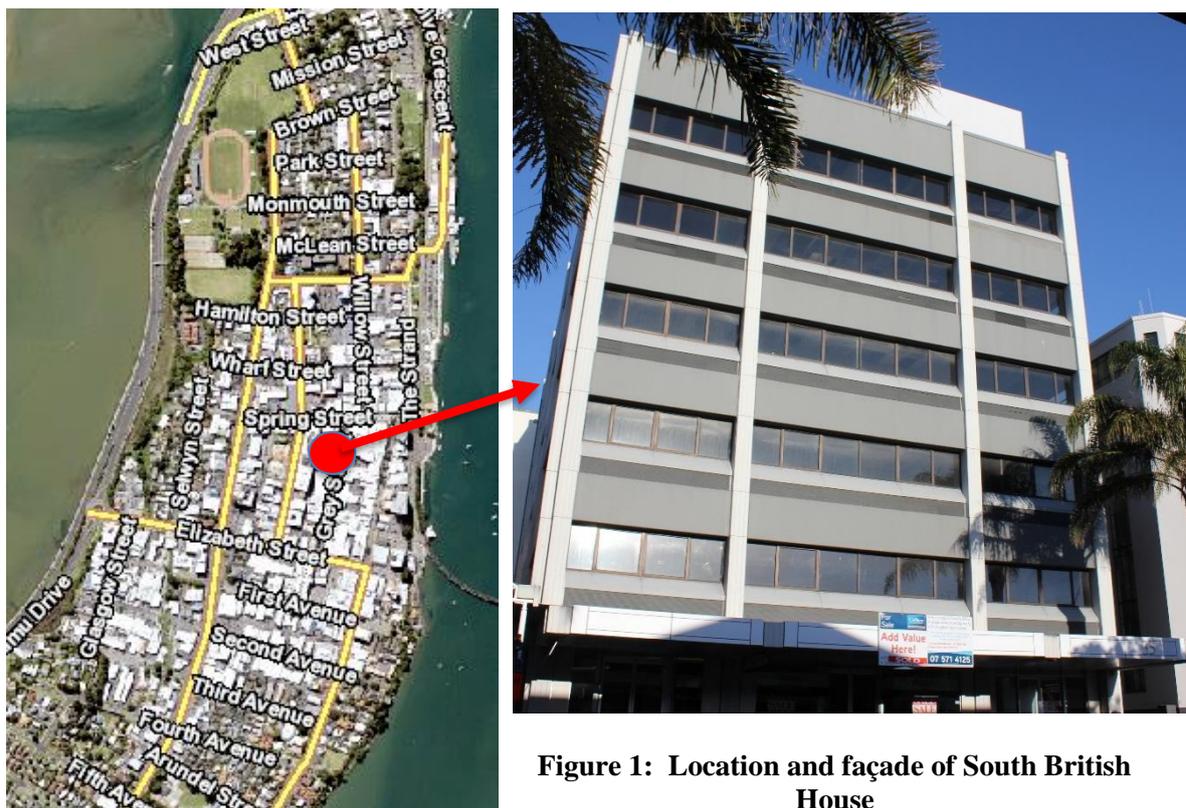
Figure 1: Location and façade of South British House

- Uncertainty surrounding the existing pile depths (there were no as-built records), although limited testing indicated there was variability in the lengths;
- An asymmetric structural system;
- The building is located within a constrained site (see Figure 1) surrounded by other buildings, an alley way and Grey Street. The majority of any foundation works would need to be carried out from within the building, i.e. with limited headroom;
- The presence of a significant underground service (11kV cable) running under the rear of the building which presented a significant constraint to investigation, design and construction;
- The Client's preference that the existing tenants at the front of the building on the ground floor should be able to remain during the works.

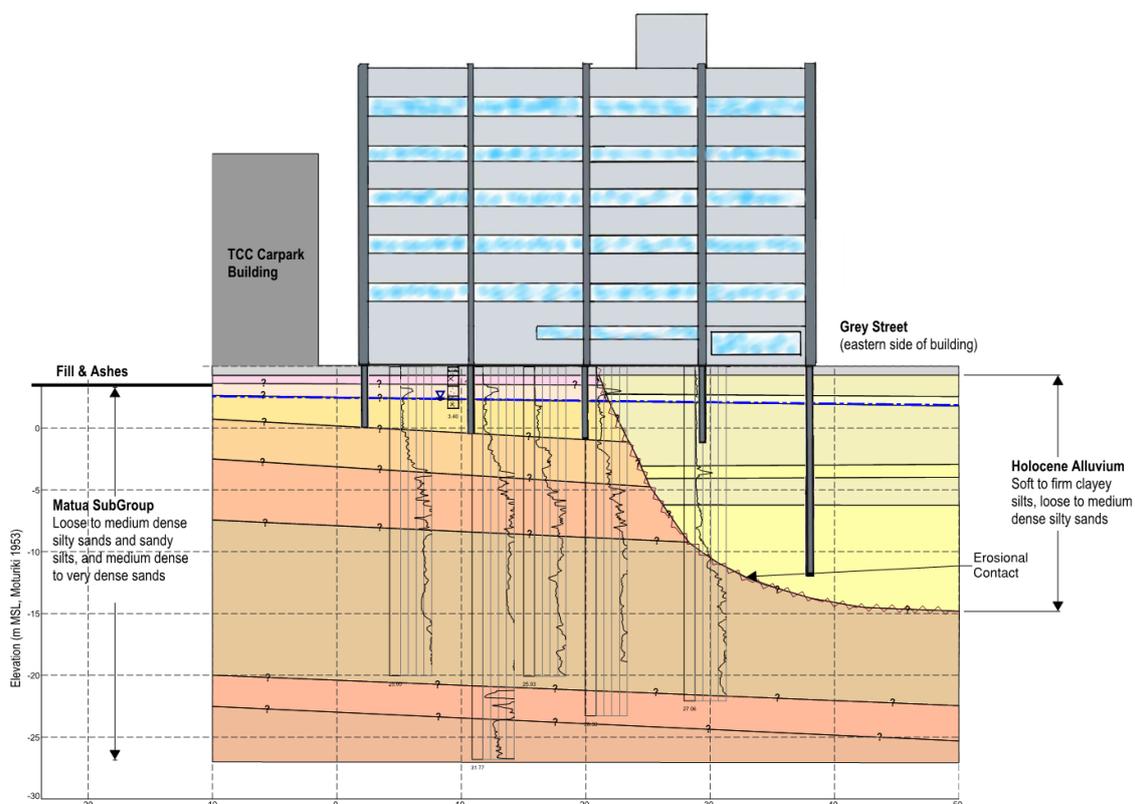
The soil profile was collated from both series of investigations and was found to comprise fill and undifferentiated volcanic ashes overlying silty sands and sandy silts of the Matua Subgroup, with groundwater at around 2.5m bgl (refer Figure 2). The Matua Subgroup soils are of Pleistocene age (c. 1.8 Ma to 10,000 years) and can be highly variable in their distribution. The Matua Subgroup soils encountered included a succession of loose to medium dense silty sands and sandy silts, and medium dense to very dense sands.

Figure 2: Soil profile and pile lengths southern side (Lavin et al, 2016)

Other methods to confirm the pile depths were considered destructive, and as the piles were to be retained, it was decided to complete the low strain pile integrity testing on the remainder of the piles. This concluded that with the exception of the Grey Street piles, all piles were founded at approximately 5-6m bgl, and thus founded on or within a liquefiable layer (Figure 2). The testing

was not conclusive for two piles located on the northern side, possibly shorter than anticipated, and this was considered during our analysis.

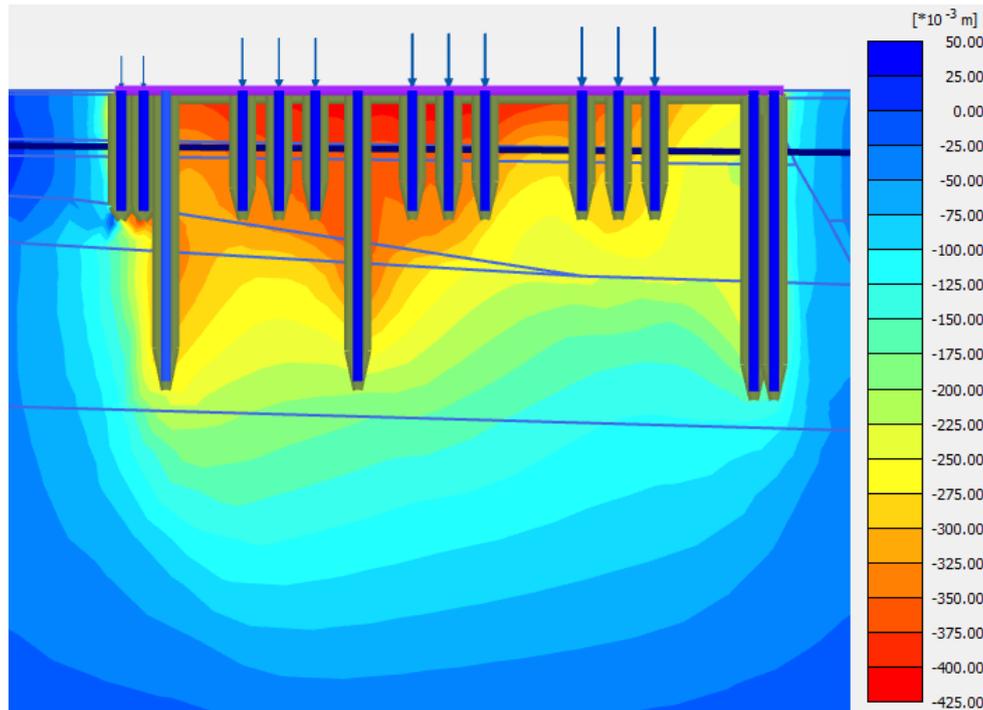
Figure 3: Plaxis2D analysis vertical settlements on northern side

The inclusion of additional piles, in the centre and western areas of the building, which are founded well beneath the liquefiable layers, was found to provide a robust solution with resilience of the foundations to liquefaction (Figures 3 and 4). The soil movements resulting from this solution were considered manageable for the superstructure when included in the eTABS structural model.

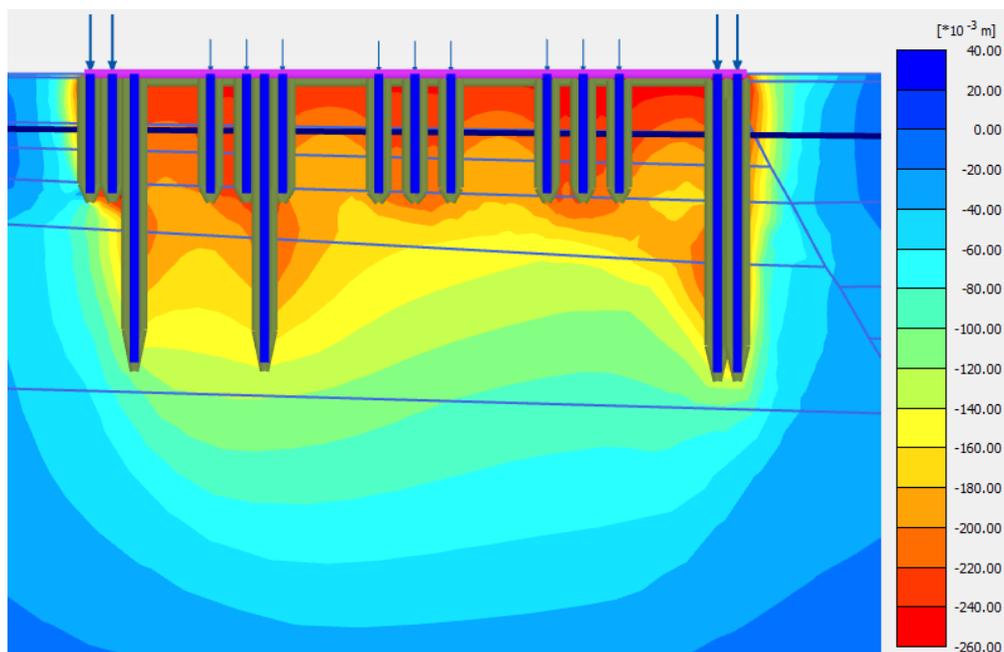
Figure 4: Plaxis2D analysis vertical settlements on southern side

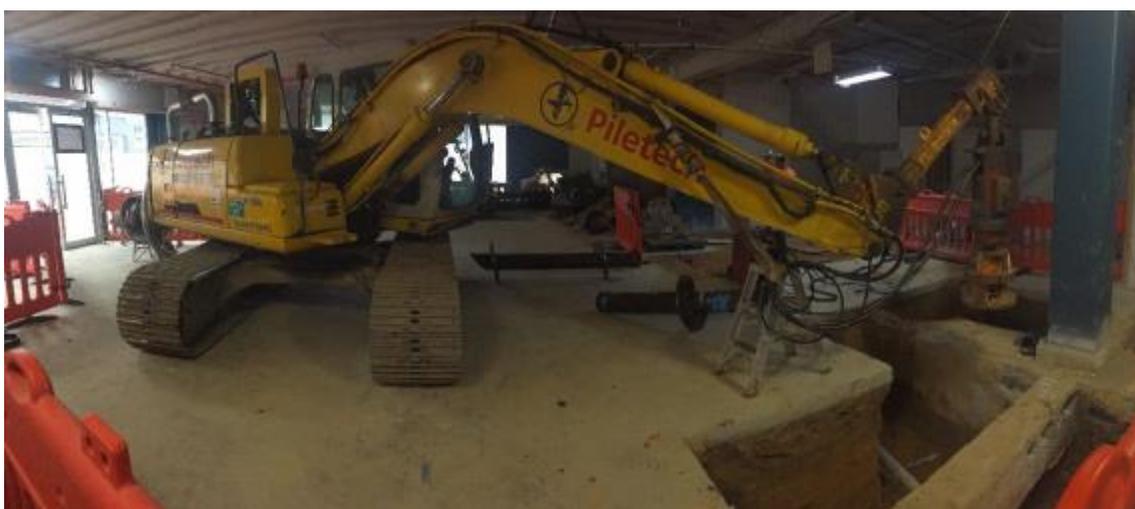
**Figure 6: Stage 1 installation of screw piles (Lavin et al, 2016)**

Initial screw piling began in late 2016 (Figure 6) with the raft foundation adjacent to the shear wall completed in June 2017. It is anticipated that construction of the foundations will be completed by the end of August 2017.
